Title: Return Vehicle Parts Analysis

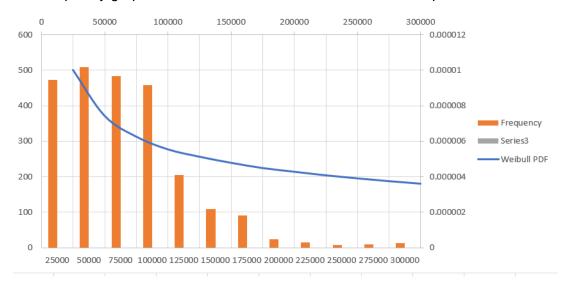
The frequency graph and fitted Weibull distribution for functional parts:

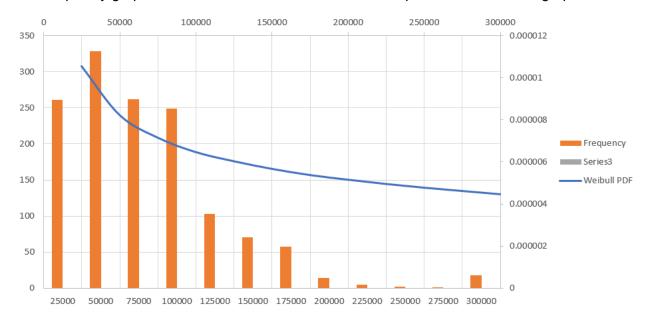
The frequency graph and fitted Weibull distribution for failed parts see in the next graph:

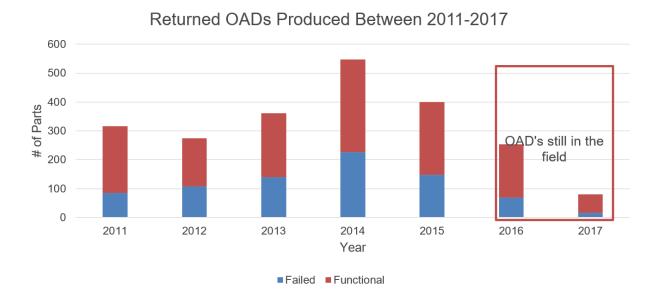
The over all relation between the failed part and still functional per production year was found:
