Five-Year Review Report

Third Five-Year Review Report for the Tar Creek Superfund Site Ottawa County, Oklahoma

September 2005

THIRD FIVE-YEAR REVIEW
Tar Creek Superfund Site
EPA ID# OKD980629844
Ottawa County, Oklahoma

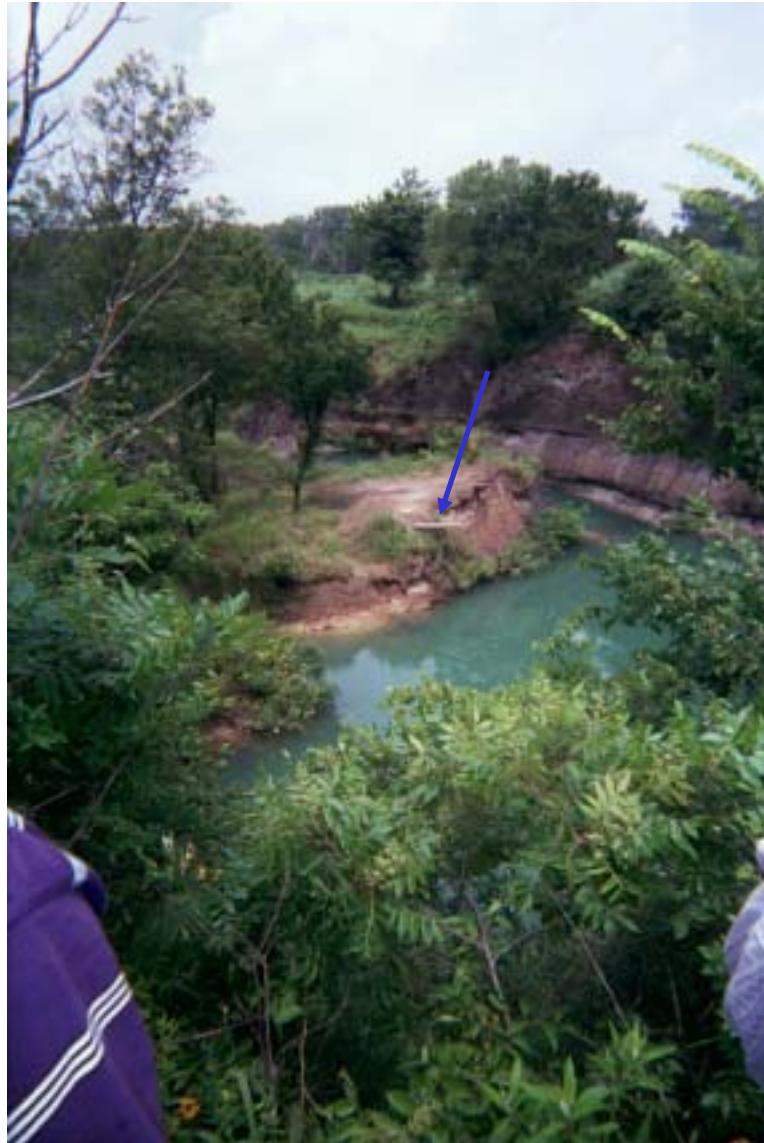
Photograph 59 of 76

Photo 60: View inside subsidence at the Big John Mine site, located in Kansas. A diving board is visible in the center of the picture (at blue arrow). ODEQ noted that this location is frequented by swimmers.
