# SIGNAL ANALYSIS REPORT (AC)

DUT: AC_DETECTOR | Timestamp: 31/10/2026, 10:09:46 am

*Hardware Capacitive Antenna [Channel: 230V] → Active Filtration → ADC → 10 kHz DSP*

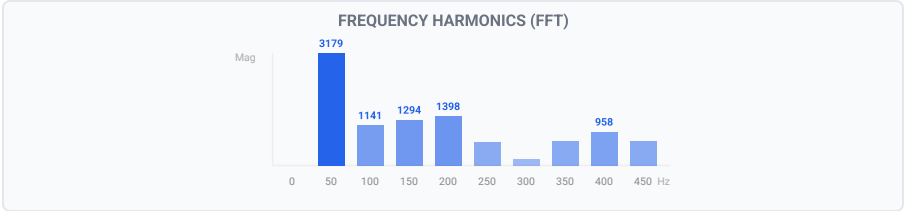
## BLC (Core Antenna) - Pure AC Waveform

| **Wave Type:** | Complex / Noisy |
| **DC Bias:** | 1645 mV |
| **True RMS:** | 30 mV |
| **Peak-to-Peak:** | 144 mV |
| **Dom. Freq:** | 50.0 Hz |
| **THD:** | 96.96% |

**[HIGH DISTORTION]**
