PRELIMINARY SURVEY REPORT**August 13, 2025**

Your Ref.	:		Our Ref.	:	25-116868
Date of Assignment	:	August 5, 2025	Inspected by	:	<surveyor name>
Date of Survey	:	August 6 and 12, 2025	Place of Survey	:	<survey location>
Vessel/Carrier	:	<vessels name>	Voyage	:	<voyage number>
Port of Discharge	:	<port name>	Date of Discharge	:	August 6, 2025
Consignment	:	1360 boxes of "Frozen Cherries, 18,509.60kg" from 40ft refrigerated container TEMU9238382 transloaded in route (Panama) to MSDU9734453			
Shipper Delivering Carrier	:	Shipper details	Consignee	:	<consignee details>
	:		Waybill No.	:	<way bill number>
Date of Delivery	:	August 7, 2025	Cargo Exceptions:	:	Alleged Damage to Cargo

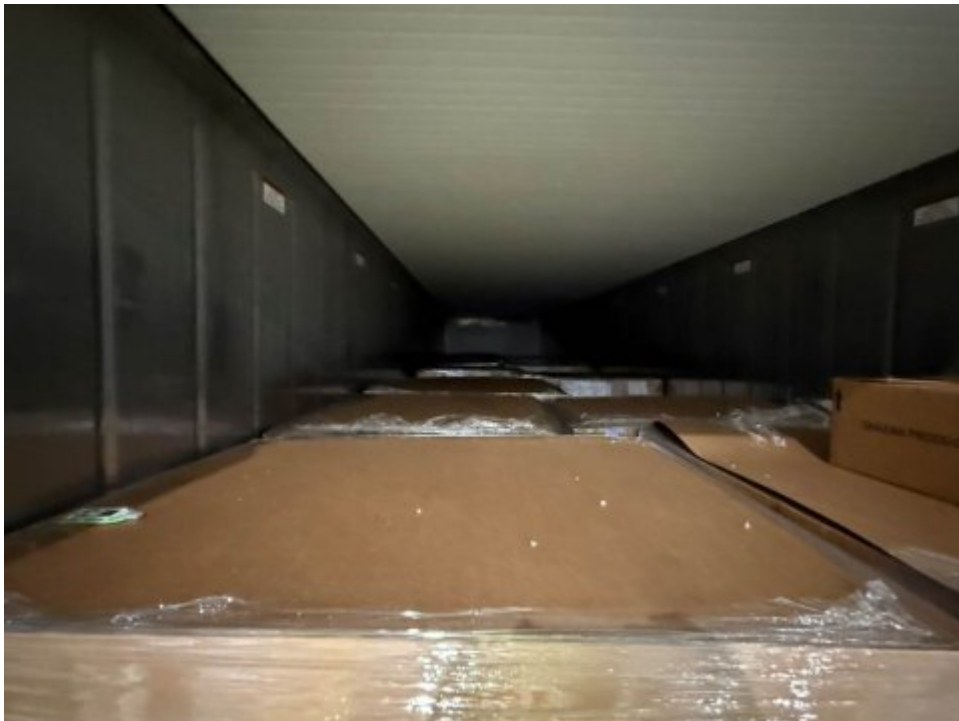
6.

Cartons appeared crisp and showed no signs of exposure to moisture. Surveyor opened nine cartons from various pallets for inspection. Cartons showed no sign of leakage or water damage. Product had slight frosting on surface and appeared consistent in all cartons. No signs of product thawing and leaking or malodor were observed. Overall, the cargo appeared to be in apparent good condition.

Slight frosting near the doors

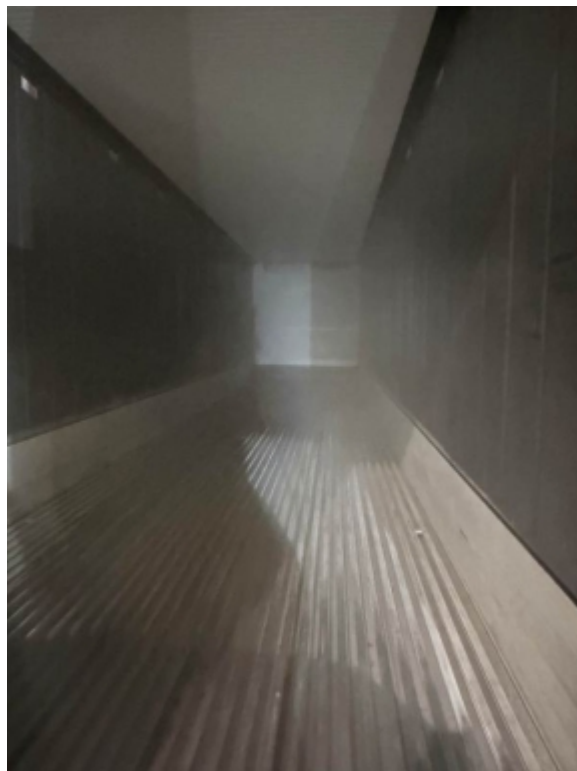
10.

Silver nitrate test on three pallets was negative for chlorides
Container floor was dry and clean.

Empty container

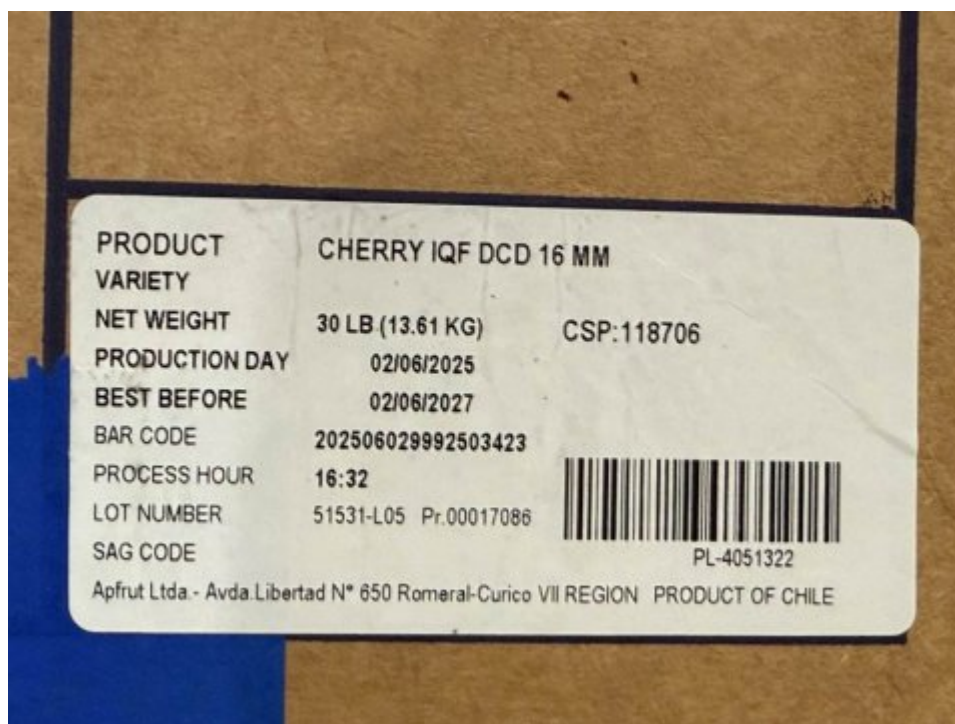
13.

Typical labels
