INDOOR ENVIRONMENTAL ASSESSMENT

Address of the Inspected Property: **31 Ross St E, Smiths Falls, ON K7A 4V7, Canada**

Date: September 3, 2026

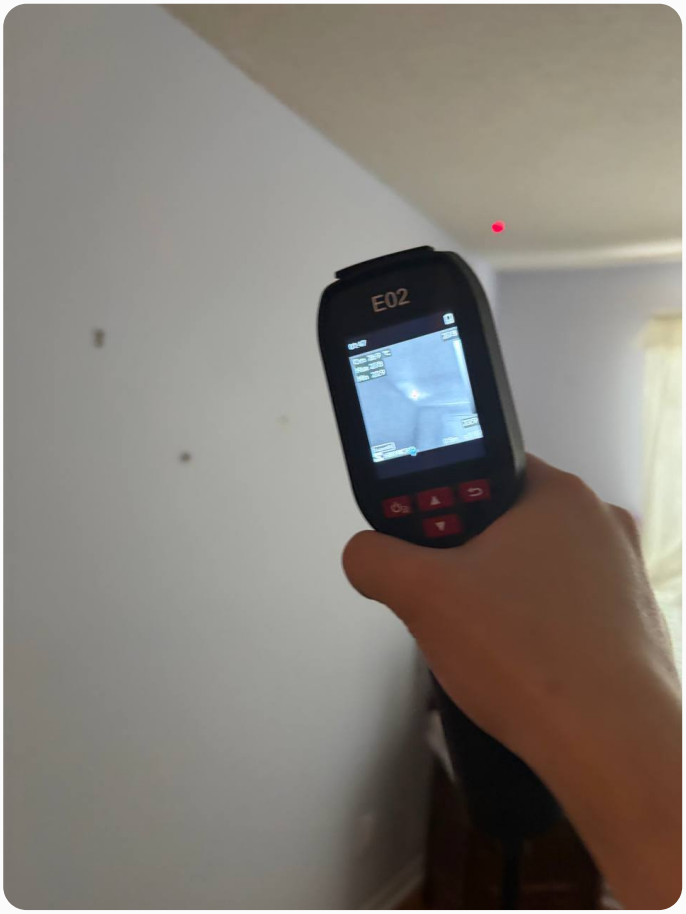
• Thermal imaging revealed multiple anomalies on the ceiling indicative of disturbed and unevenly distributed insulation. Such conditions can result in thermal inefficiencies and should be corrected to ensure optimal energy performance.

• Anomalies detected at the attic hatch through thermal imaging suggest similar issues with insulation distribution or air sealing around this area which may contribute to heat loss or gain depending on seasonal conditions.

Thermal anomalies throughout the property

• Ensure that the insulation in the attic meets current standards (R-50) and is evenly distributed throughout the space to prevent heat loss and potential condensation issues which could contribute to mold growth.

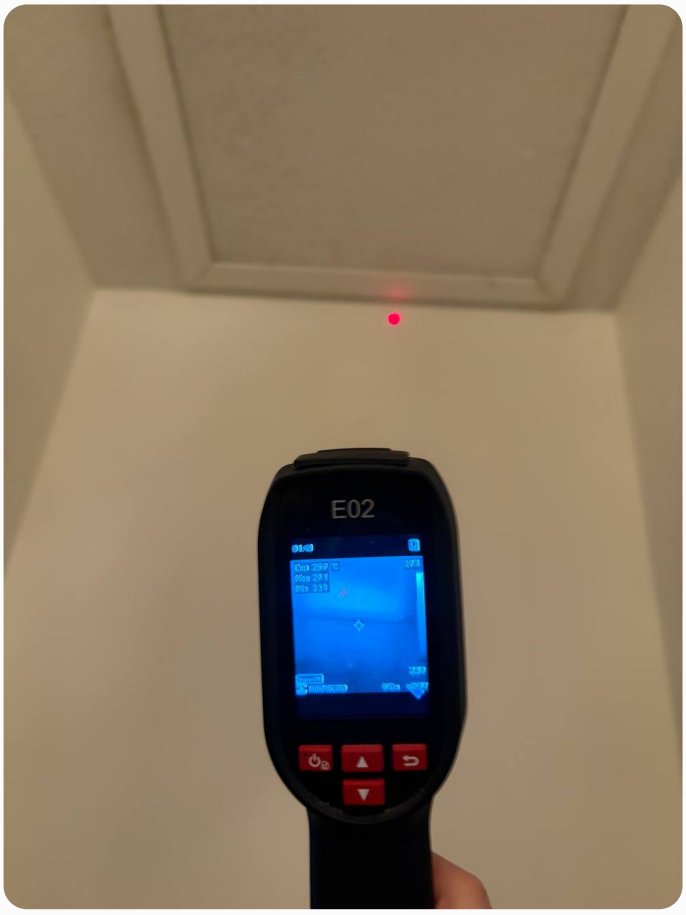
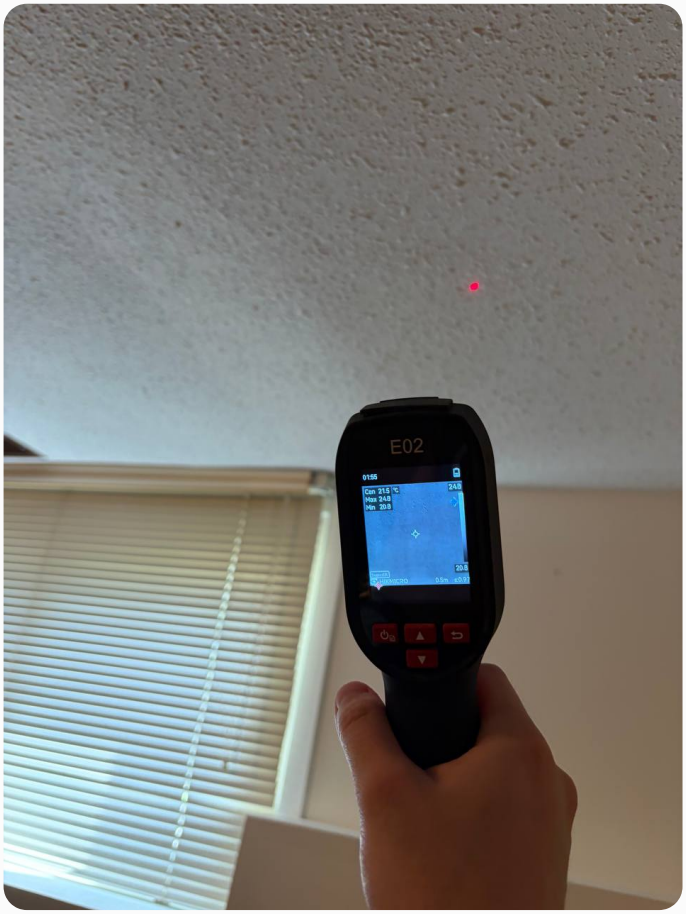
Thermal anomalies throughout the property

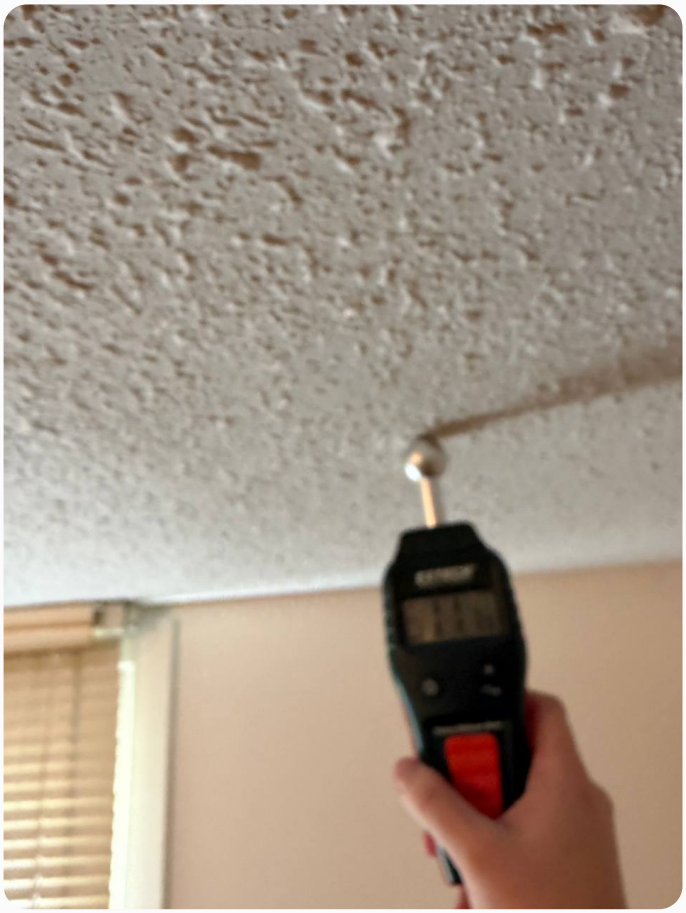
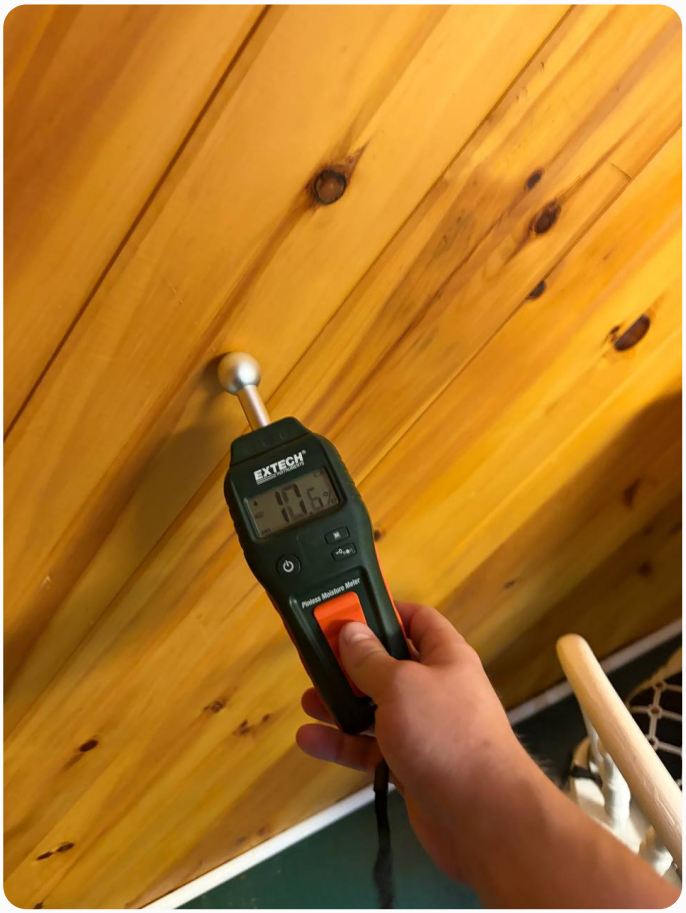
• Throughout various sections of property inspected, several exposed holes were noted in materials suspected of containing asbestos further necessitating cautionary measures until confirmed testing results are obtained regarding their composition status ensuring safety.

Exposed holes on the popcorn ceiling

• Address exposed holes on popcorn ceilings throughout the property by containing them properly until testing confirms if they are asbestos containing or not.
