INDOOR ENVIRONMENTAL ASSESSMENT

Address of the Inspected Property: **2575 Rue de la Canardière, Laval, QC**

Date: August 26, 2026

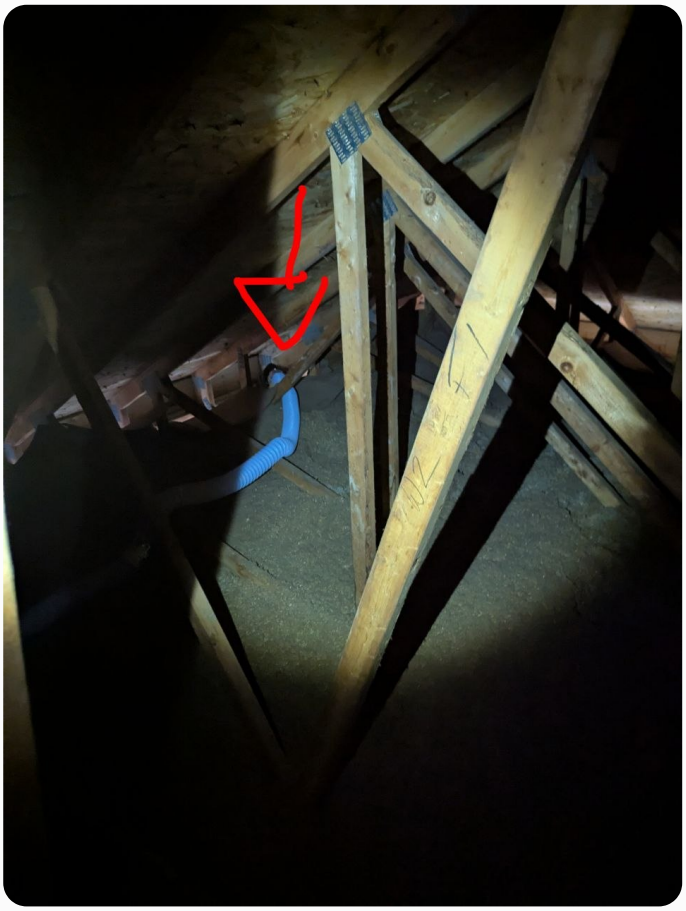
A few small patches of visible apparent mold were observed in the attic.
Attic insulation appears to be in good condition.
Relative humidity was within an acceptable range at the time of inspection.
No active moisture was detected.
No noticeable odor was present.
Swab testing returned a **positive result for mold**.

Visible mold

Remediation/topical treatment of the affected attic areas is recommended.
