Navi Mumbai airport build-out

Navi Mumbai International Airport site, Maharashtra | Before - Sentinel-2 - 2019-01-13 to After - Sentinel-2 - 2024-12-17

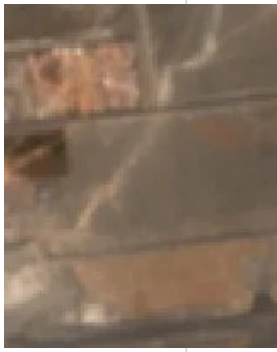
Water receded

Rank 5 of 265 | Critical priority

Size	9.61 ha (96,100 m2), about 13 football pitches
Confidence	97 %
Location	18.99084, 73.06284 (open in Google Maps)
What it is	Water that was there before has gone.
Why flagged	built-up index rose (+0.17), vegetation index rose (+0.22), water index fell (-0.38), SWIR/blue ratio (paved surfaces are flatter) rose (+1.63)
What to do	Check first. A large, strong change; send someone or review recent imagery now.
