Used Car Inspection Report

ID: 3022
Engineer: MD SADDAM HUSSAIN
Customer Name: AYON ROY

Car: GRAND I10 NIOS

Car Registration Number: WB12BP0584

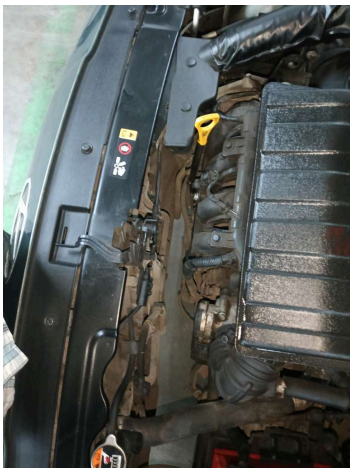
Radiator Core Support

Radiator Core Support: OK

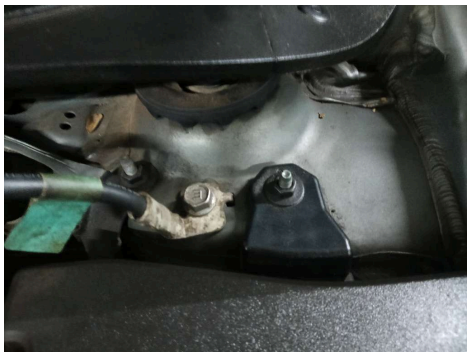
Passenger Strut Tower Apron

Passenger Strut Tower Apron: OK

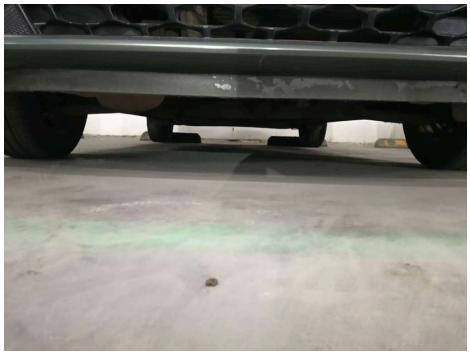
Front Bonnet UnderBody

Front Bonnet UnderBody: OK

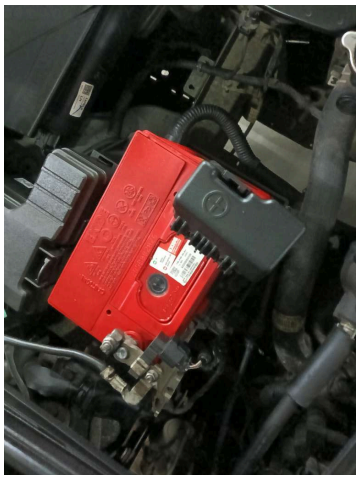
Wiring

Wiring: OK

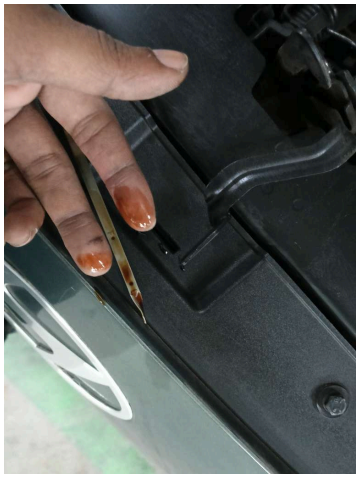
Engine Oil Quality

Engine Oil Quality: CLEAN AND COMPLETE

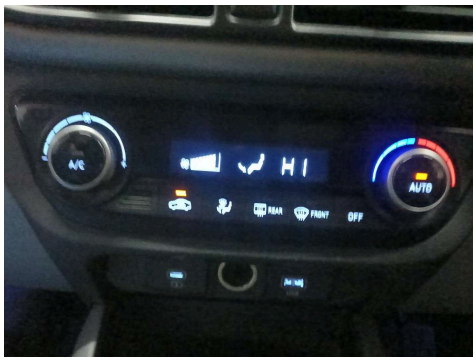
AC Hot Mode Temperature

AC Hot Temperature: 27.0

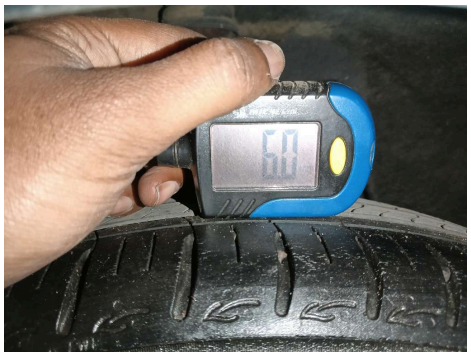
Driver Back Tyre Depth Check: GOOD

Driver Back Tyre Manufacturing Date: 2623

Driver Back Tyre Shape: OK

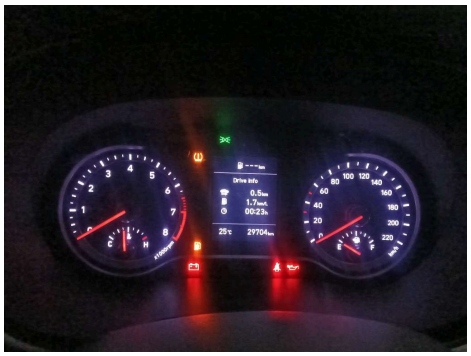
Car KM Reading

Car KM Current Reading: 29703
