Inspection report - FS-DEMO-0001. Generated 10/13/2026, 3:36:44 PM. Final review completed 10/13/2026, 3:36:45 PM by Inspector.

Claim / inspection reference: FS-DEMO-0001
Property: 100 Sample Street, Testville, ST, 00000
Insured / contact: Alex Example (fictional)
Property type: Single-family dwelling, 1 story, built 2004
Roof covering (as recorded): Laminated composition shingles, one layer (as observed)
Reported loss type(s): Hail, Wind, Water
Reported date of loss: 2026-09-21
Inspection date: 2026-10-02
Inspector: Not recorded
Workflow status: In progress

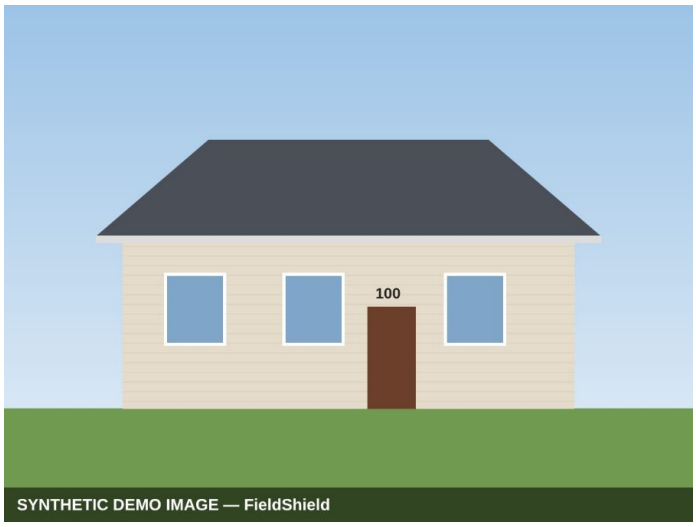
Main dwelling > Front elevation
- Front elevation siding and windows: no visible dents, cracks or tears. (Component: Siding; No damage observed; Photo 1)
  Photo 1 filed under this area.

Photo 1 - Main dwelling > Front elevation
Front elevation overview with address marker

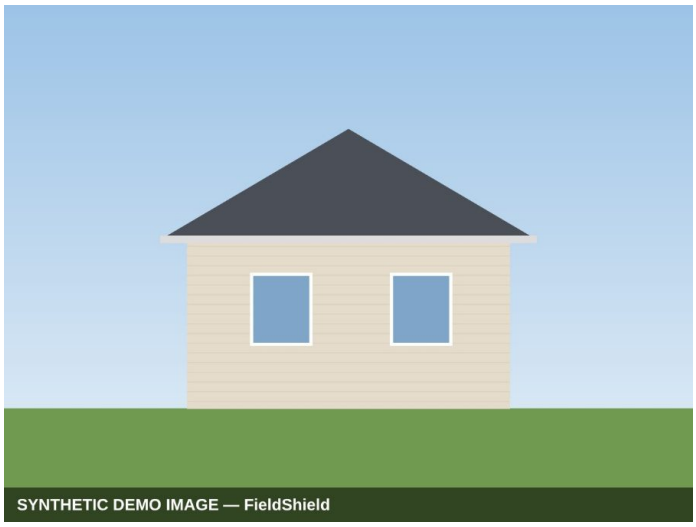
Main dwelling > Left elevation
- Left elevation siding: no visible damage. (Component: Siding; No damage observed; Photo 2)
  Photo 2 filed under this area.

Photo 2 - Main dwelling > Left elevation
Left elevation overview

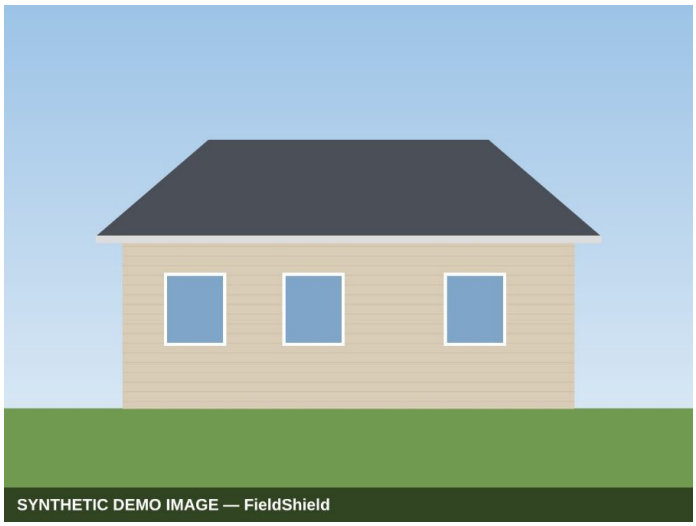
Photo 3 - Main dwelling > Rear elevation
Rear elevation overview

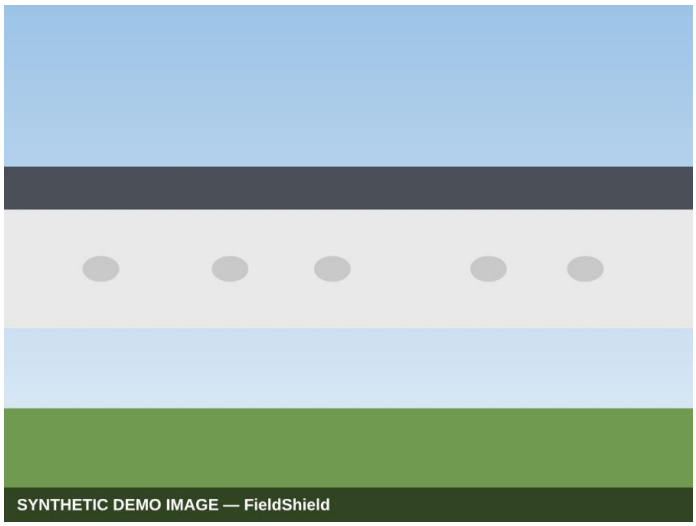
Main dwelling > Rear elevation
- Rear gutter has multiple dents along the front face. (Component: Gutter; Damage observed; Photo 4)
  Photos 3, 4 filed under this area.

Photo 4 - Main dwelling > Rear elevation
Rear gutter - dents along front face

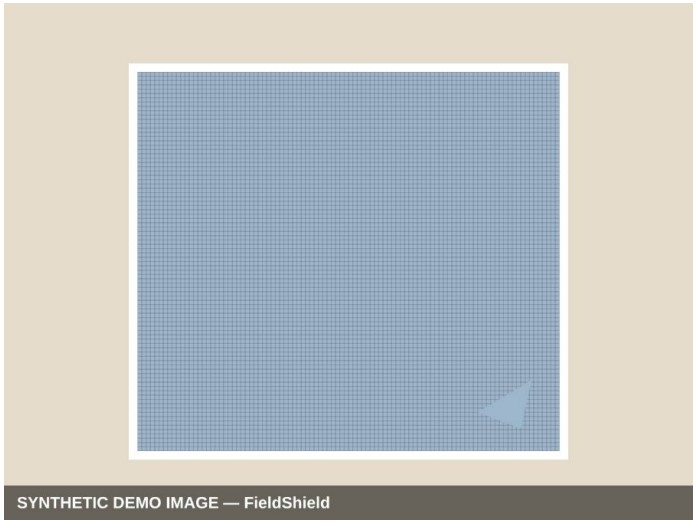
Main dwelling > Right elevation
- Window screen on right elevation: no tears observed. (Component: Window screen; No damage observed)
- Window screen on right elevation has a small tear near the lower corner. (Component: Window screen; Damage observed; Photo 5)
  Photo 5 filed under this area.

Type	Issue
contradiction	Contradiction at Main dwelling > Right elevation (Window screen): recorded both as "damage observed" and "no damage observed". Review and correct one of the entries.
warning	Possible unsupported conclusion: the direct observation "Front slope test square: 9 circular marks with granule disp..." includes cause language. Consider recording the cause as a preliminary interpretation.
warning	Preliminary interpretation "Kitchen ceiling stain location may correspond to the roof a..." has no linked photographs or measurements supporting it.

Photo 5 - Main dwelling > Right elevation
Right elevation window screen

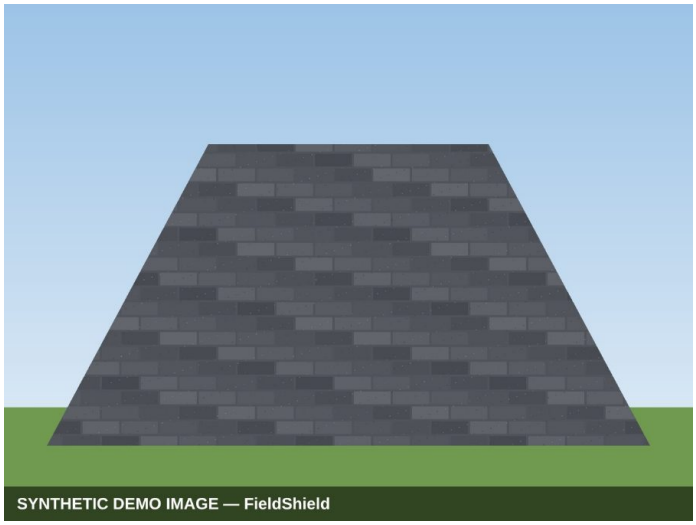
Main dwelling > Roof
- Roof covering is laminated composition shingle, one layer, granule loss visible at several locations. (Component: Roof covering; Damage observed; Photo 6; Measurements: Roof plane Front slope: 900 sq ft [measured]; Roof plane Rear slope: 900 sq ft [measured])
  Photo 6 filed under this area.

Photo 6 - Main dwelling > Roof
Roof overview from front

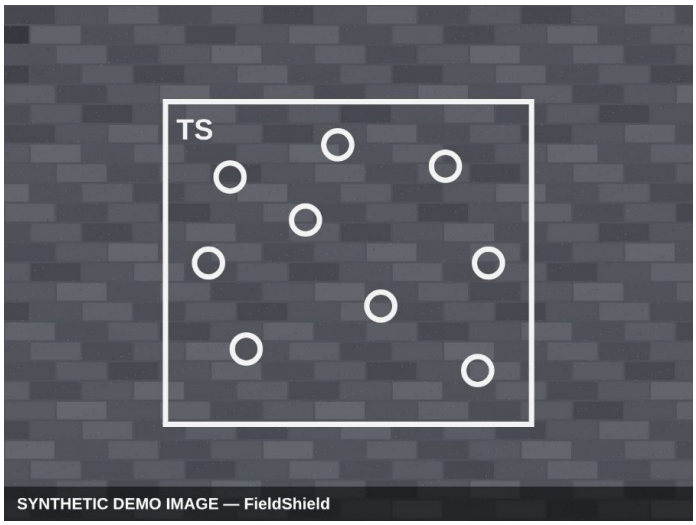
Main dwelling > Front slope
- Front slope test square: 9 circular marks with granule displacement caused by hail. (Component: Roof covering; Damage observed; Photos 7, 8; Measurements: Roof plane Front slope: 900 sq ft [measured])
  Photos 7, 8 filed under this area.

Photo 7 - Main dwelling > Front slope
Front slope test square (10 ft × 10 ft) marked in chalk

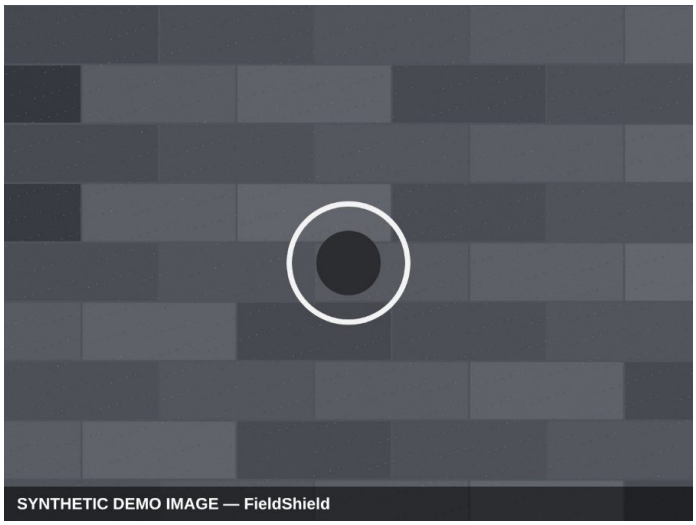
Photo 8 - Main dwelling > Front slope
Front slope - circular mark on shingle, chalk circled

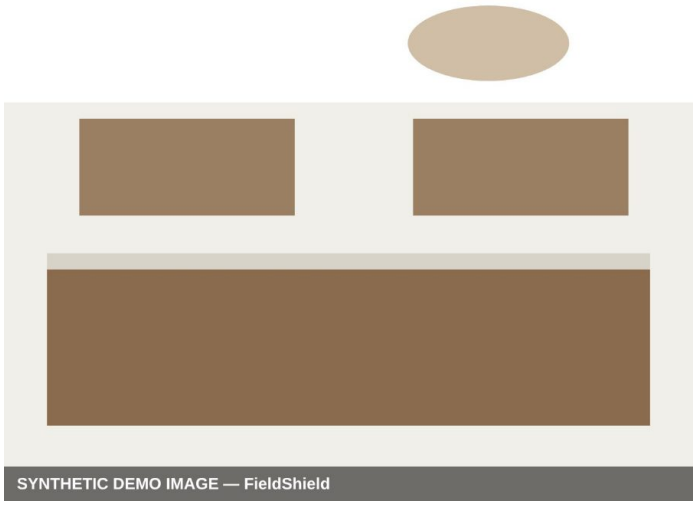
Main dwelling > Kitchen (Level 1)
- Kitchen ceiling has a brown ring-shaped stain approximately 3 ft by 2 ft near the exterior wall. (Component: Ceiling drywall; Damage observed; Photo 9; Measurements: Room Kitchen: floor 168 sq ft, walls 382 sq ft [measured])
  Photo 9 filed under this area.

- Main dwelling > Kitchen (Level 1): Kitchen ceiling stain location may correspond to the roof area above the front slope.

- Main dwelling > Kitchen (Level 1): Was the attic accessible above the kitchen? Attic not entered during this visit.

Photo 9 - Main dwelling > Kitchen (Level 1)
Kitchen overview

- Follow-up: Return with working moisture meter for kitchen readings (due 2026-10-09)
- Follow-up: Measure right hip end height
- Gap: Main dwelling > Front elevation: possibly missing close-up photo

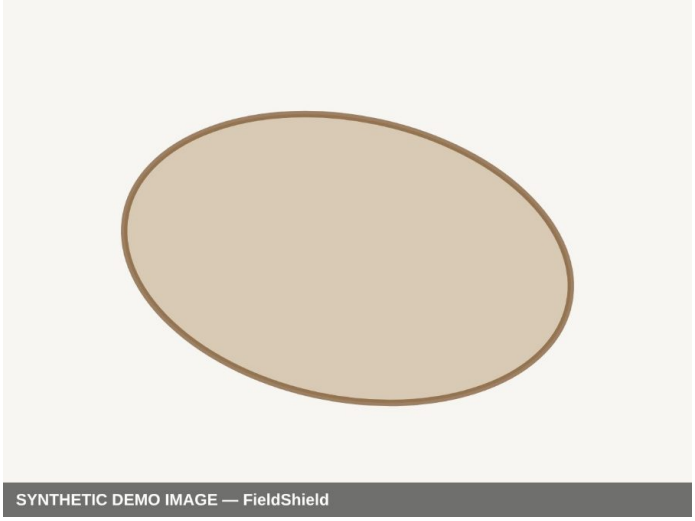
Main dwelling > Kitchen (Level 1)	Ceiling drywall	Kitchen ceiling has a brown ring-shaped stain approximately 3 ft by 2 ft near the exterior wall.	Room Kitchen: floor 168 sq ft, walls 382 sq ft [measured]	Photo 9	Direct observation
