TEST REPORT

Report No.: 53673

Test Requested: KESTERNICH TEST

Sample Descr. (#): UNALLOYED ZINC COATED PART CODE 17825060000 - BASE MAT. S420MC 6 mm THK-NO WELDING COMPONENTS

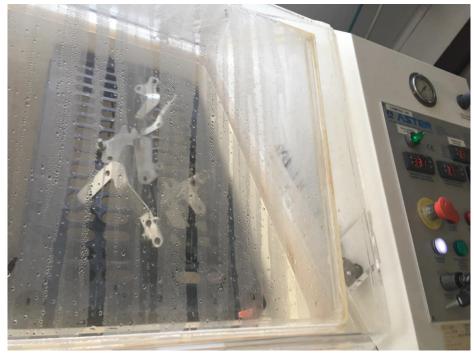
SIDE A : NO BASE METAL CORROSION SIDE B : NO BASE METAL CORROSION

NOTE: COMPLIANCE TO TL217:2009 SPECIFICATION
