TEST REPORT

Report No.: 53672

Test Requested: KESTERNICH TEST

Sample Descr. (#): UNALLOYED ZINC COATED PART CODE 17825050000 - BASE MAT. S420MC 6 mm THK-NO WELDING COMPONENTS

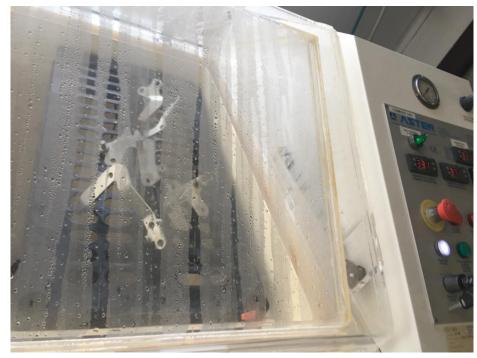
SIDE A : NO BASE METAL CORROSION SIDE B : NO BASE METAL CORROSION
