**TEST REPORT**

**Report No.:** 53691

Test Requested: HUMIDITY TEST

Sample Descr. (#): UNALLOYED ZINC COATED PART CODE 17825030000+KTL - BASE MAT. S420MC 4 mm THK-3 WELDING COMPONENTS

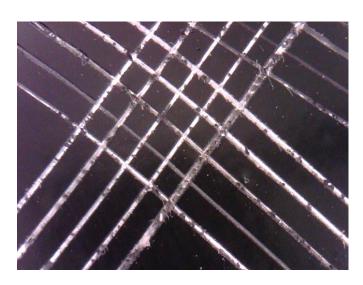
No blistering, no zinc corrosion, no base metal corrosion; Cross cut test ISO 2409 rating <=1

SAMPLE AFTER THE HUMIDITY TEST

CROSS CUT PHOTO
