Detailed Diagnostic Report (DDR)

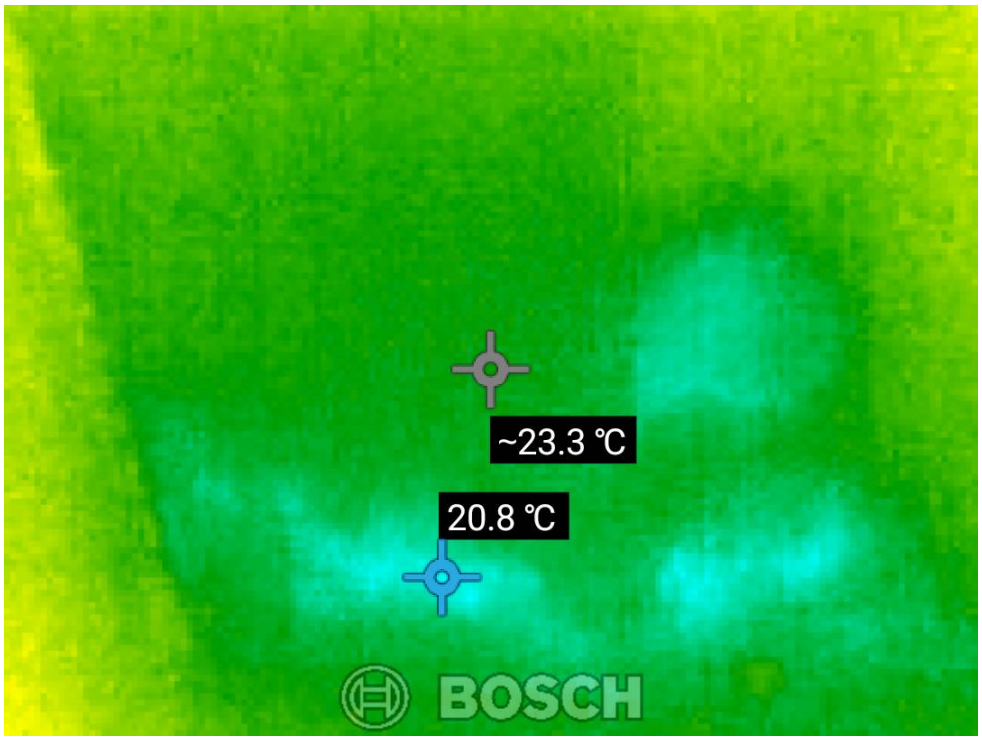
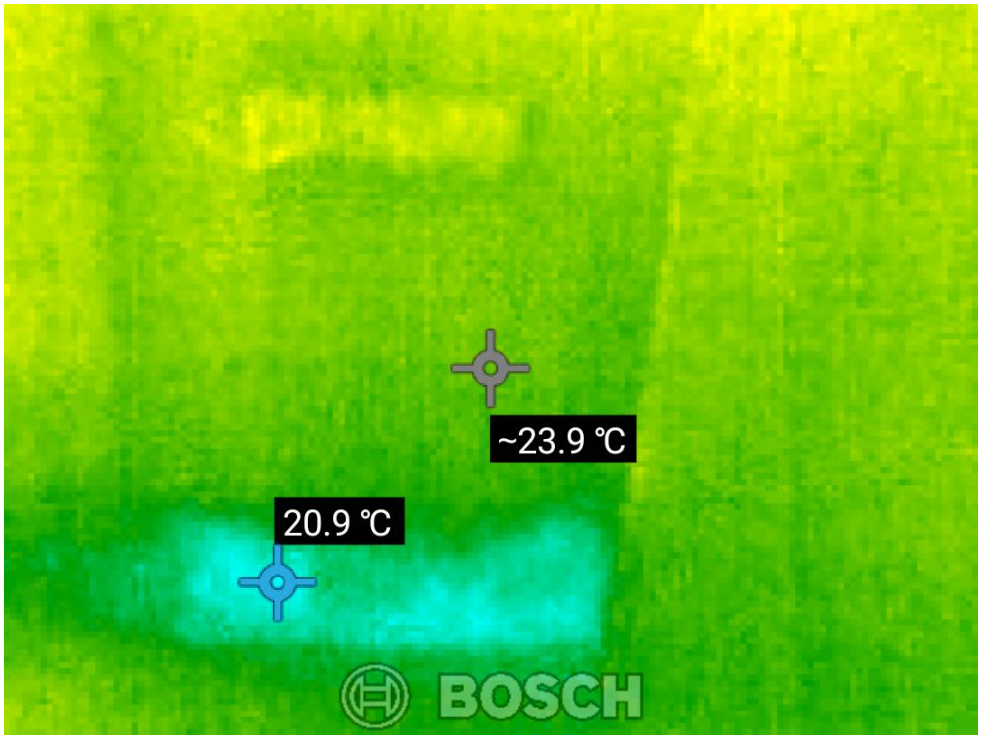
Hall

- Observation: Dampness at skirting level.

- Conduct detailed plumbing inspection and repair all concealed leaks, including Nahani trap and plumbing joints.
- Re-grout and seal all tile joints in bathrooms to prevent water ingress.
- Repair and seal external wall cracks; clean and treat algae/moss growth.

- Apply appropriate waterproofing measures on skirting levels and external walls.
- Address parking area seepage by identifying and fixing source of water ingress.
- Monitor repaired areas for recurrence of dampness.
- Consider repainting affected areas after repairs with moisture-resistant paint.
- Use thermal imaging periodically to detect hidden moisture.
