PROJECT AD-KY041 · 2440 Regency Road · Lexington, KY 40503

CONFIDENTIAL · STRATEGIC FORENSIC AUDIT

FORENSIC ENVELOPE AUDIT · V1.0

Strategic Thermal Reconnaissance Report

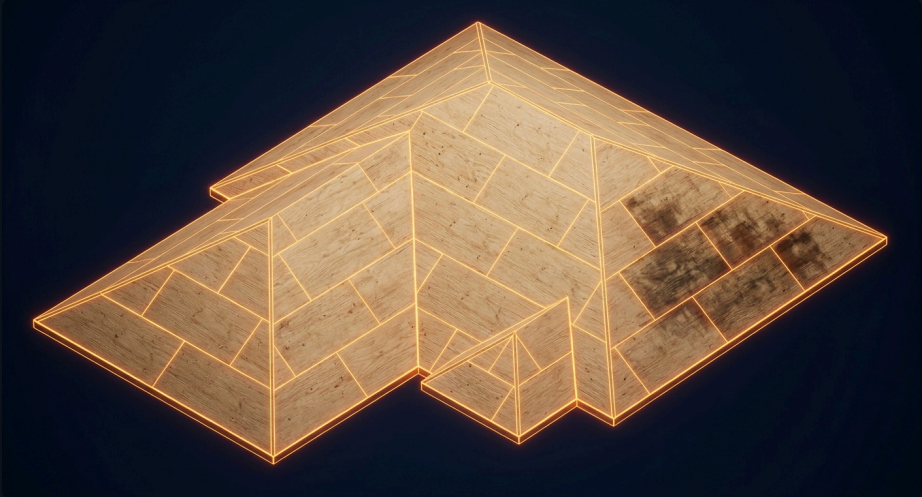
LAYER 02 · DECKING + UNDERLAYMENT

7/16" CDX · I&W shield at valleys/eaves · 2 existing shingle layer(s)
