PROJECT AD-KY041 · 2440 Regency Road · Lexington, KY 40503

FORENSIC ENVELOPE AUDIT · V1.0

Strategic Thermal Reconnaissance Report

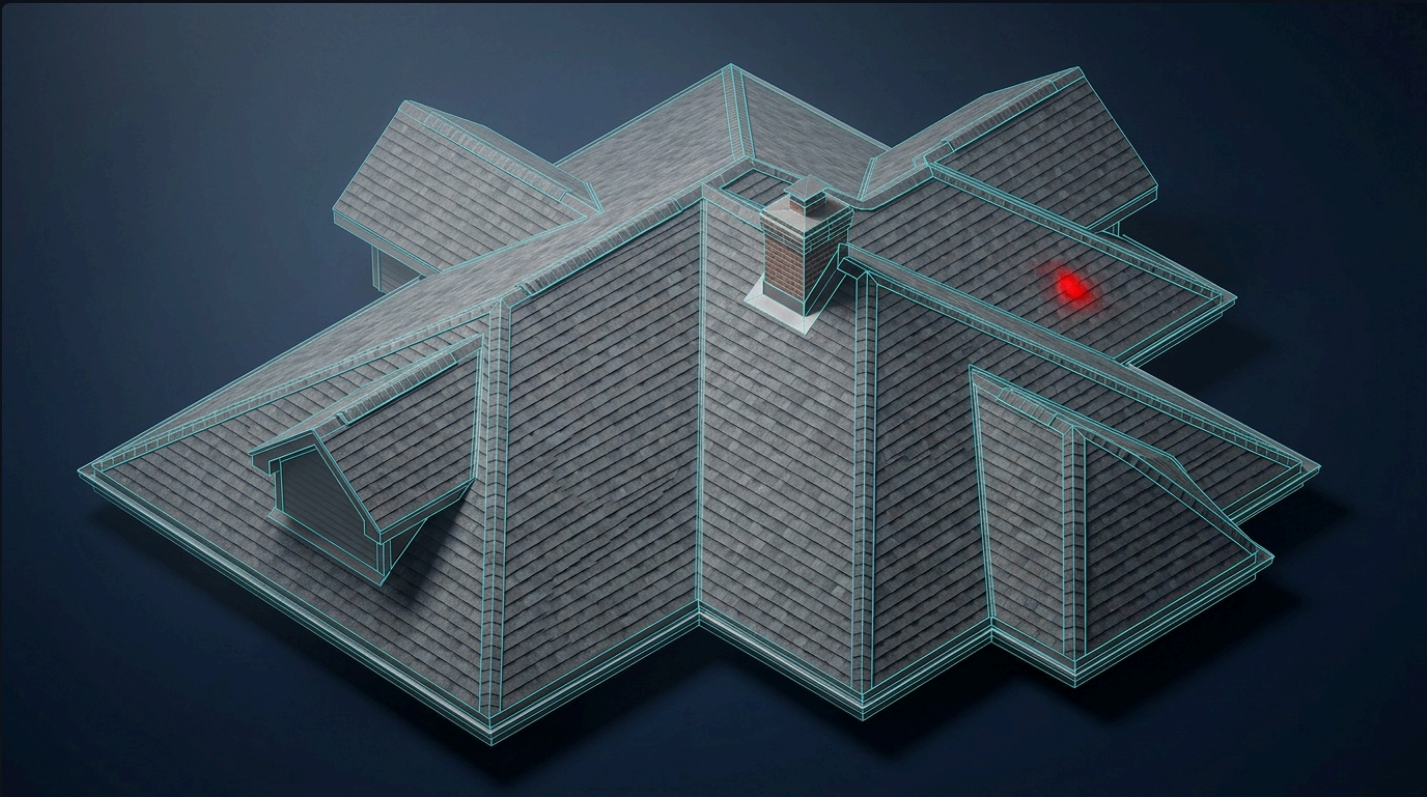
RADIOMETRIC OVERLAY · ROOF

CYAN: scan-vector overlay · ORANGE: thermal hotspot · Confidence threshold ≥ 85%

SEV	ID	TYPE	LOCATION	CONF	SF	DIAGNOSIS	EST
URGENT	AD-KY041-004	CDX Deck Rot	Facet F2 (Rear Hip)	92.3%	164.2	Trapped sub-surface moisture, multi-season propagation.	\$17,645.00
HIGH	AD-KY041-007	Soffit Blockage	North eave run	88.1%	0.0	Cellulose insulation blocking 14 of 22 soffit vents.	\$1,240.00
HIGH	AD-KY041-011	Window Header Leak	2nd story front bay	86.0%	0.0	Capillary water intrusion at flashing.	\$980.00

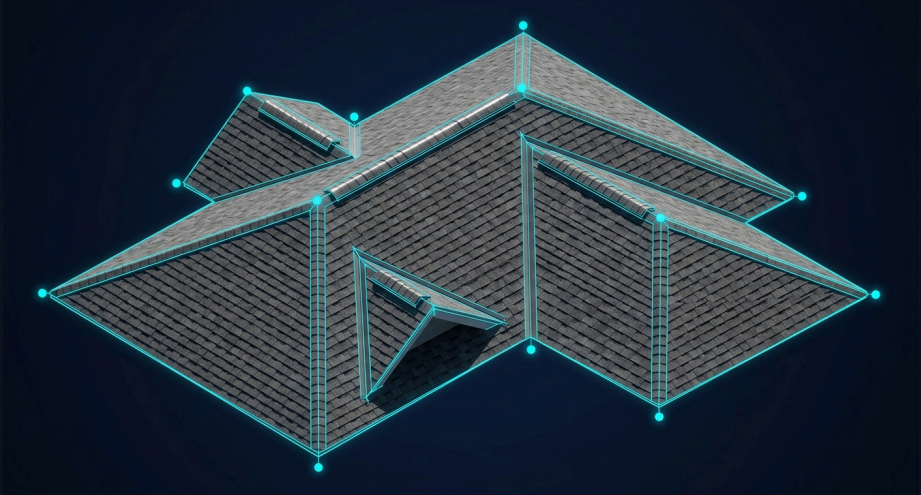
LAYER 01 · FINISHED SLATE

Squares 24.31 · Pitch 8/12

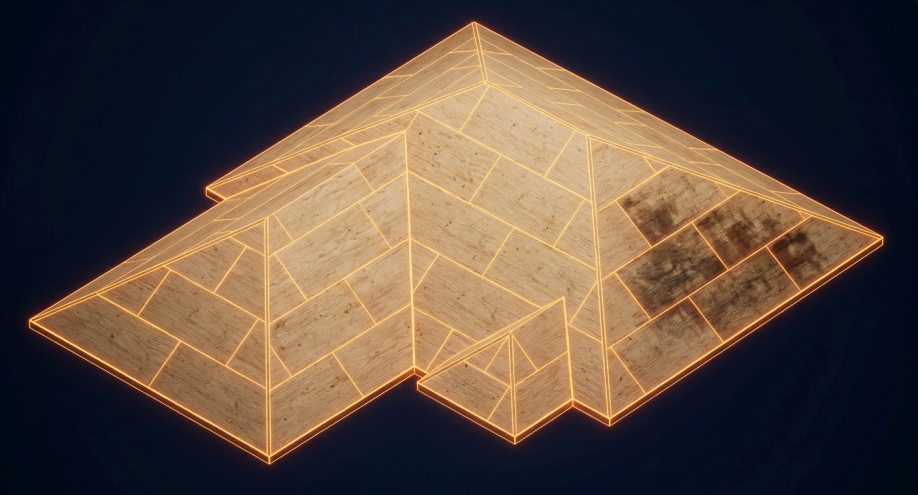
LAYER 02 · DECKING + UNDERLAYMENT

7/16" CDX · I&W shield at valleys/eaves · 2 existing shingle layer(s)
