PROJECT AD-KY041 · 2440 Regency Road · Lexington, KY 40503

CONFIDENTIAL · STRATEGIC FORENSIC AUDIT

FORENSIC ENVELOPE AUDIT · V1.0

Strategic Thermal Reconnaissance Report

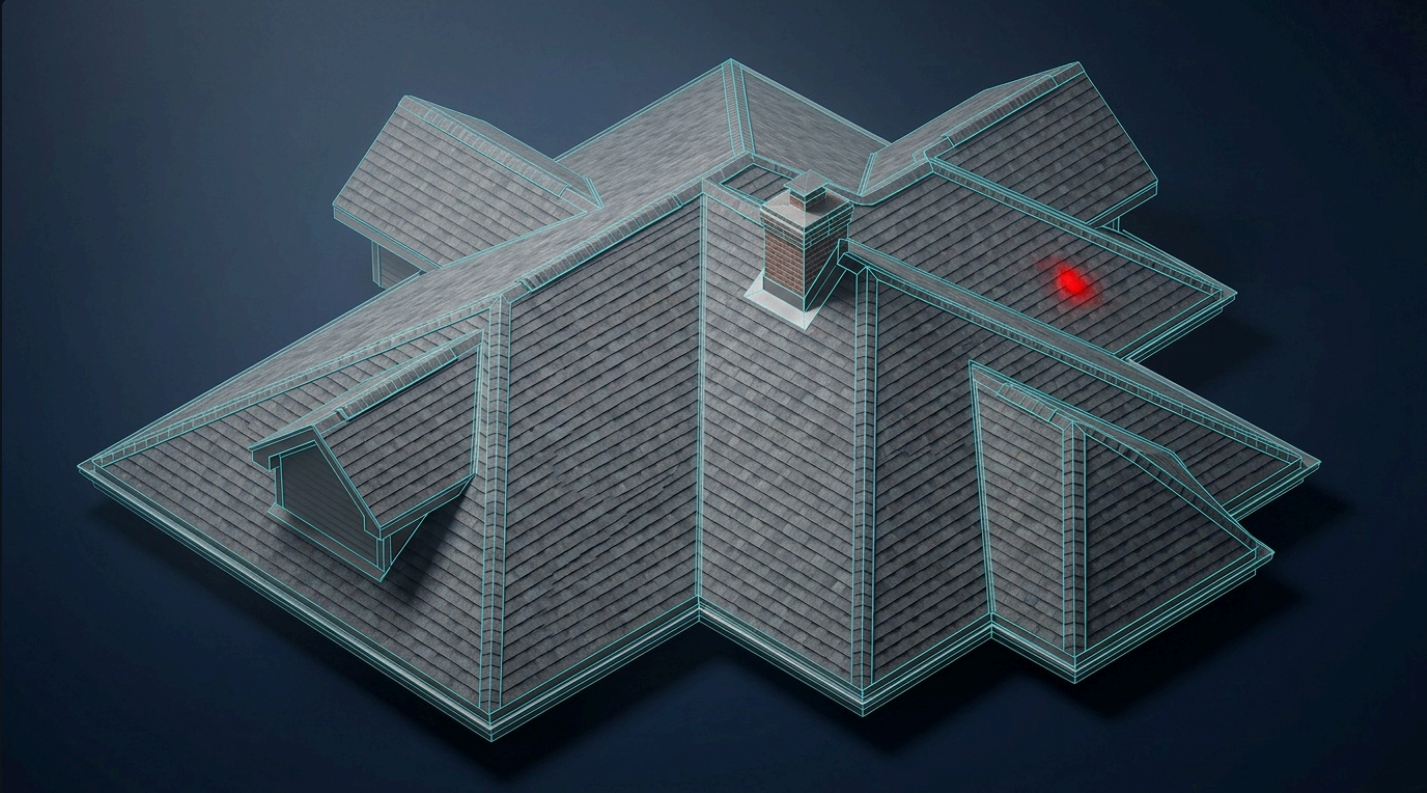
RADIOMETRIC OVERLAY · ROOF

CYAN: scan-vector overlay · ORANGE: thermal hotspot · Confidence threshold ≥ 85%

SEV	ID	TYPE	LOCATION	CONF	SF	DIAGNOSIS	EST
URGENT	AD-KY041-004	CDX Deck Rot	Facet F2 (Rear Hip)	92.3%	164.2	Trapped sub-surface moisture, multi-season propagation.	\$17,645.00
HIGH	AD-KY041-007	Soffit Blockage	North eave run	88.1%	0.0	Cellulose insulation blocking 14 of 22 soffit vents.	\$1,240.00
HIGH	AD-KY041-011	Window Header Leak	2nd story front bay	86.0%	0.0	Capillary water intrusion at flashing.	\$980.00

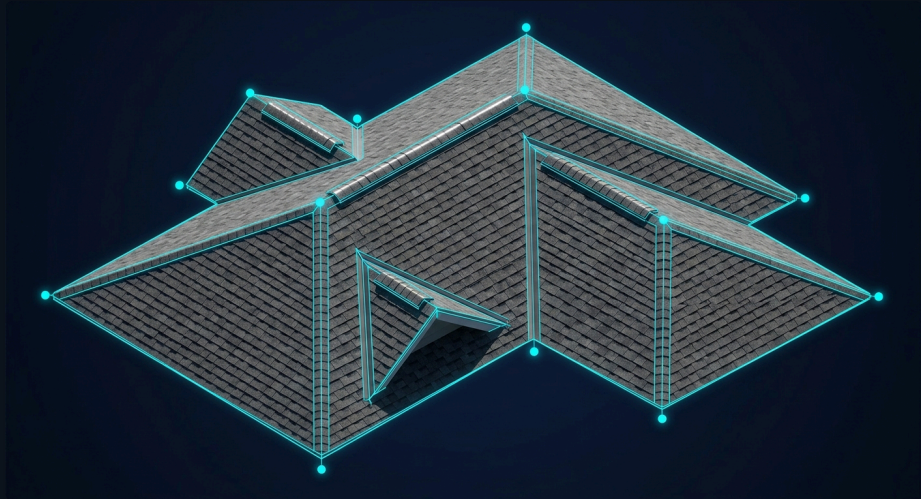
LAYER 01 · FINISHED SLATE

Squares 24.31 · Pitch 8/12

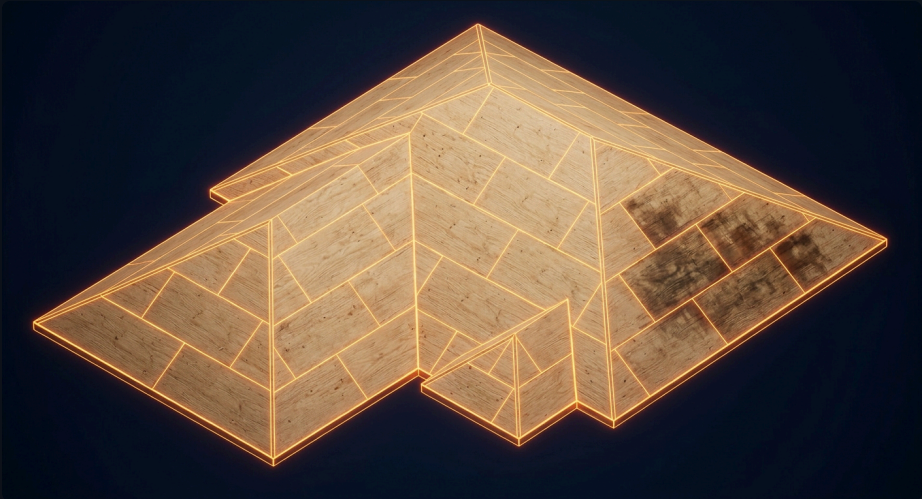
LAYER 02 · DECKING + UNDERLAYMENT

7/16" CDX · I&W shield at valleys/eaves · 2 existing shingle layer(s)

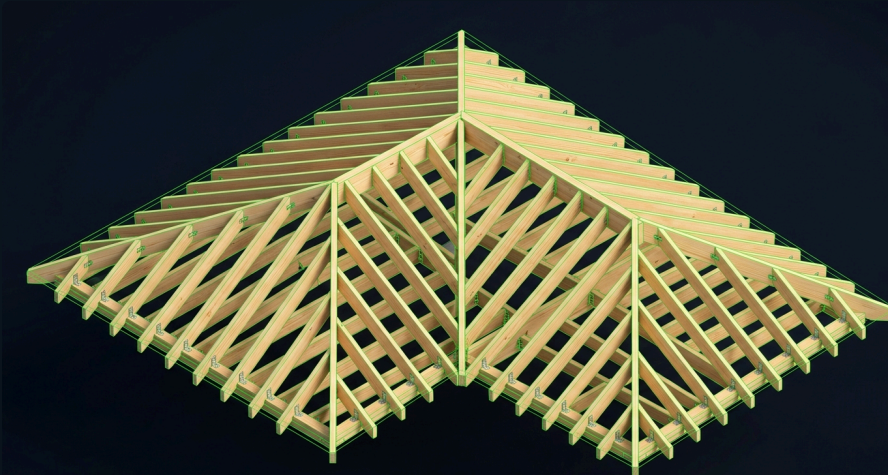
LAYER 03 · STRUCTURAL FRAMING

2x8 rafters @ 16" o.c. · LVL ridge · Hurricane ties **VERIFIED**
