PROJECT AD-KY041 · 2440 Regency Road · Lexington, KY 40503

SCAN 2026-06-25 · GROUND-TRUTH ±0.78 cm

FORENSIC ENVELOPE AUDIT · V1.0

# Strategic Thermal Reconnaissance Report

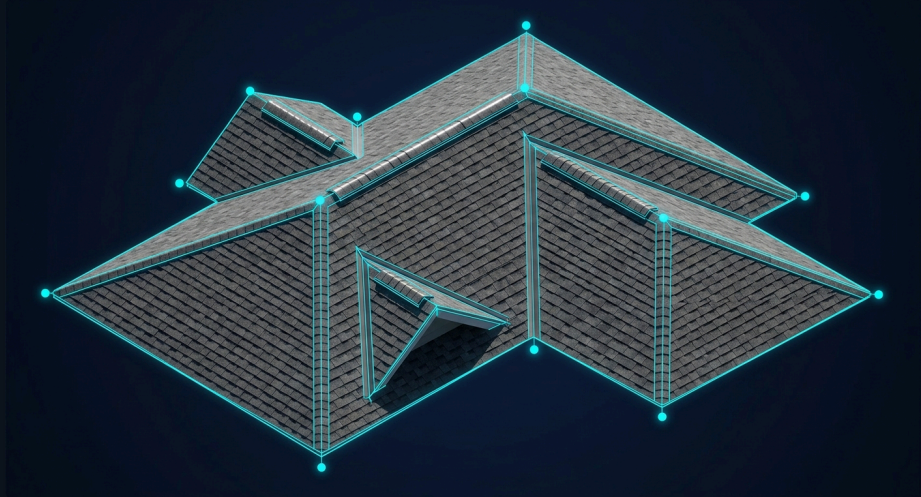
LAYER 01 · FINISHED SLATE

Squares 24.31 · Pitch 8/12

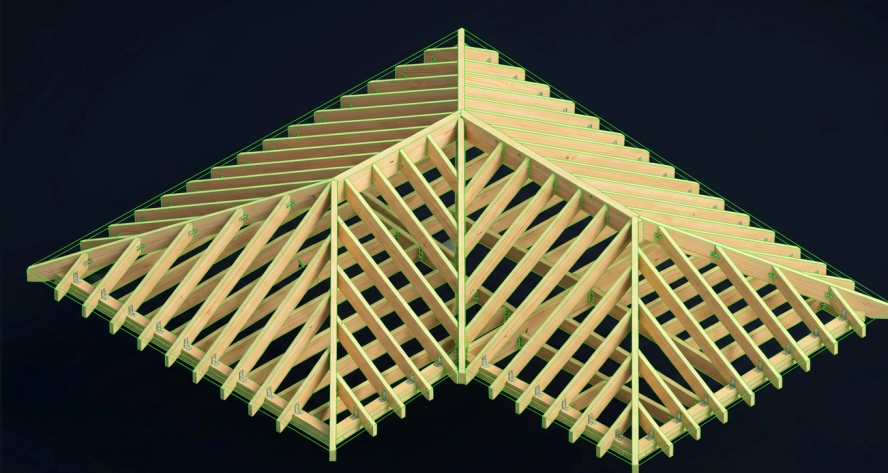
LAYER 03 · STRUCTURAL FRAMING

2x8 rafters @ 16" o.c. · LVL ridge · Hurricane ties **VERIFIED**
