EAGLE EYE

Cabinet QC report · drawing-first verification

EE-DEMO-01

HOLD · 4 faults to fix before shipping

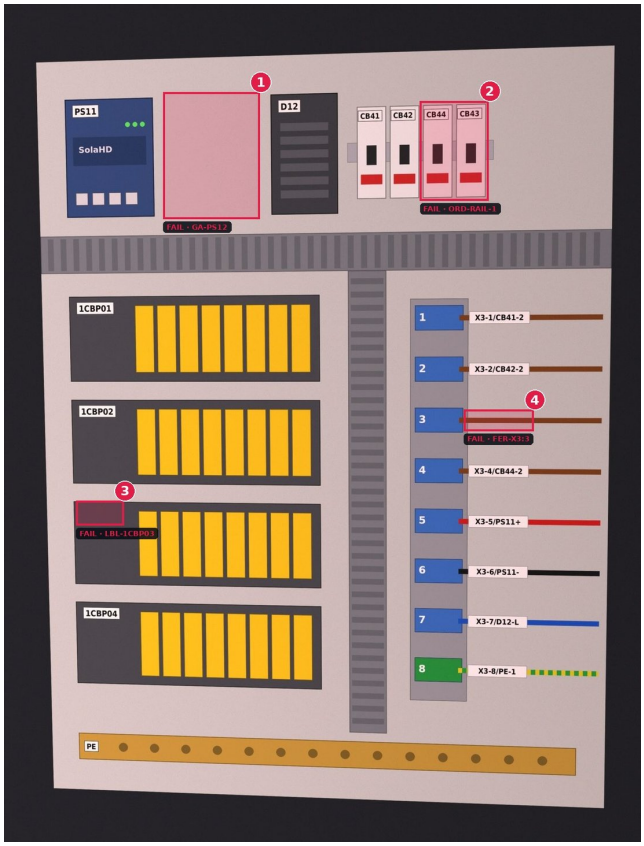
Every FAIL is boxed on the photo with expected-vs-found proof.

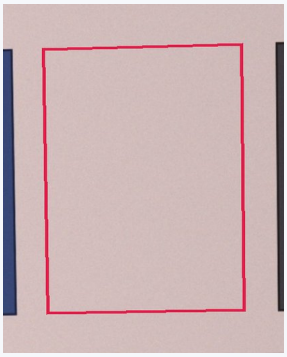
1 GA-PS12 Part present — FAIL

Expected (drawing)	Installed
Found (photo)	Missing
Evidence	slot occupancy 0%; label seen: False

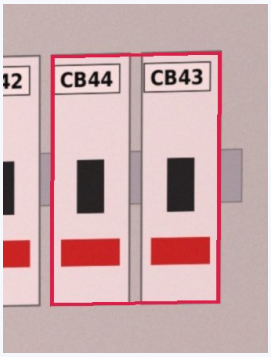
2 ORD-RAIL-1 Rail order — FAIL

Expected (drawing)	CB41-CB42-CB43-CB44
Found (photo)	CB43 <-> CB44 swapped
Evidence	read along rail: CB41-CB42-CB44-CB43

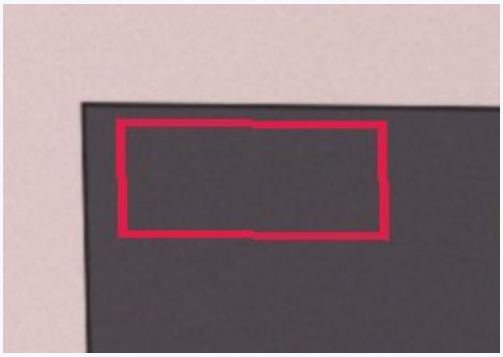
3 LBL-1CBP03 Device label

FAIL

Expected (drawing)	1CBP03
Found (photo)	No label
Evidence	label sticker+print found: False; OCR votes ['EULUEOASSLDBGR', '', '', '']
