# EAGLE EYE

Cabinet QC report · drawing-first verification

**EE-DEMO-01**

## HOLD · 1 fault to fix before shipping

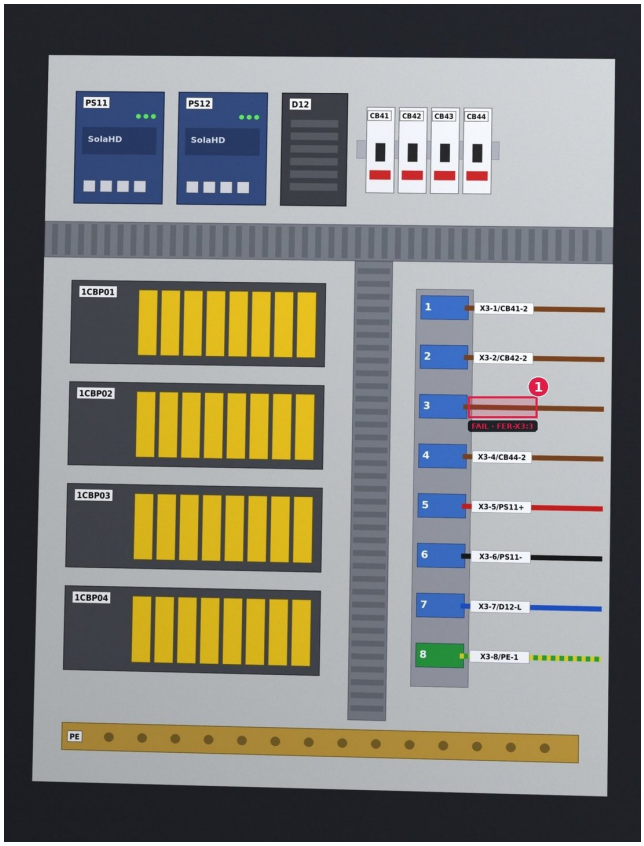
Every FAIL is boxed on the photo with expected-vs-found proof.
