EAGLE EYE

Cabinet QC report · drawing-first verification

EE-DEMO-01

Run 20261024-202459-3de1
2026-10-24 20:24:59

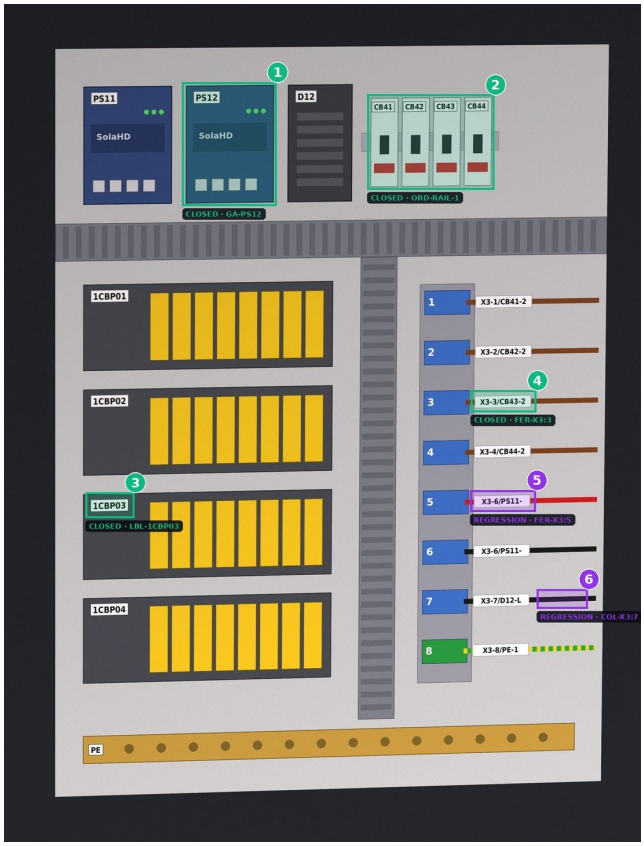
HOLD · 2 faults to fix before shipping

Every FAIL is boxed on the photo with expected-vs-found proof.

Expected (drawing)	X3-5/PS11+
Found (photo)	Wrong ferrule: X3-6/PS11-
Evidence	OCR votes ['X3-6/PS11-', 'X3-6/PS11-', 'X3-6/PS11-', 'X3-6/PS11-']
Before re-check	PASS: X3-5/PS11+

Expected (drawing)	BU
Found (photo)	BK
Evidence	green 0% yellow 0%
Before re-check	PASS: BU

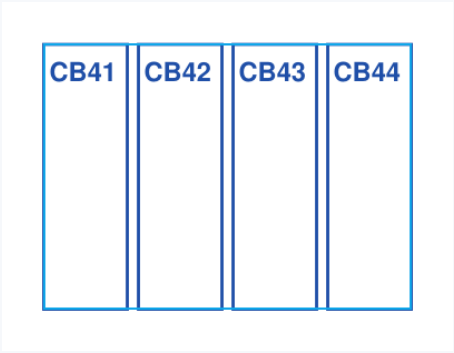
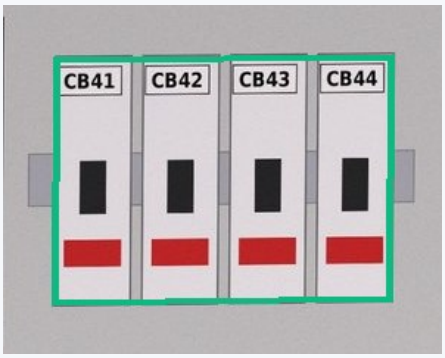
2 ORD-RAIL-1 Rail order

Expected (drawing)	CB41-CB42-CB43-CB44
Found (photo)	CB41-CB42-CB43-CB44
Evidence	read along rail: CB41-CB42-CB43-CB44
Before re-check	FAIL: CB43 <-> CB44 swapped

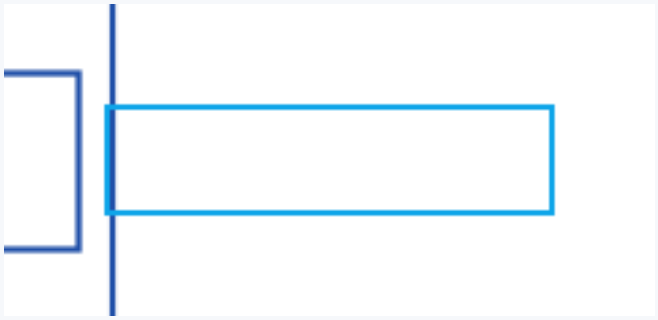
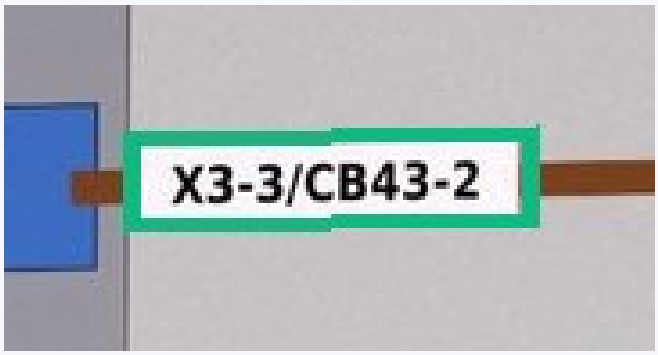
4 FER-X3:3 Ferrule text

Expected (drawing)	X3-3/CB43-2
Found (photo)	X3-3/CB43-2
Evidence	OCR votes ['X3-3/CB43-2', 'X3-3/CB43-2', 'X3-3/CB43-2', 'X3-3/CB43-2']
Before re-check	FAIL: No ferrule

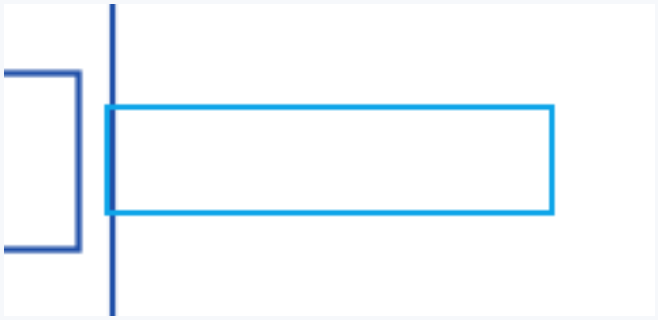
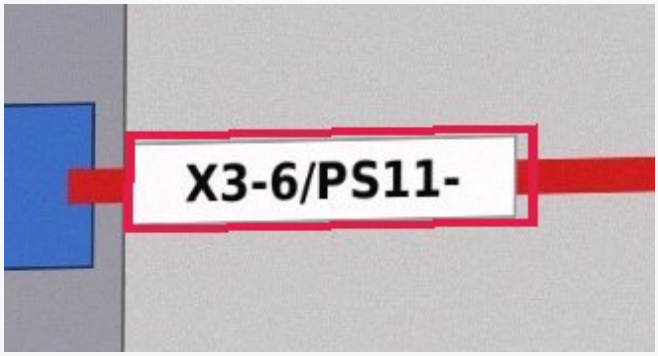
5 FER-X3:5 Ferrule text

REGRESSION

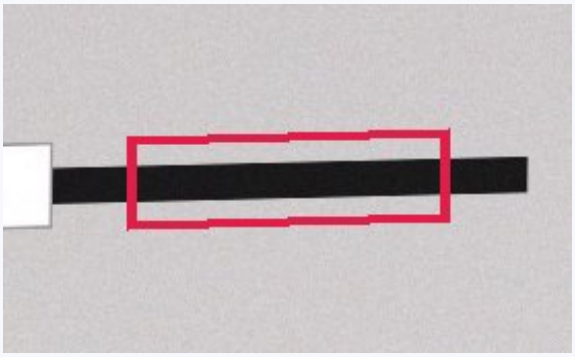
6 COL-X3:7 Wire colour

REGRESSION
