EAGLE EYE

Cabinet QC report · drawing-first verification

EE-DEMO-01

Run 20261024-202459-457d
2026-10-24 20:25:00

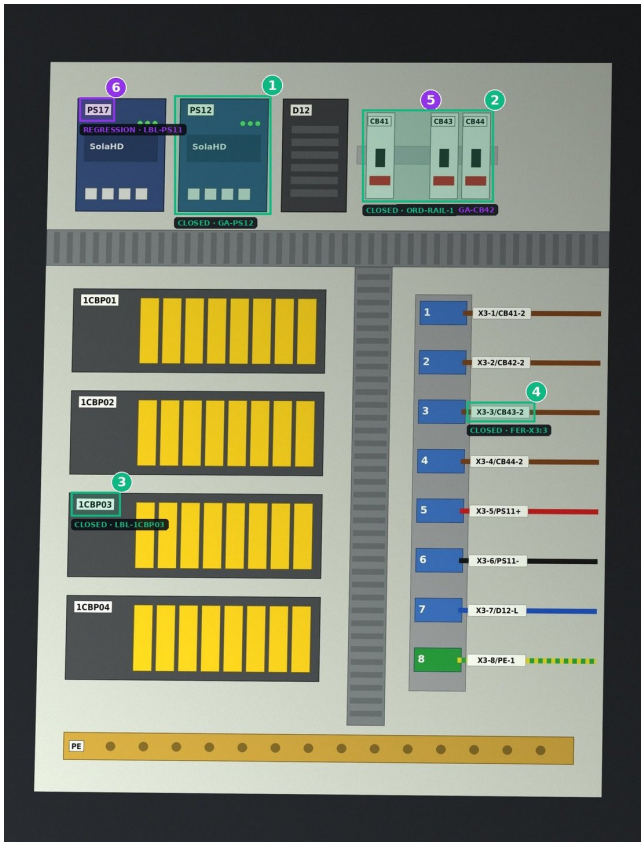
HOLD · 2 faults to fix before shipping

Every FAIL is boxed on the photo with expected-vs-found proof.

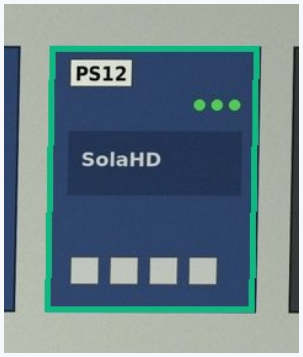
1 GA-PS12 Part present

Expected (drawing)	Installed
Found (photo)	Present
Evidence	slot occupancy 92%; label seen: True
Before re-check	FAIL: Missing

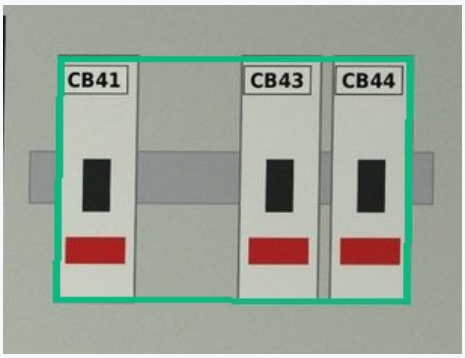
2 ORD-RAIL-1 Rail order

Expected (drawing)	CB41-CB42-CB43-CB44
Found (photo)	CB41-(empty)-CB43-CB44
Evidence	read along rail: CB41-(empty)-CB43-CB44
Before re-check	FAIL: CB43 <-> CB44 swapped

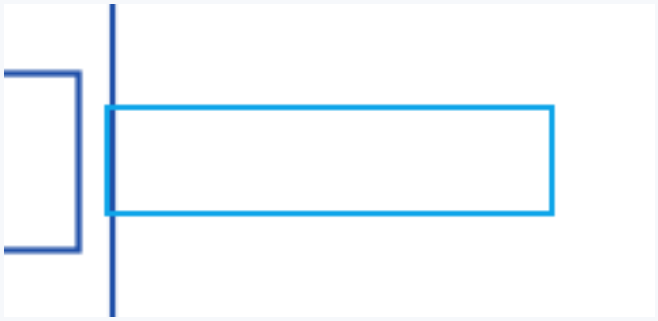
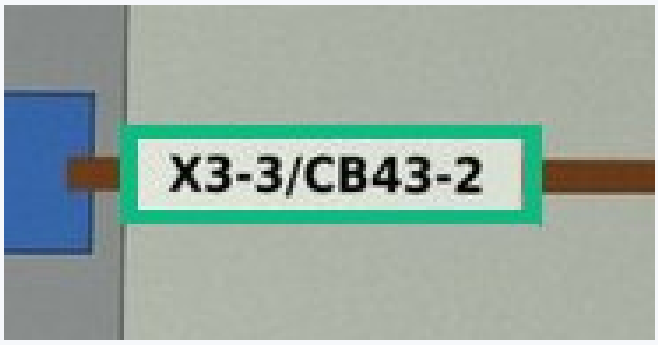
4 FER-X3:3 Ferrule text

Expected (drawing)	X3-3/CB43-2
Found (photo)	X3-3/CB43-2
Evidence	OCR votes ['X3-3/CB43-2', 'X3-3/CB43-2', 'X3-3/CB43-2', 'X3-3/CB43-2']
Before re-check	FAIL: No ferrule
