EAGLE EYE

Cabinet QC report · drawing-first verification

EE-DEMO-01

Run 20261024-202501-790d

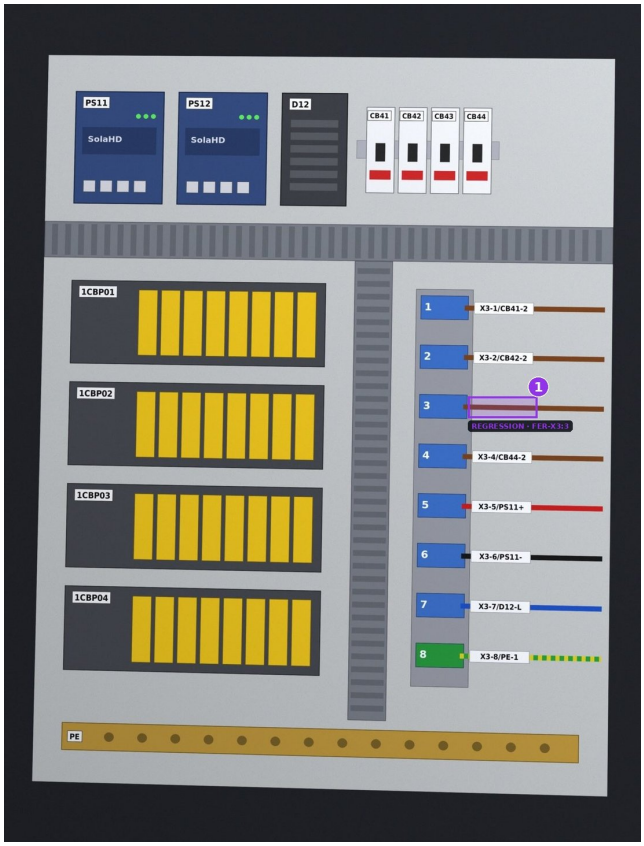
HOLD · 1 fault to fix before shipping

Every FAIL is boxed on the photo with expected-vs-found proof.
