EAGLE EYE

Cabinet QC report · drawing-first verification

EE-DEMO-01

Run 20261024-202502-bfc6
2026-10-24 20:25:02

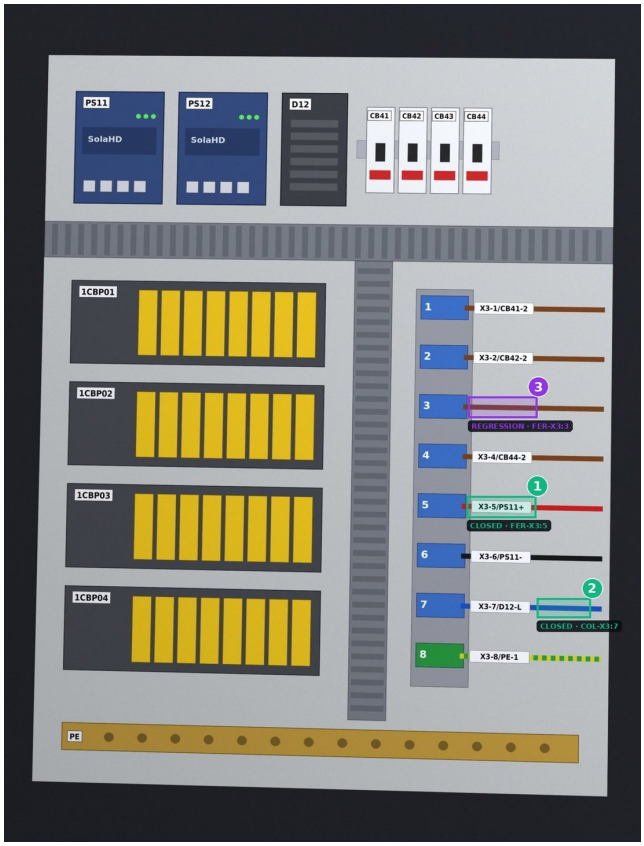
HOLD · 1 fault to fix before shipping

Every FAIL is boxed on the photo with expected-vs-found proof.

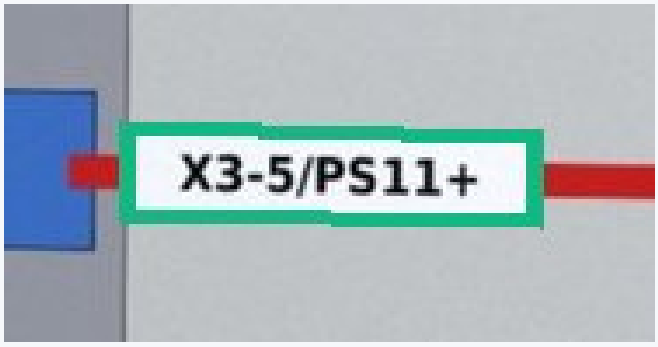
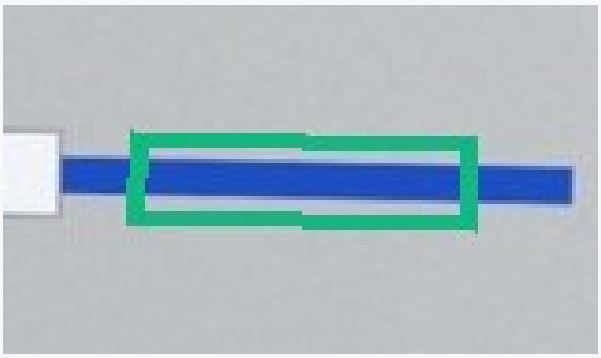
1 FER-X3:5 Ferrule text

CLOSED

Expected (drawing)	X3-5/PS11+
Found (photo)	X3-5/PS11+
Evidence	OCR votes ['X3-5/PS11+', 'X3-5/PS11+', 'X3-5/PS11+', 'X3-5/PS11+']
Before re-check	FAIL: Wrong ferrule: X3-6/PS11-
