EAGLE EYE

Cabinet QC report · drawing-first verification

EE-DEMO-01

Run 20261024-202503-f6e6
2026-10-24 20:25:04

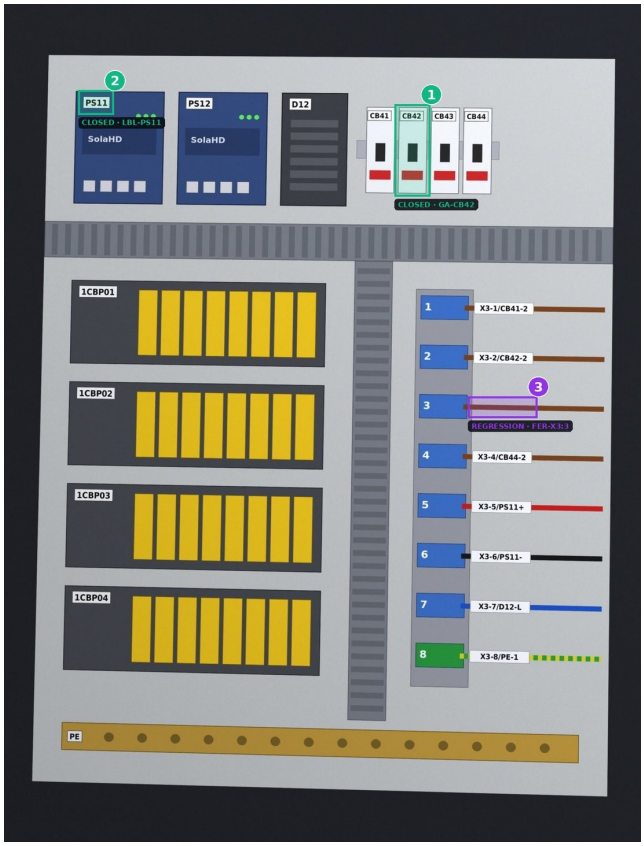
HOLD · 1 fault to fix before shipping

Every FAIL is boxed on the photo with expected-vs-found proof.

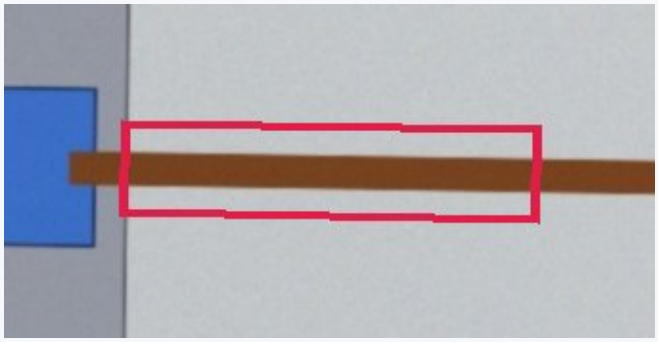
3 FER-X3:3 Ferrule text

REGRESSION

Expected (drawing)	X3-3/CB43-2
Found (photo)	No ferrule
Evidence	sleeve pixels 0%
Before re-check	PASS: X3-3/CB43-2
