# EAGLE EYE

Cabinet QC report · drawing-first verification

**EE-DEMO-01**

## HOLD · 2 faults to fix before shipping

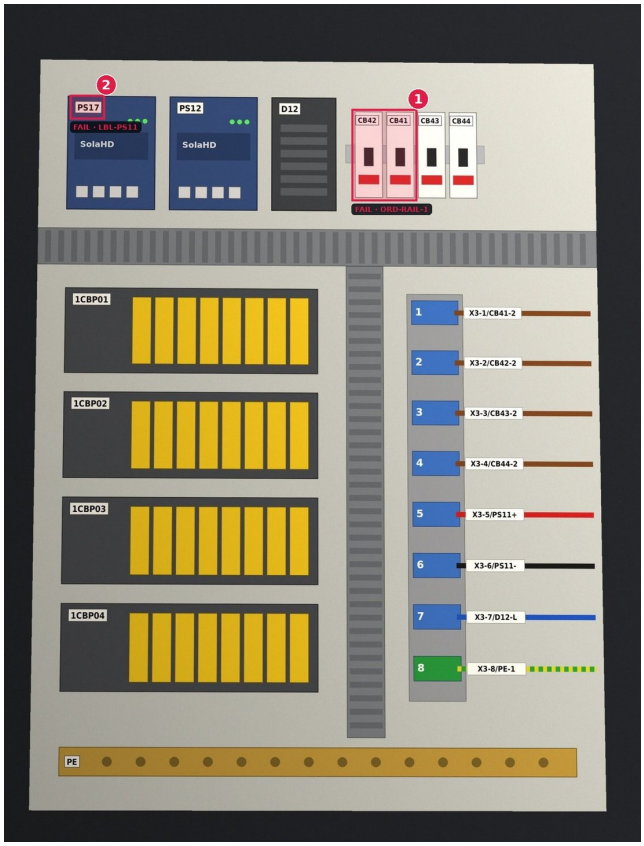
Every FAIL is boxed on the photo with expected-vs-found proof.

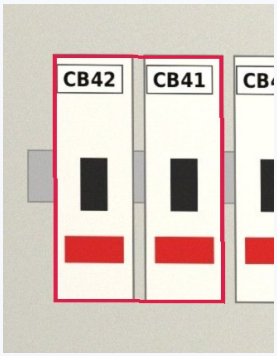
## 1 ORD-RAIL-1 Rail order — FAIL

| Expected (drawing) | CB41-CB42-CB43-CB44 |
| Found (photo) | CB41 <-> CB42 swapped |
| Evidence | read along rail: CB42-CB41-CB43-CB44 |

## 2 LBL-PS11 Device label — FAIL

| Expected (drawing) | PS11 |
| Found (photo) | Wrong label: reads 'PS17' |
| Evidence | label sticker+print found: True; OCR votes ['PS17', 'PS17', 'PS17', 'PS17'] |
