EAGLE EYE

Cabinet QC report · drawing-first verification

EE-DEMO-01

Run 20261024-202532-e342
2026-10-24 20:25:33

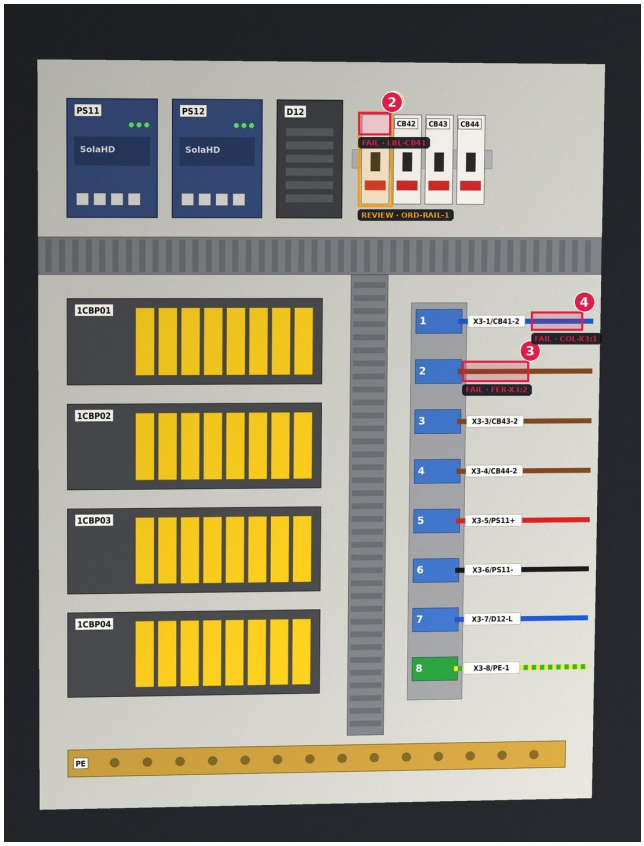
HOLD · 3 faults to fix before shipping

Every FAIL is boxed on the photo with expected-vs-found proof. 1 check(s) also require review.

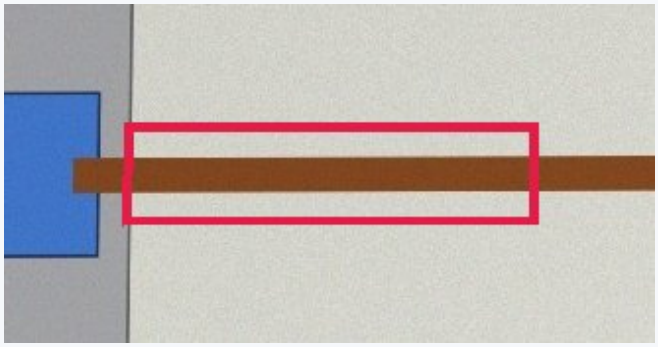
3 FER-X3:2 Ferrule text

FAIL

Expected (drawing)	X3-2/CB42-2
Found (photo)	No ferrule
Evidence	sleeve pixels 0%

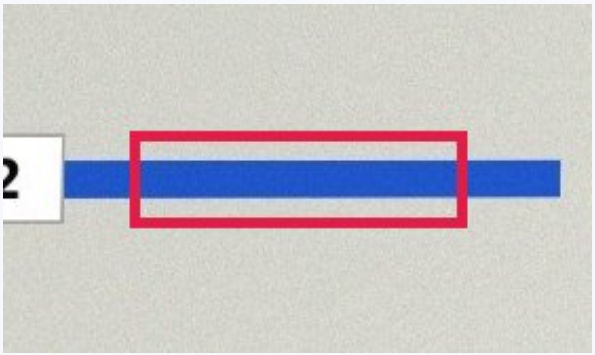
4 COL-X3:1 Wire colour

FAIL

Expected (drawing)	BN
Found (photo)	BU
Evidence	green 0% yellow 0%
