EAGLE EYE

Cabinet QC report · drawing-first verification

EE-DEMO-01

Run 20261024-202535-685e
2026-10-24 20:25:37

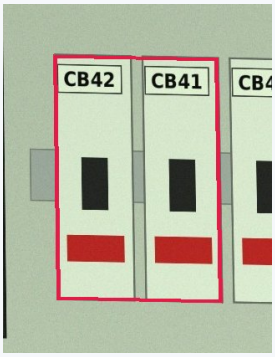
1 ORD-RAIL-1 Rail order

FAIL

Expected (drawing)	CB41-CB42-CB43-CB44
Found (photo)	CB41 <-> CB42 swapped
Evidence	read along rail: CB42-CB41-CB43-CB44

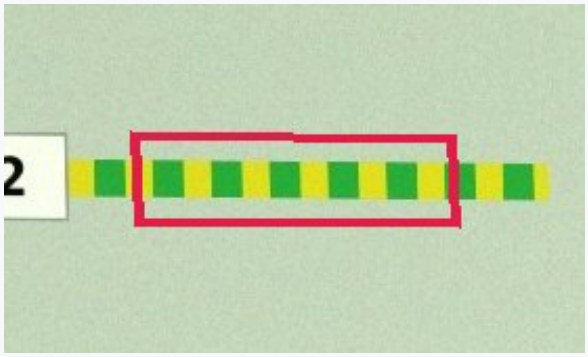
2 COL-X3:3 Wire colour

FAIL

Expected (drawing)	BN
Found (photo)	GNYE
Evidence	green 49% yellow 42%

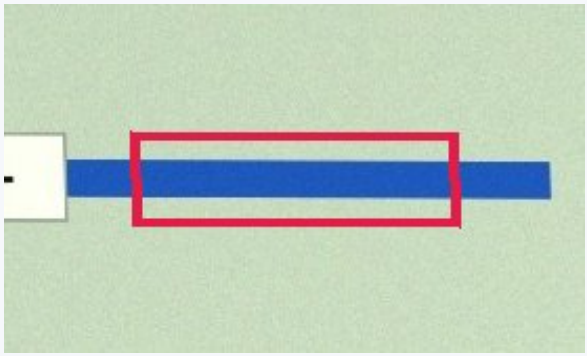
3 COL-X3:5 Wire colour

FAIL

Expected (drawing)	RD
Found (photo)	BU
Evidence	green 0% yellow 0%
