HOLD · 4 faults to fix before shipping

Inspection details

Cabinet	EE-DEMO-01
Photo	01_emerson_example_4_faults.jpg
Re-check of	20261017-040856-7edf
GA drawing	GA_EE-DEMO-01.pdf
Wire list	WireList_EE-DEMO-01.xlsx
QC checklist	QC_Checklist_EE-DEMO-01.xlsx
Checks	GA · ORDER · LABEL · FERRULE · COLOUR
Items checked	41 expected items from the drawing and wire list
Registration	backplate outline + 16 label/ferrule anchors, 14 RANSAC inliers; off-pattern: CB44, CB43
Processing	5.6 s on CPU
Engine	EAGLE EYE 2.0.0 · Tesseract OCR · OpenCV · PyMuPDF

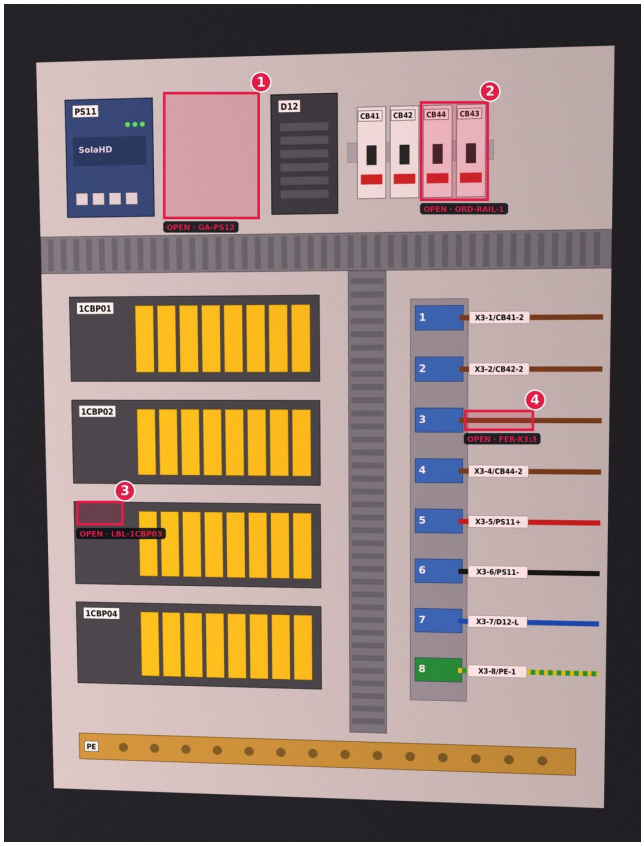
Every FAIL is boxed on the photo with expected-vs-found proof.

Expected (drawing)	Installed
Found (photo)	Missing
Evidence	slot occupancy 0%; label seen: False
Before re-check	FAIL: Missing

Expected (drawing)	CB41-CB42-CB43-CB44
Found (photo)	CB43 <-> CB44 swapped
Evidence	read along rail: CB41-CB42-CB44-CB43
Before re-check	FAIL: CB43 <-> CB44 swapped

Expected (drawing)	1CBP03
Found (photo)	No label
Evidence	label sticker+print found: False; OCR votes ['EUPUEESGR', '', '', '']
Before re-check	FAIL: No label

Expected (drawing)	X3-3/CB43-2
Found (photo)	No ferrule
Evidence	sleeve pixels 0%
Before re-check	FAIL: No ferrule
