EAGLE EYE

Cabinet QC report · drawing-first verification

EE-DEMO-01

Run 20261017-040948-0753

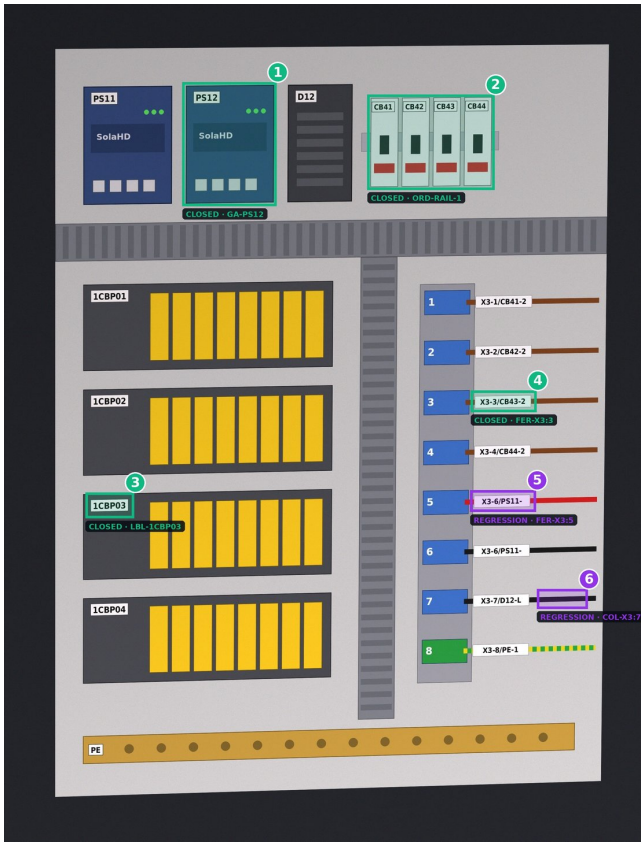
HOLD · 2 faults to fix before shipping

Every FAIL is boxed on the photo with expected-vs-found proof.

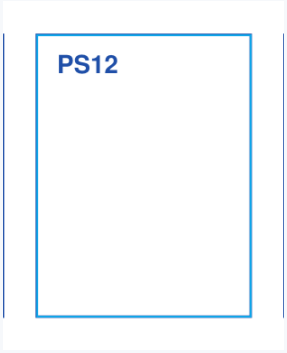
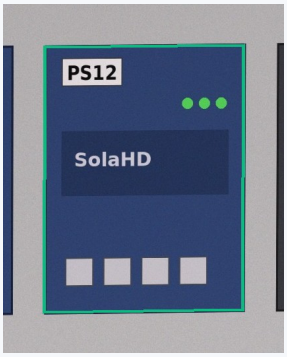
1 GA-PS12 Part present — CLOSED

Expected (drawing)	Installed
Found (photo)	Present
Evidence	slot occupancy 93%; label seen: True
Before re-check	FAIL: Missing

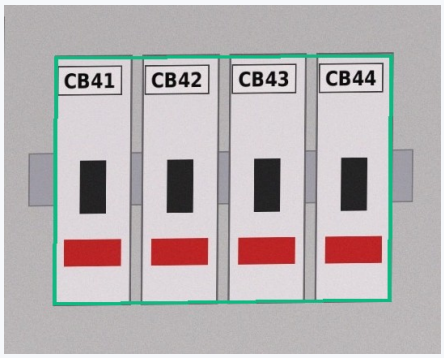
2 ORD-RAIL-1 Rail order — CLOSED

Expected (drawing)	CB41-CB42-CB43-CB44
Found (photo)	CB41-CB42-CB43-CB44
Evidence	read along rail: CB41-CB42-CB43-CB44
Before re-check	FAIL: CB43 <-> CB44 swapped

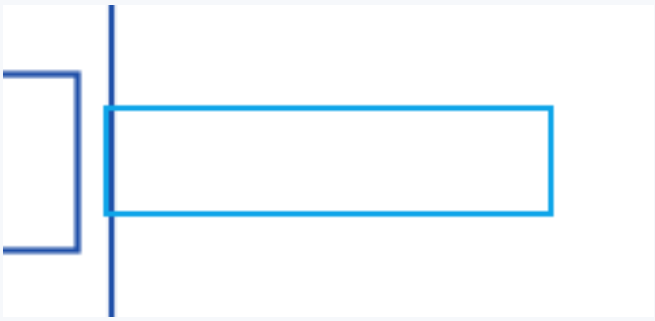
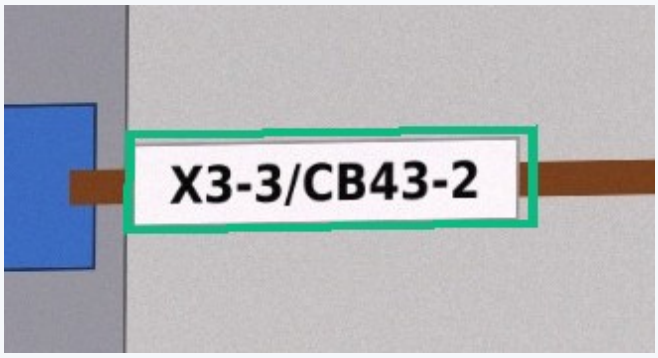
4 FER-X3:3 Ferrule text

Expected (drawing)	X3-3/CB43-2
Found (photo)	X3-3/CB43-2
Evidence	OCR votes ['X3-3/CB43-2', 'X3-3/CB43-2', 'X3-3/CB43-2', 'X3-3/CB43-2']
Before re-check	FAIL: No ferrule

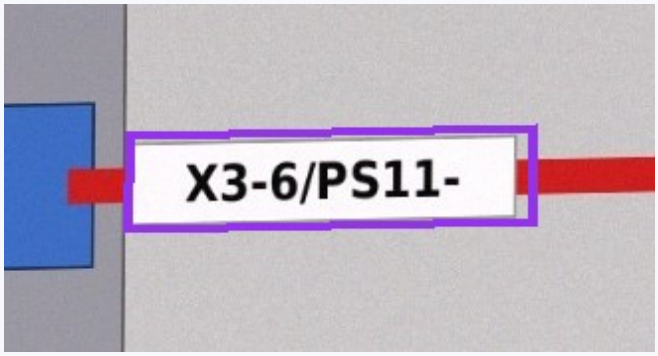
5 FER-X3:5 Ferrule text

REGRESSION

Expected (drawing)	X3-5/PS11+
Found (photo)	Wrong ferrule: X3-6/PS11-
Evidence	OCR votes ['X3-6/PS11-', 'X3-6/PS11-', 'X3-6/PS11-', 'X3-6/PS11-']
Before re-check	PASS: X3-5/PS11+

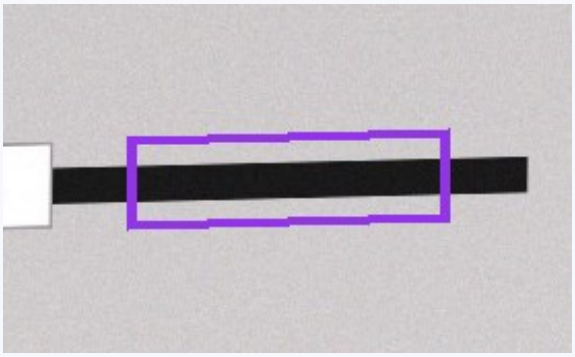
6 COL-X3:7 Wire colour

REGRESSION

Expected (drawing)	BU
Found (photo)	BK
Evidence	green 0% yellow 0%
Before re-check	PASS: BU
