EAGLE EYE

Cabinet QC report · drawing-first verification

EE-DEMO-01

Run 20261017-041021-5944

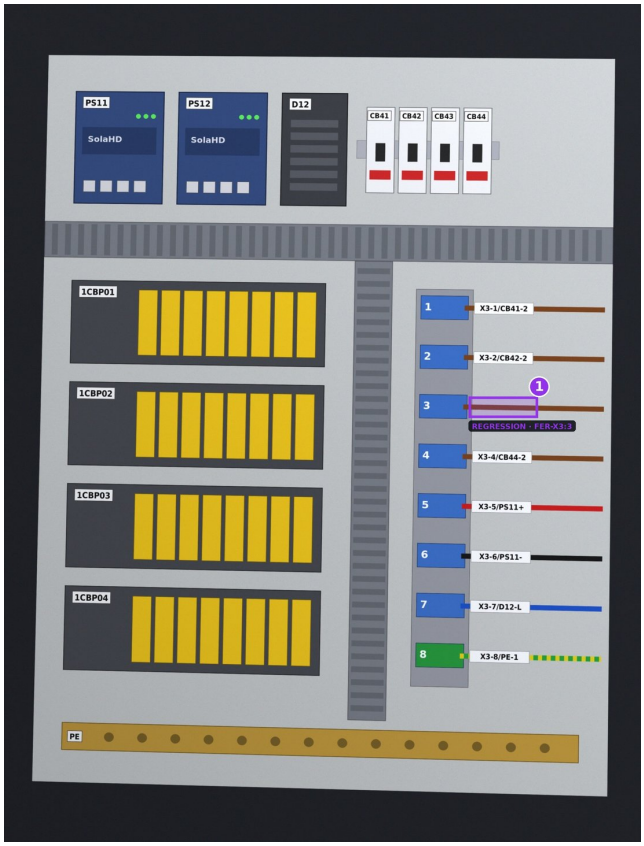
HOLD · 1 fault to fix before shipping

Every FAIL is boxed on the photo with expected-vs-found proof.
