EAGLE EYE

Cabinet QC report · drawing-first verification

EE-DEMO-01

Run 20261017-041037-ff80

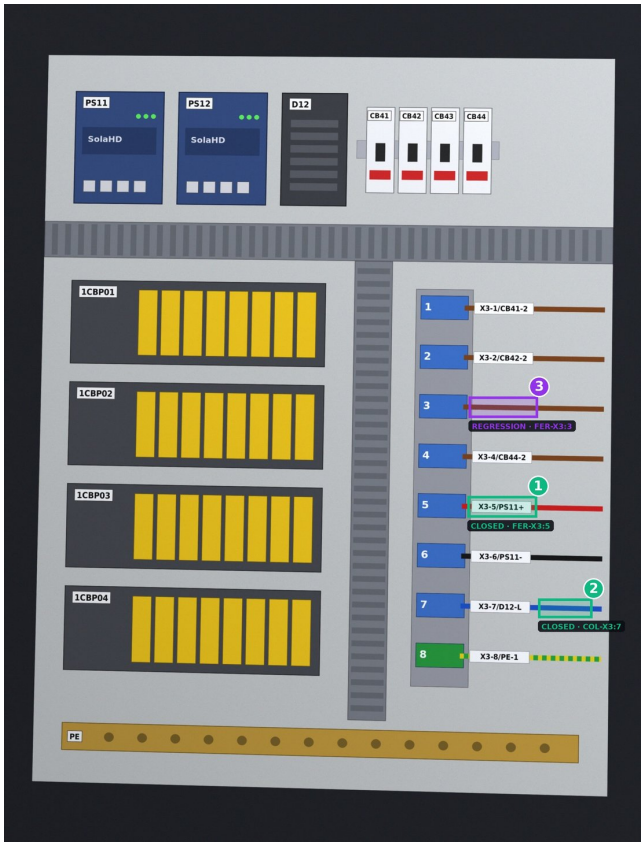
HOLD · 1 fault to fix before shipping

Every FAIL is boxed on the photo with expected-vs-found proof.

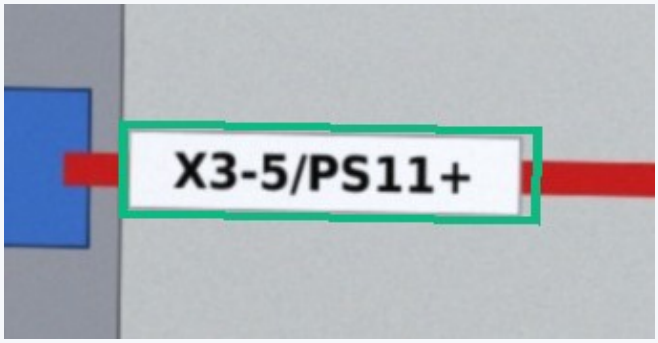
1 FER-X3:5 Ferrule text

CLOSED

Expected (drawing)	X3-5/PS11+
Found (photo)	X3-5/PS11+
Evidence	OCR votes ['X3-5/PS11+', 'X3-5/PS11+', 'X3-5/PS11+', 'X3-5/PS11+']
Before re-check	FAIL: Wrong ferrule: X3-6/PS11-
