EAGLE EYE

Cabinet QC report · drawing-first verification

EE-DEMO-01

Run 20261024-063813-d433
2026-10-24 06:38:16

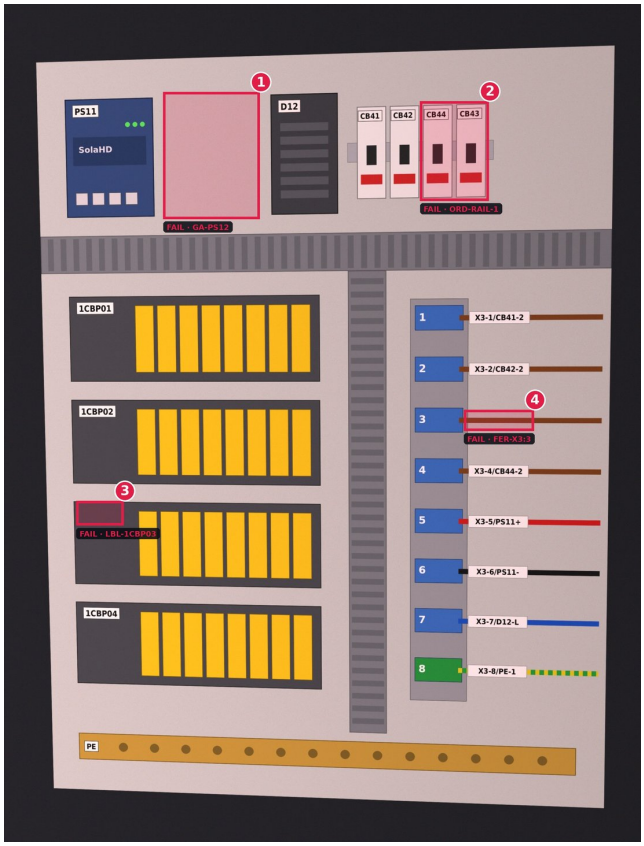
HOLD · 4 faults to fix before shipping

Every FAIL is boxed on the photo with expected-vs-found proof.

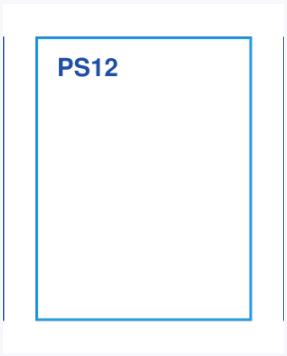
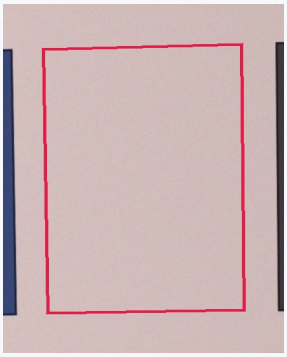
1 GA-PS12 Part present — FAIL

Expected (drawing)	Installed
Found (photo)	Missing
Evidence	slot occupancy 0%; label seen: False

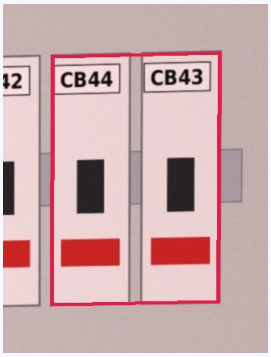
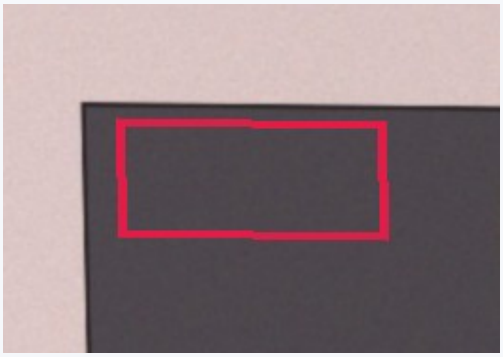
2 ORD-RAIL-1 Rail order — FAIL

Expected (drawing)	CB41-CB42-CB43-CB44
Found (photo)	CB43 <-> CB44 swapped
Evidence	read along rail: CB41-CB42-CB44-CB43

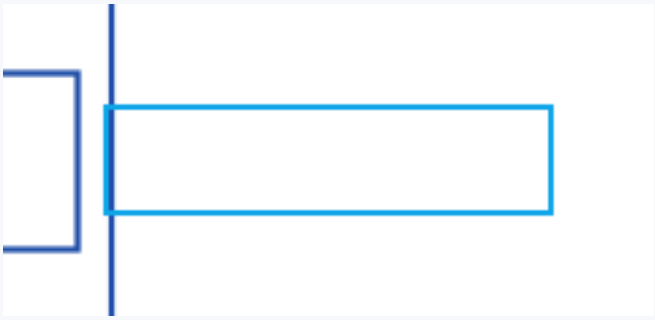
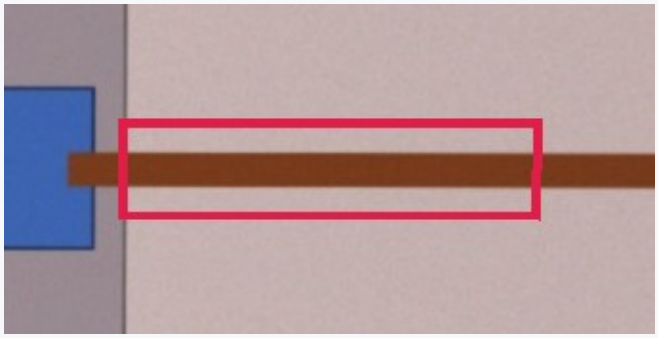
4 FER-X3:3 Ferrule text

FAIL

Expected (drawing)	X3-3/CB43-2
Found (photo)	No ferrule
Evidence	sleeve pixels 0%
