# EAGLE EYE

Cabinet QC report · drawing-first verification

**EE-DEMO-01**

Run 20261024-063829-d828

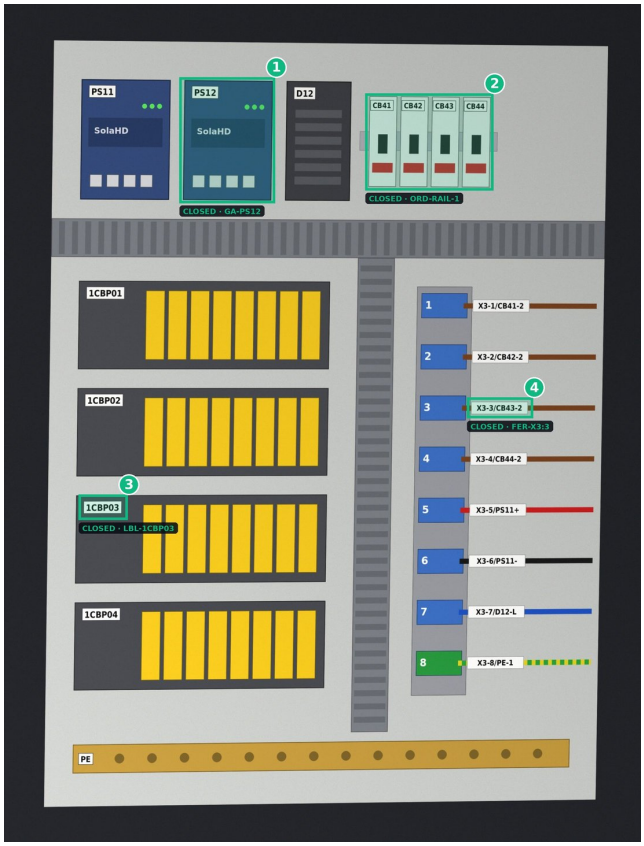
## PASS · ready to ship

All 41 items the drawing expects were verified on the photo.

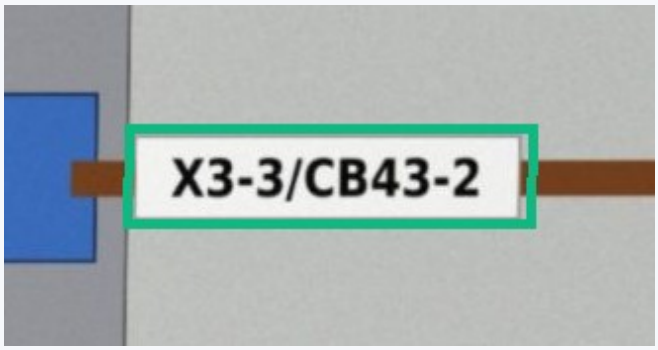
## 4 FER-X3:3 Ferrule text

| Expected (drawing) | X3-3/CB43-2 |
| Found (photo) | X3-3/CB43-2 |
| Evidence | OCR votes ['X3-3/CB43-2', 'X3-3/CB43-2', 'X3-3/CB43-2', 'X3-3/CB43-2'] |
| Before re-check | FAIL: No ferrule |
