EAGLE EYE

Cabinet QC report · drawing-first verification

EE-DEMO-01

Run 20261024-063832-b6d3
2026-10-24 06:38:34

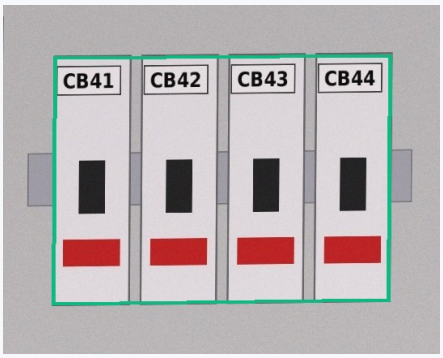
2 ORD-RAIL-1 Rail order — CLOSED

Expected (drawing)	CB41-CB42-CB43-CB44
Found (photo)	CB41-CB42-CB43-CB44
Evidence	read along rail: CB41-CB42-CB43-CB44
Before re-check	FAIL: CB43 <-> CB44 swapped
