EAGLE EYE

Cabinet QC report · drawing-first verification

EE-DEMO-01

Run 20261024-063834-5ce0
2026-10-24 06:38:37

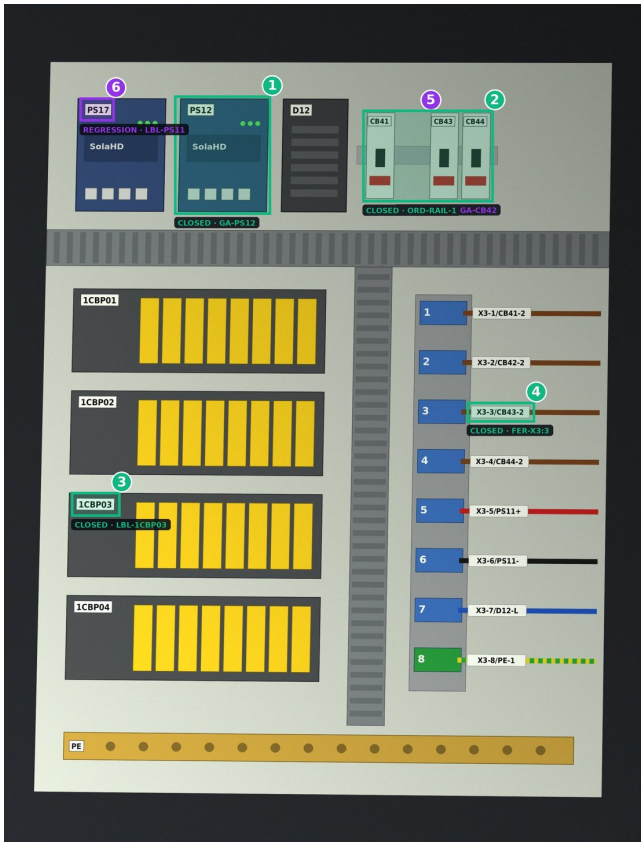
HOLD · 2 faults to fix before shipping

Every FAIL is boxed on the photo with expected-vs-found proof.

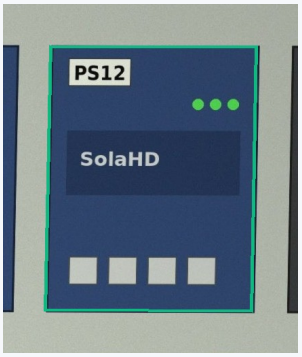
1 GA-PS12 Part present

CLOSED

Expected (drawing)	Installed
Found (photo)	Present
Evidence	slot occupancy 92%; label seen: True
Before re-check	FAIL: Missing

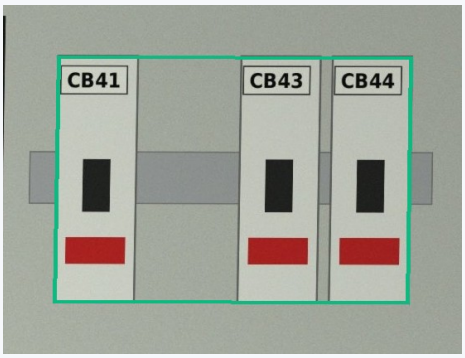
2 ORD-RAIL-1 Rail order

CLOSED

Expected (drawing)	CB41-CB42-CB43-CB44
Found (photo)	CB41-(empty)-CB43-CB44
Evidence	read along rail: CB41-(empty)-CB43-CB44
Before re-check	FAIL: CB43 <-> CB44 swapped

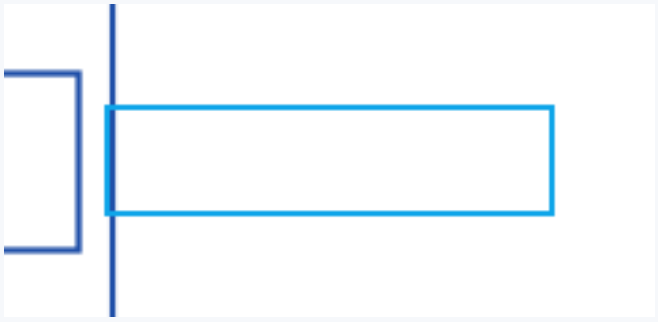
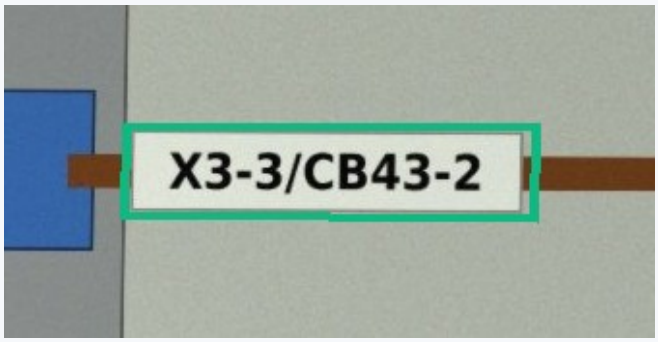
4 FER-X3:3 Ferrule text

CLOSED

Expected (drawing)	X3-3/CB43-2
Found (photo)	X3-3/CB43-2
Evidence	OCR votes ['X3-3/CB43-2', 'X3-3/CB43-2', 'X3-3/CB43-2', 'X3-3/CB43-2']
Before re-check	FAIL: No ferrule
