HOLD · 1 fault to fix before shipping

Cabinet	EE-DEMO-01
Photo	05_after_fix_one_left_open.jpg
Re-check of	20261024-063821-03b4
GA drawing	GA_EE-DEMO-01.pdf
Wire list	WireList_EE-DEMO-01.xlsx
QC checklist	QC_Checklist_EE-DEMO-01.xlsx
Checks	GA · ORDER · LABEL · FERRULE · COLOUR
Items checked	41 expected items from the drawing and wire list
Registration	backplate outline + 19 label/ferrule anchors, 19 RANSAC inliers
Processing	1.6 s on CPU
Engine	EAGLE EYE 3.0.0 · Tesseract OCR · OpenCV · PyMuPDF

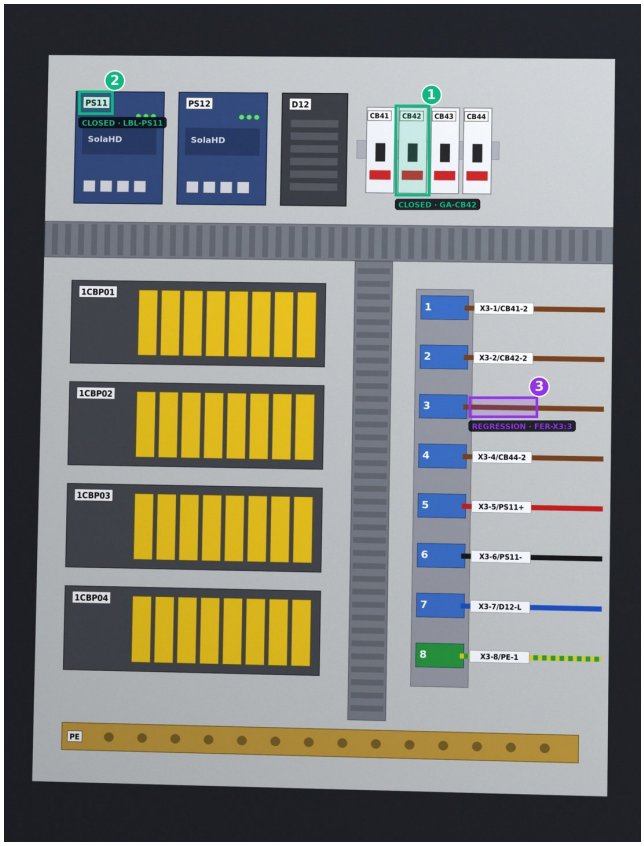
Every FAIL is boxed on the photo with expected-vs-found proof.

Expected (drawing)	X3-3/CB43-2
Found (photo)	No ferrule
Evidence	sleeve pixels 0%
Before re-check	PASS: X3-3/CB43-2

#	Item	Before	Now	Status
1	GA-CB42	FAIL: Missing	PASS: Present	CLOSED
2	LBL-PS11	FAIL: Wrong label: reads 'PS17'	PASS: PS11	CLOSED
3	FER-X3:3	PASS: X3-3/CB43-2	FAIL: No ferrule	REGRESSION

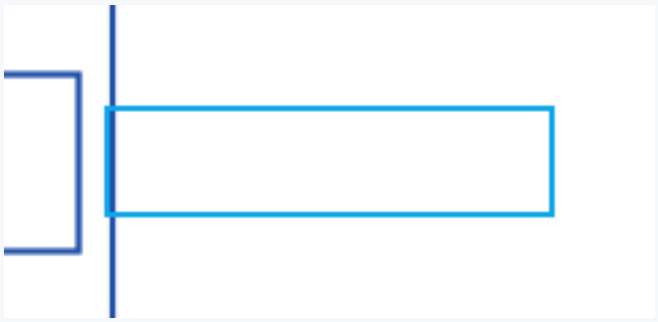
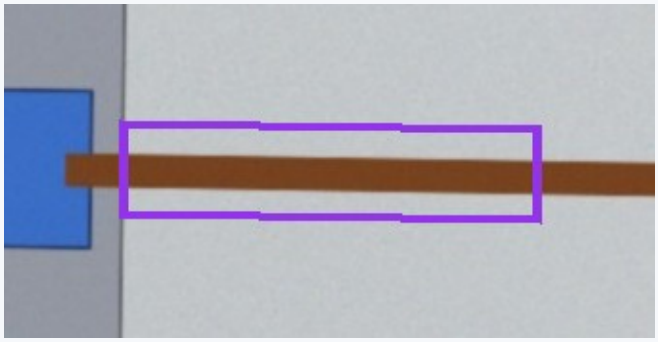
3 FER-X3:3 Ferrule text

REGRESSION
