EAGLE EYE

Cabinet QC report · drawing-first verification

EE-DEMO-01

Run 20261024-063950-c2ba
2026-10-24 06:39:51

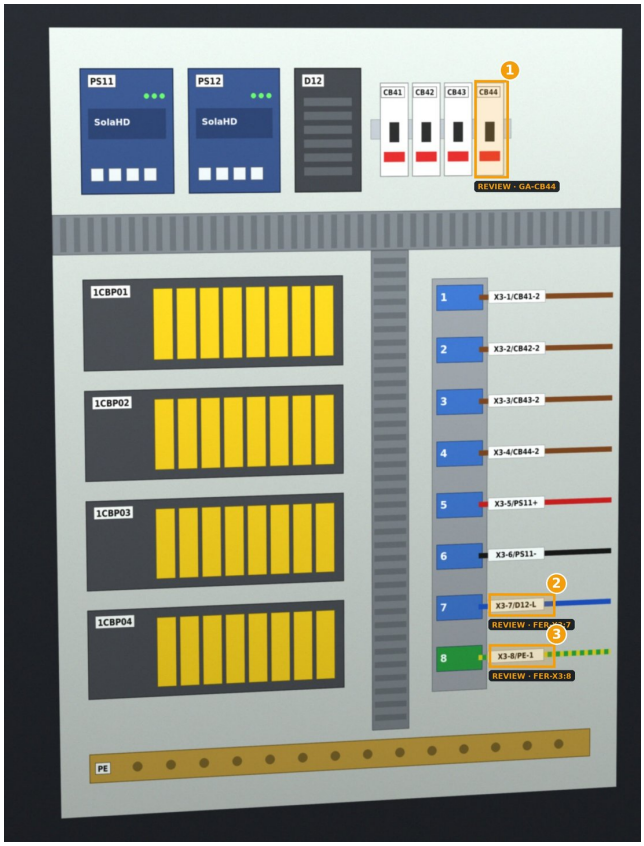
REVIEW · re-photo 3 zones

No confirmed faults. Some items could not be read clearly, so EAGLE EYE asks for a better photo instead of guessing.

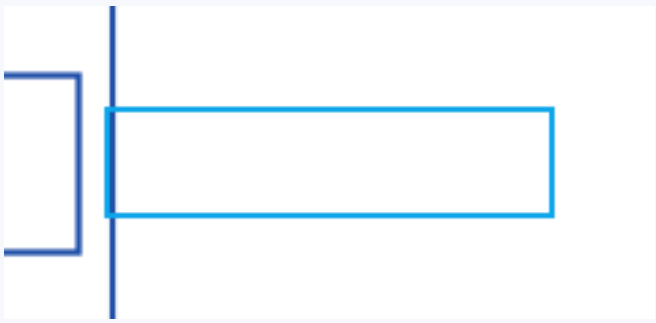
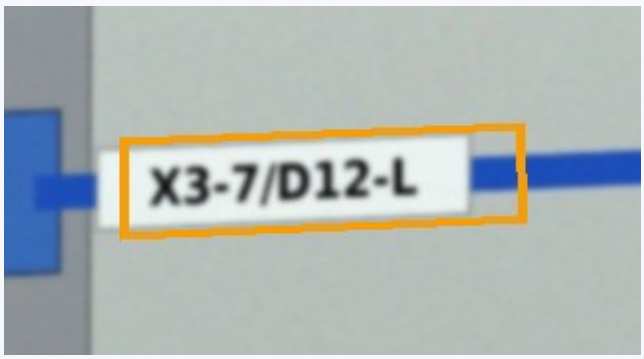
2 FER-X3:7 Ferrule text

REVIEW

Expected (drawing)	X3-7/D12-L
Found (photo)	Unreadable ('5')
Evidence	OCR votes ['KS', '5', '3:', 'X3']

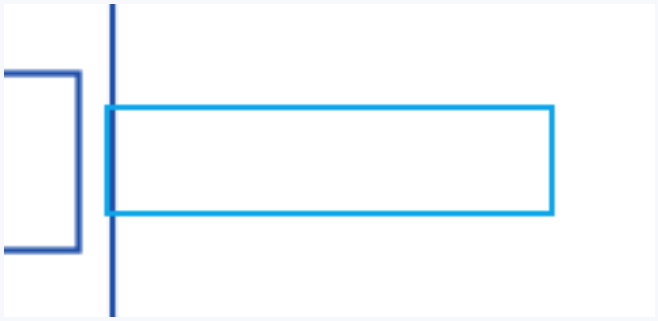
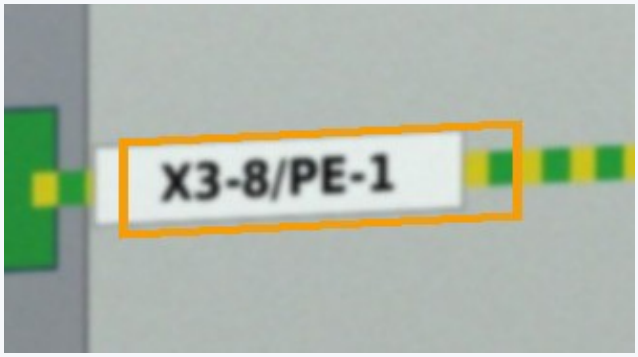
3 FER-X3:8 Ferrule text

REVIEW

Expected (drawing)	X3-8/PE-1
Found (photo)	Unreadable ('X3')
Evidence	OCR votes ['', 'X3', 'XS', 'X3']
