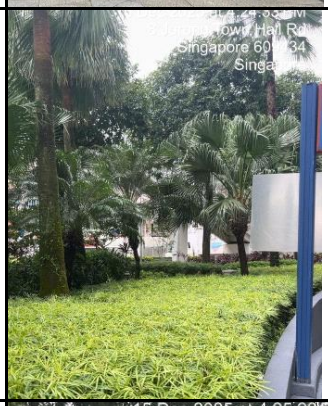
| Property Inspection Checklist | | | | |
|---|---|---|---|---|
| | | | External<br>Plants are healthy.<br>No action required. | |

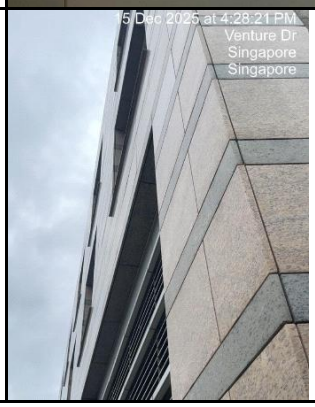
| Property Inspection Checklist | | | | |
|---|---|---|---|---|
| 2 | Façade | | Façade<br>Generally clean.<br>No action required. | |

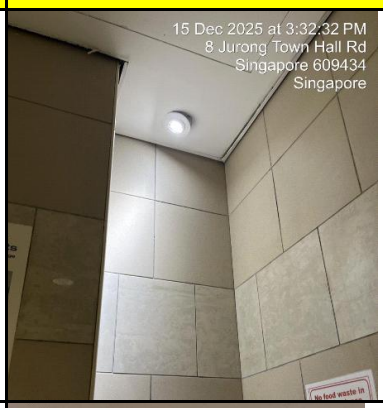
| Property Inspection Checklist | | | | |
|---|---|---|---|---|
| 1 | Toilets | | L14 Male Toilet<br>Downlight fixture is dangling.<br>For rectification. | |

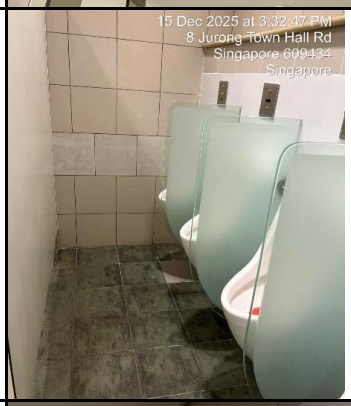
| Property Inspection Checklist | | | | |
|---|---|---|---|---|
| 3 | Toilets | | L14 Male Toilet<br>Urinals are clean and overall area is clean.<br>No action required. | |

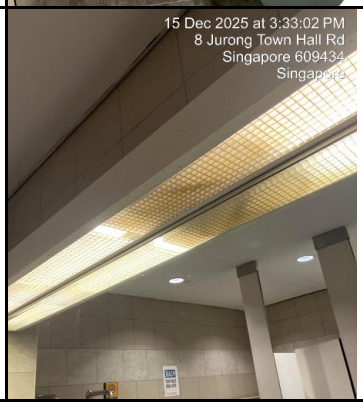
| Property Inspection Checklist | | | | |
|---|---|---|---|---|
| 4 | Toilets | | L14 Male Toilet<br>Lighting is not functional.<br>To check and rectify/replace parts. | |

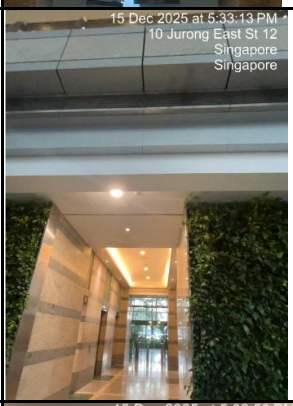
| Property Inspection Checklist | | | | |
|---|---|---|---|---|
| 2 | L1 | | L1 Lift Landing<br>All lights are functional.<br>Area is tidy and clean.<br>No action required. | |

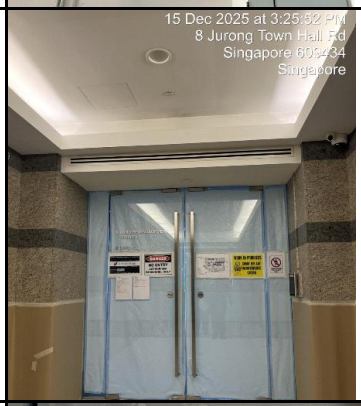
| Property Inspection Checklist | | | | |
|---|---|---|---|---|
| 2 | L21 | | L21 Renovation Floor<br>Project information and safety notice are sighted.<br>No action required. | |

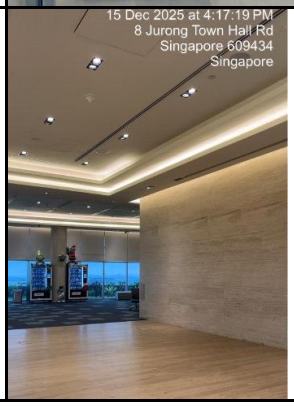
| Property Inspection Checklist | | | | |
|---|---|---|---|---|
| 4 | L31 | | L31 Penthouse<br>Clean and tidy.<br>No action required. | |

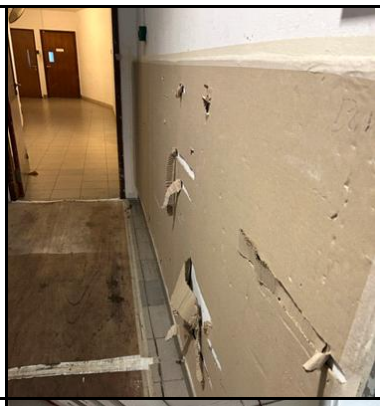
| 5 | L1 | | L1 BOH<br>Temporary wall coverings in back of house hallways on L1 (near Management Office) is damaged and looks unsightly.<br>Suggest a more permanent solution. | |

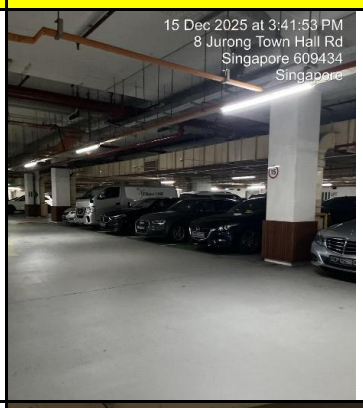
| Property Inspection Checklist | | | | |
|---|---|---|---|---|
| 1 | B2 | | B2 Carpark<br>Driveway are clean and tidy.<br>No action required. | |

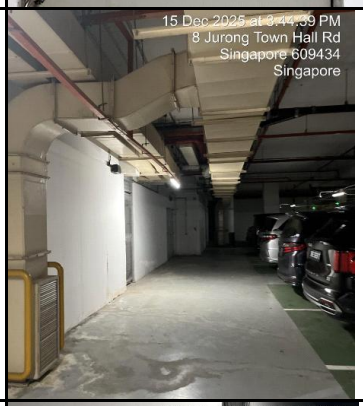
| Property Inspection Checklist | | | | |
|---|---|---|---|---|
| 3 | B2 | | B2 Carpark nearby Fire Srinker Tank<br>Floor has efflourescent / water mark.<br>For clearing. | |

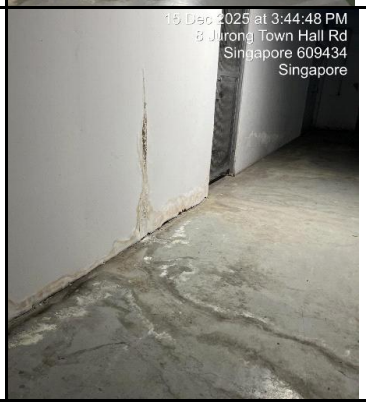
| Property Inspection Checklist | | | | |
|---|---|---|---|---|
| 4 | B2 | | B2 Carpark nearby Fire Srinker Tank<br>Floor has efflourescent / water mark.<br>For clearing. | |

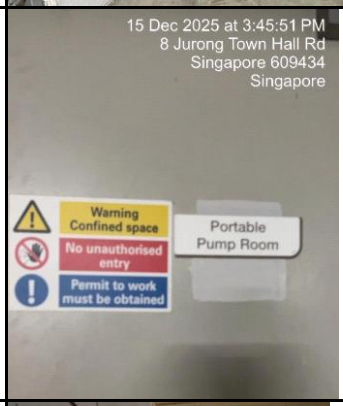
| 6 | B2 | | B2 Potable Pump Room Door has the appropriate signage.<br>No action required. | |

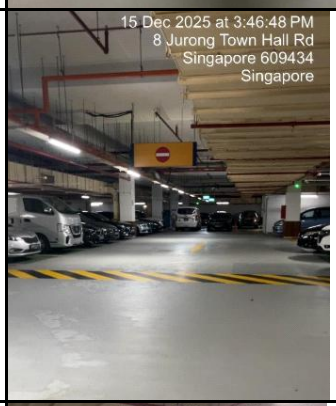
| 7 | B2 | | B2 Carpark<br>Generally is clean and tidy.<br>No action required. | |

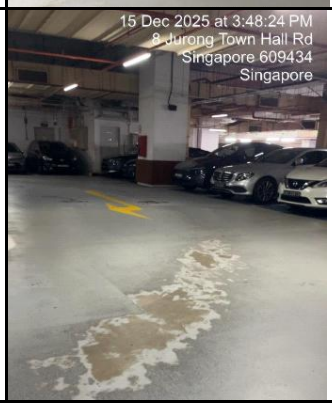
| 8 | B2 | | B2 Carpark<br>Generally is clean and tidy.<br>Except some minor peeling off epoxy paint.<br>No plan rectification. | |

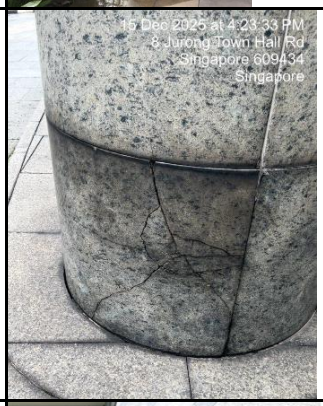
| Property Inspection Checklist | | | | |
|---|---|---|---|---|
| 3 | External | | Eternal<br>Drop off point.<br>Crack granite.<br>For rectification. | |

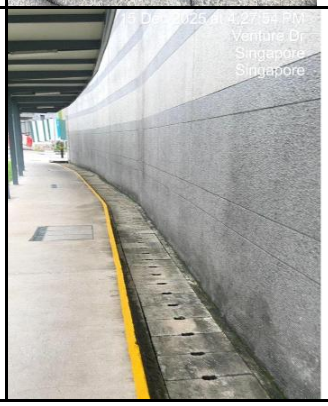
| Property Inspection Checklist | | | | |
|---|---|---|---|---|
| 4 | Perimeter | | Permiter<br>generally clean and tidy with visible safety yellow.<br>No action required. | |

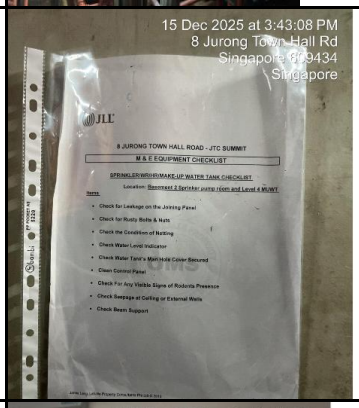
| 6 | | | B2 Pump Room<br>Equipment checklist is sighted.<br>No action required. | |

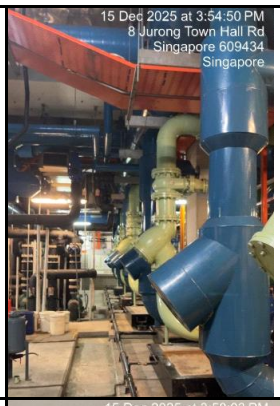
| 9 | B1 iPia1 | | B1 Chiller Plant Room Door.<br>Room is clean and tidy.<br>No action required. | |

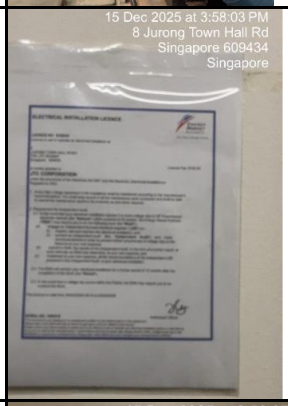
| 10 | B1 iPilibale1 | | B1 Main Switch Room<br>EMA license was avalibale and valid.<br>No action required. | |

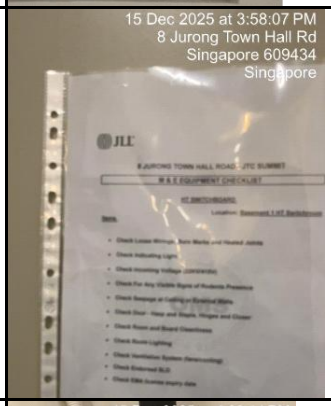
| 11 | B1 | | B1 Main Switch Room<br>Equipment checklist is available.<br>No action required. | |

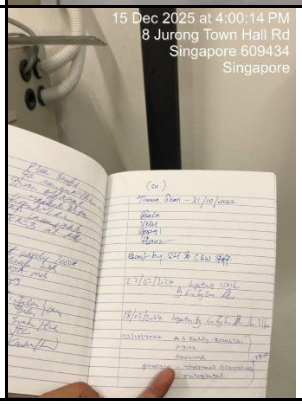
| 12 | B1 | | B1 Main Switch Room<br>Logbook is avaible but not updated.<br>Suggest to implement its usage or incporporate with the monitoring sheet of staff movement for the plant room. | |

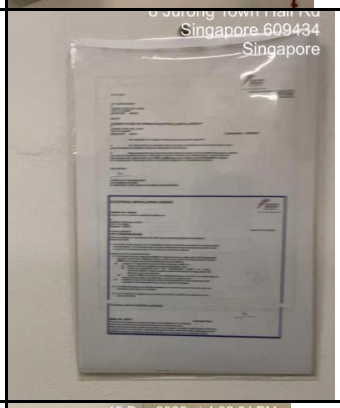
| 15 | B1 | | B1 SwitchGear Room<br>EMA license is sighted, valid.<br>No action required. | |

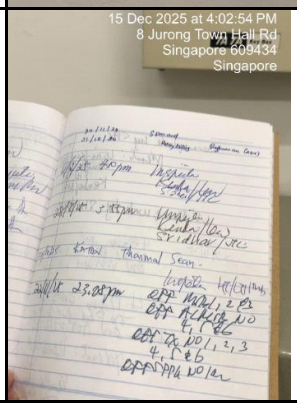
| 16 | B1 | | B1 SwitchGear Room<br>Logbook is updated.<br>No action required. | |

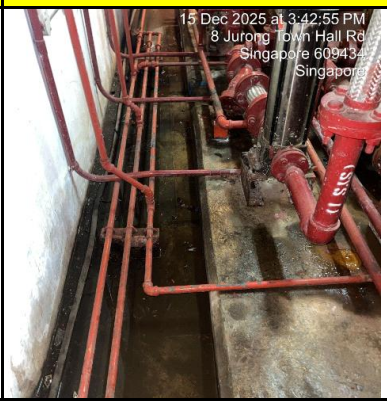
| Property Inspection Checklist | | | | |
|---|---|---|---|---|
| 1 | B2 | | B2 Pump Room<br>Stagnant water on the drain. Potential mosquito breeding.<br>For drying. | |

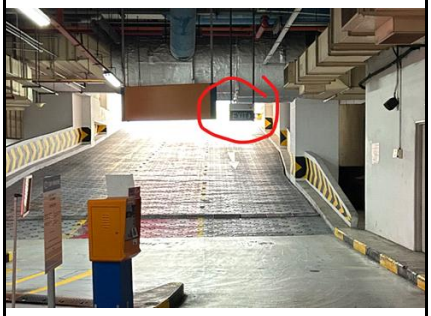
| 9 | | | B1 Ramp<br>Exit light not illuminated at carpark entry.<br>Rectify or replace exit light. | |

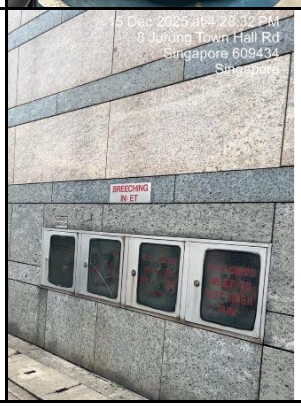
| 11 | | | Perimeter Breeching Inlet<br>Broken Glass and faded label.<br>See below. | |

| 12 | | | Perimeter Breeching Inlet<br>Broken Glass<br>For replacement of glass and redo signage. | |
| 13 | | | Perimeter Breeching Inlet<br>Faded signage.<br>To redo signage. | |
