Pre-Existing Damage Report

Condition of the property before the tenancy began: 4 items of existing damage, recorded on video.

Property address **12 Example Street, Sampletown**

Inspection date **2026-11-01**

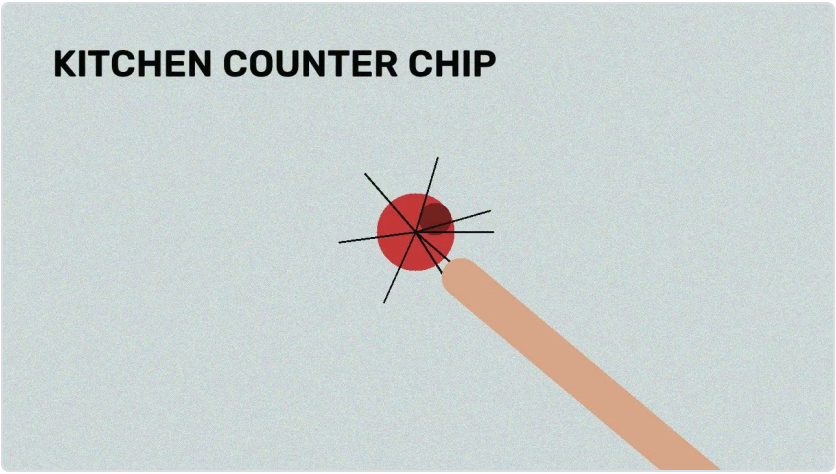
1 Kitchen - on the countertop, to the left of the sink

There's a chip on the front edge, about half an inch wide.

0:04 On the countertop, to the left of the sink, there's a chip on the front edge, about half an inch wide.

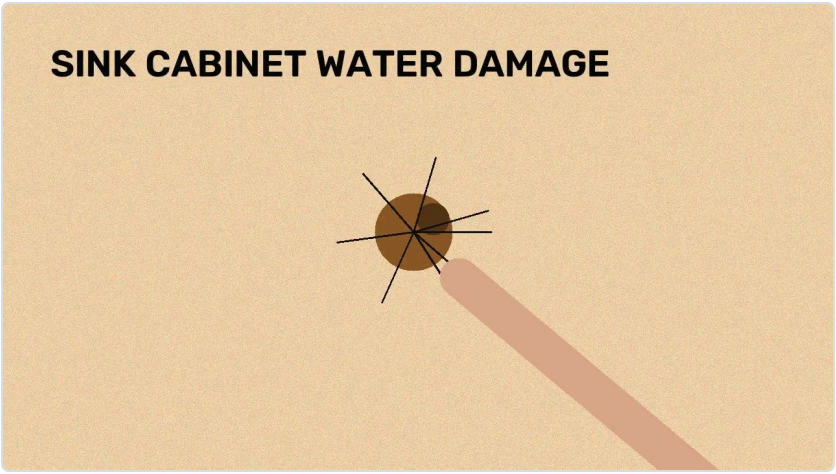
2 Kitchen, the cabinet door under the sink

There's water damage at the bottom, the wood is swollen and the paint is peeling.

0:18 There's water damage at the bottom, the wood is swollen and the paint is peeling.

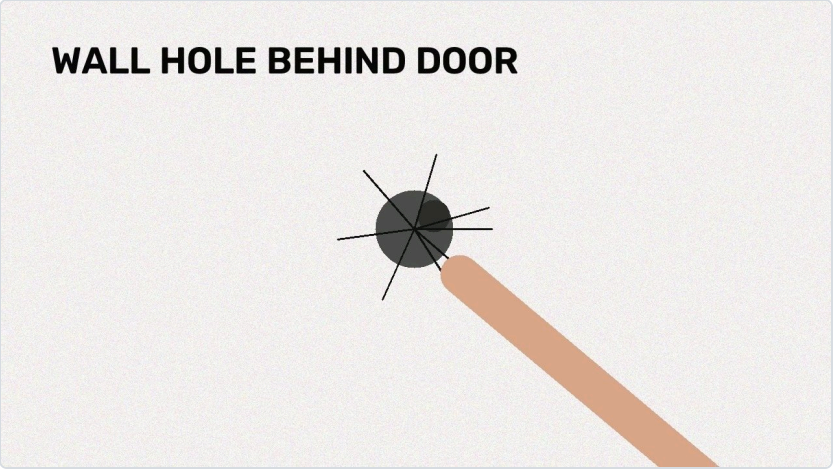
3 Living room, the wall behind the front door

There is a hole in the drywall from the door handle, about two inches across.

0:30 There is a hole in the drywall from the door handle, about two inches across.

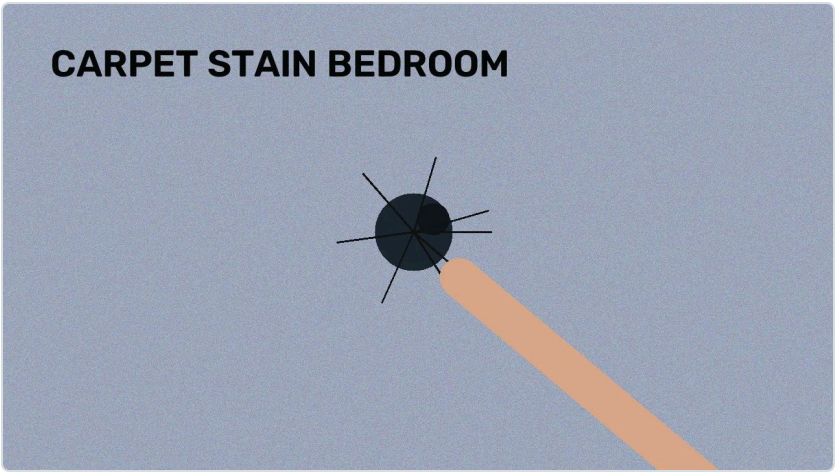
4 Main bedroom carpet, near the closet

There's a dark stain roughly the size of a dinner plate.

0:42 There's a dark stain roughly the size of a dinner plate.
