WHS ALERT #129

'Edge board plywood falling 4.37M to GF during stripping'

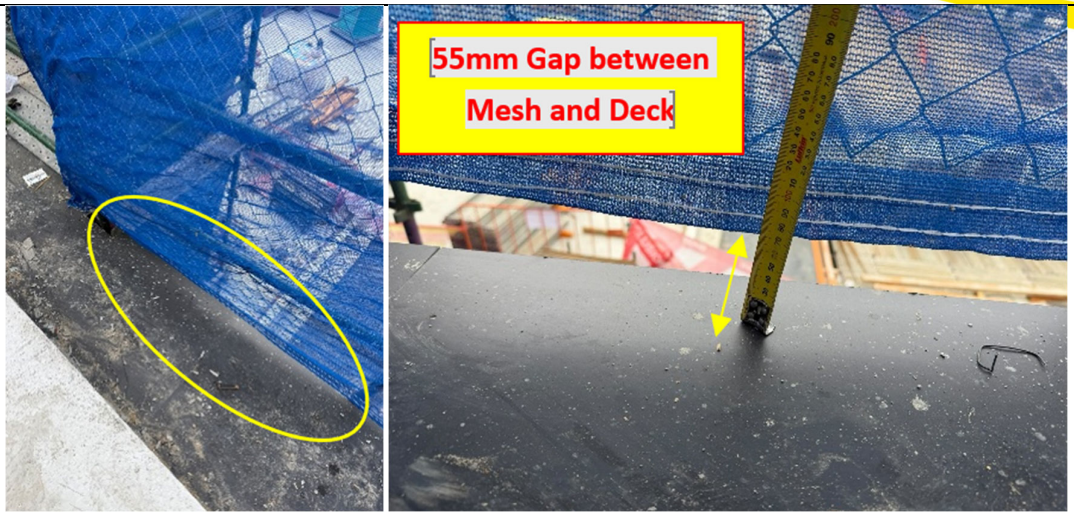
What Happened:	**Incident Summary:** At approximately 9:30 am on Monday, 14 September 2026 at Liverpool Hospital, a worker from the formwork stripping crew was removing edge boards from the slab edge at Level 1, Pour H. During the activity, the worker had temporarily leaned a stripped edge board plywood against the scaffold edge protection while removing the next edge board from the slab. While removing the next section of the edge board from the slab, a plywood section impacted the edge board positioned against the scaffold edge protection. This impact caused the plywood to pass through a 55mm gap between the mesh and deck, falling approximately 4.37m to Ground Floor, Pour G. Although an exclusion zone had been established below, it did not extend the full length of the work area. As a result, the plywood landed just outside of the exclusion zone, within an area that remained restricted due to ongoing works. The dimensions of the fallen plywood sections were ~450mm × 1,720mm & 500mm × 1,410mm. No personnel were working in the immediate vicinity at the time of the incident. The Ground Floor area had been restricted due to perimeter scaffold erection works, and the crane crew was also landing shutters in the area. All workers were positioned well clear of the incident location. All works ceased, notification to Lendlease Management and BKH Management. This further was reported to SafeWork NSW who released the scene immediately.  **Figure A** – Edge board which has fallen from Level 1- Pour H (Approx. 4.37m) down to GF Pour G.

- ✓ Make sure exclusion zones are established in entirety and at all possible entry points of all stripping works, and wherever there is a potential to have a dropped object.
- ✓ Ensure all gaps are adequately covered or closed before commencing work.
- ✓ Review slab configurations where kickboards have not been installed.
- ✓ Maintain good housekeeping practices. Stripped materials must be stored well clear of edges to minimise the risk of dropped objects.

- Conduct a Toolbox Talk on this Safety Alert with all site team.
- Ensure all workers adequately plan their tasks before commencing work.
- Establish full complete exclusion zones for all stripping works at any possible entry points to the stripping and potential area material can fall into.
- Identify gaps prior to stripping and ensure covered prior to commencment of works.
- Verify that all work areas are clear of loose materials prior to starting any task to eliminate the risk of falling objects.

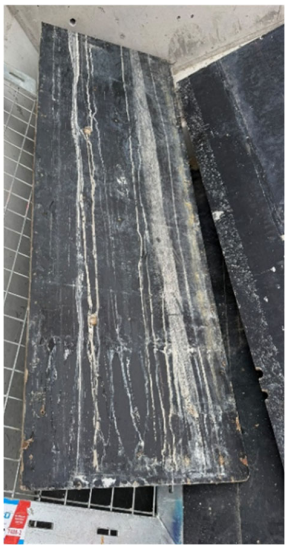
Figure B – Area from where the edge board fell through the gap (Approx. 55mm) between the mesh and the deck and landed on GF, Pour G.
