RTU Preventative Maintenance Report

Job Number	8401L0070
Report Form Type	Preventative Maintenance
System Description	ISOSS SECURITY SYSTEM
Station Name	Ang Mo Kio Offtake / 192.169.1.1
Project No	1500
Customer	PUB
Report Title	RTU Preventative Maintenance Report

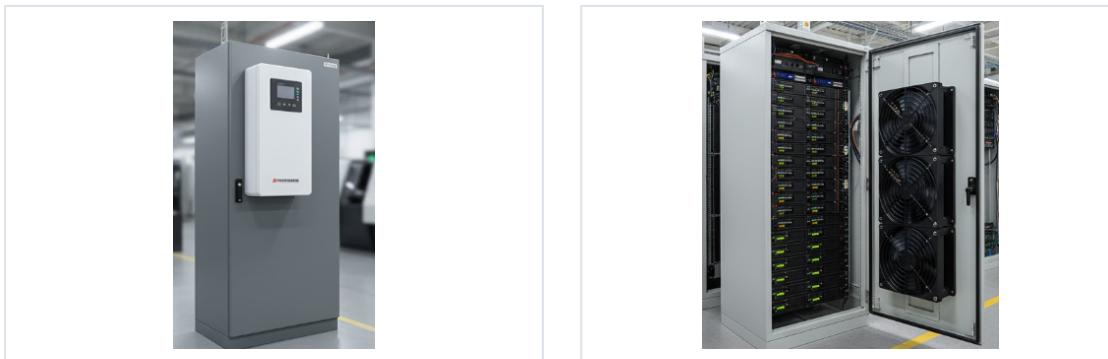
Chamber Images

#	Chamber No.	OG Box	Contact 1	Contact 2	Contact 3	Remarks
1	2	FAIL	PASS	PASS	FAIL	N/A
2	1	PASS	PASS	PASS	PASS	N/A
