# How to read input shaper graphs: a work in progress

Compilation by Reth (the original Reth)

Reth's Voron Trident – serial 1190

Version 4-24-2024

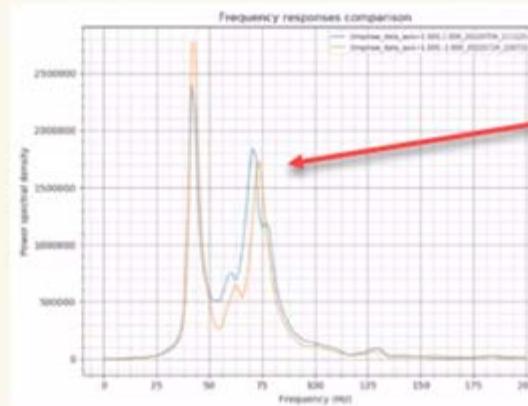
- binding
- loose bolts
- over-dampening
- loose belts
- wire loom issues
- printer design issues

peaks not aligned  
bad belt tension

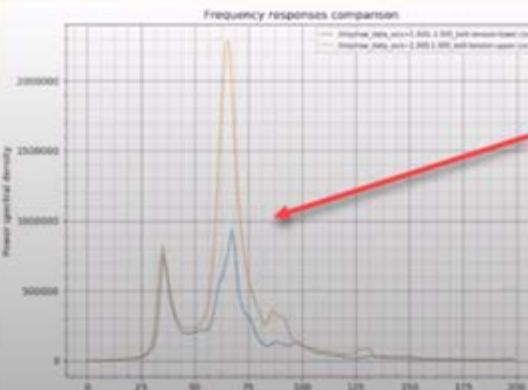
Peaks are aligned, but amplitude is to low.  
generally indicates  
1) belts were not cut  
the same length, or  
2) belts length coming  
out of the x-carriage is  
not the same, or  
3) something else in  
belt path

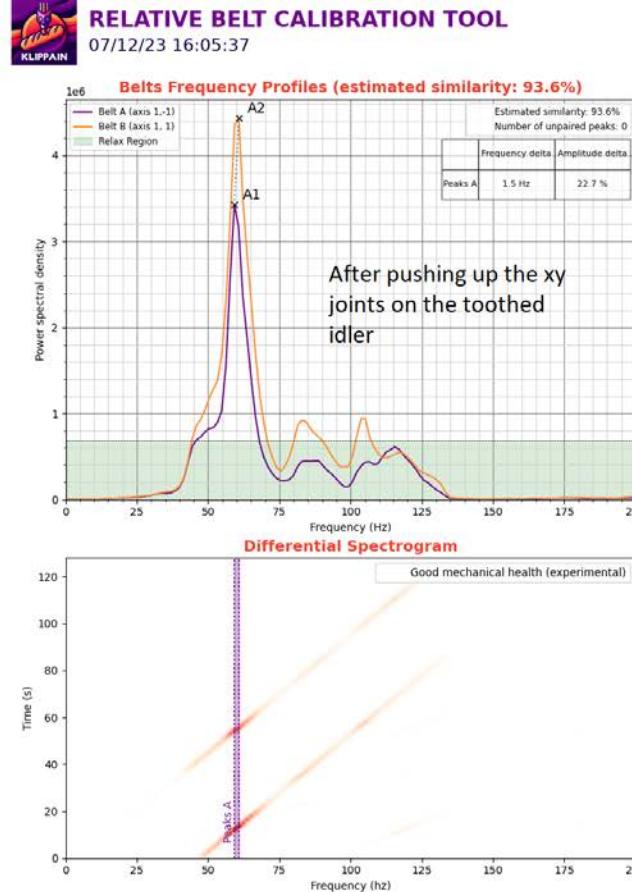
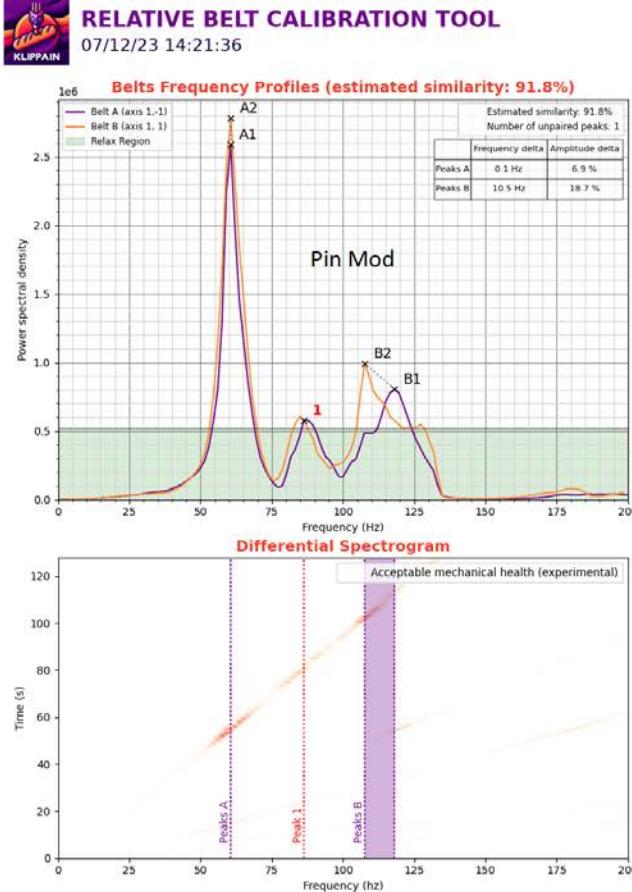
# Pin Mod: may need to push up the xy joint around the idler

What one can see here is that for the pin mod it is really easy to have the plastic around the toothed idler to contact the flange of the toothed idler thereby dampening is belt shaper

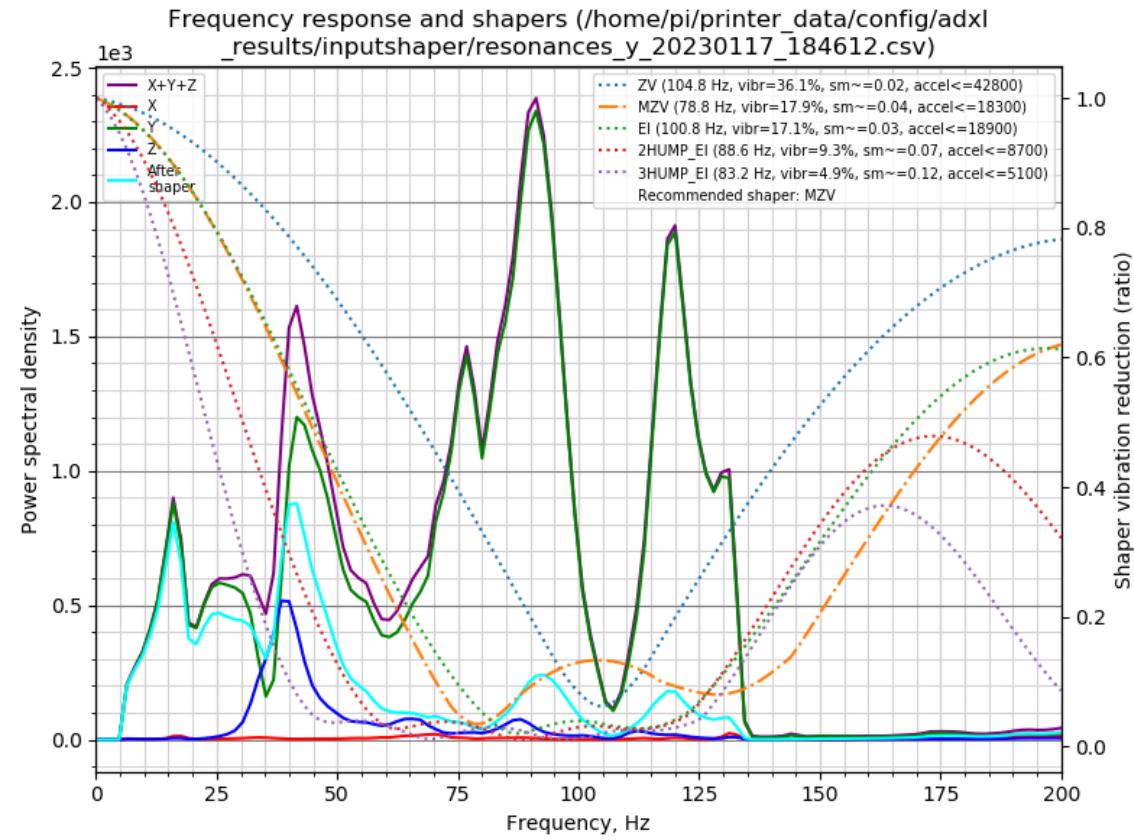
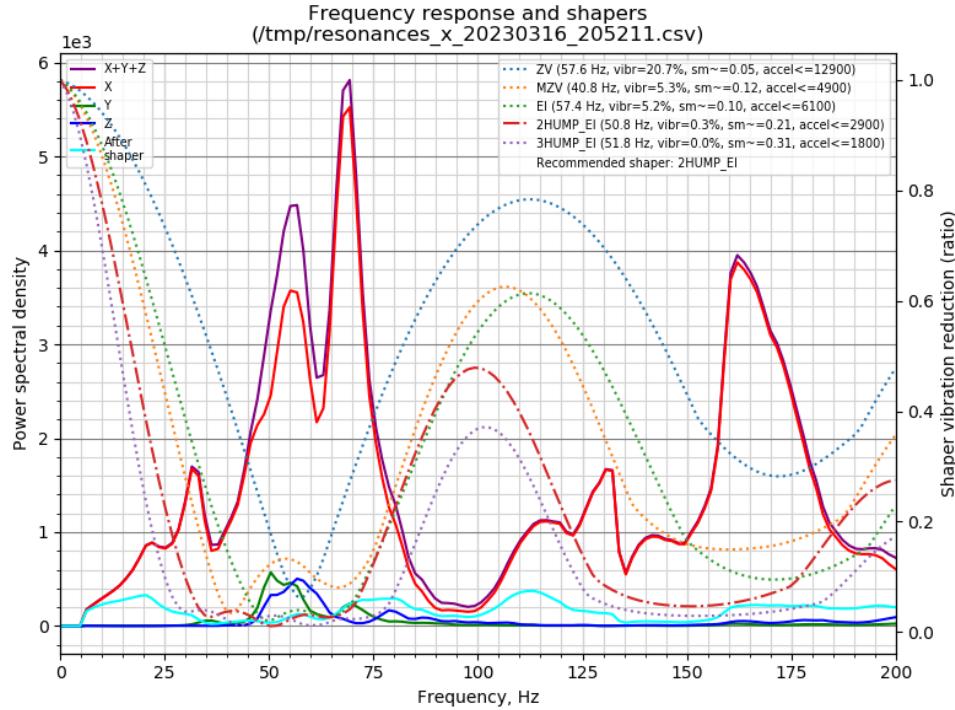
# Binding, racking, wobbly table, etc.

check every moving part

start by placing printer on a stable surface (floor)

then check belt path, then derack, then belt tension.

If problem persist consider relubing linear rails, replacing bearings/idlers

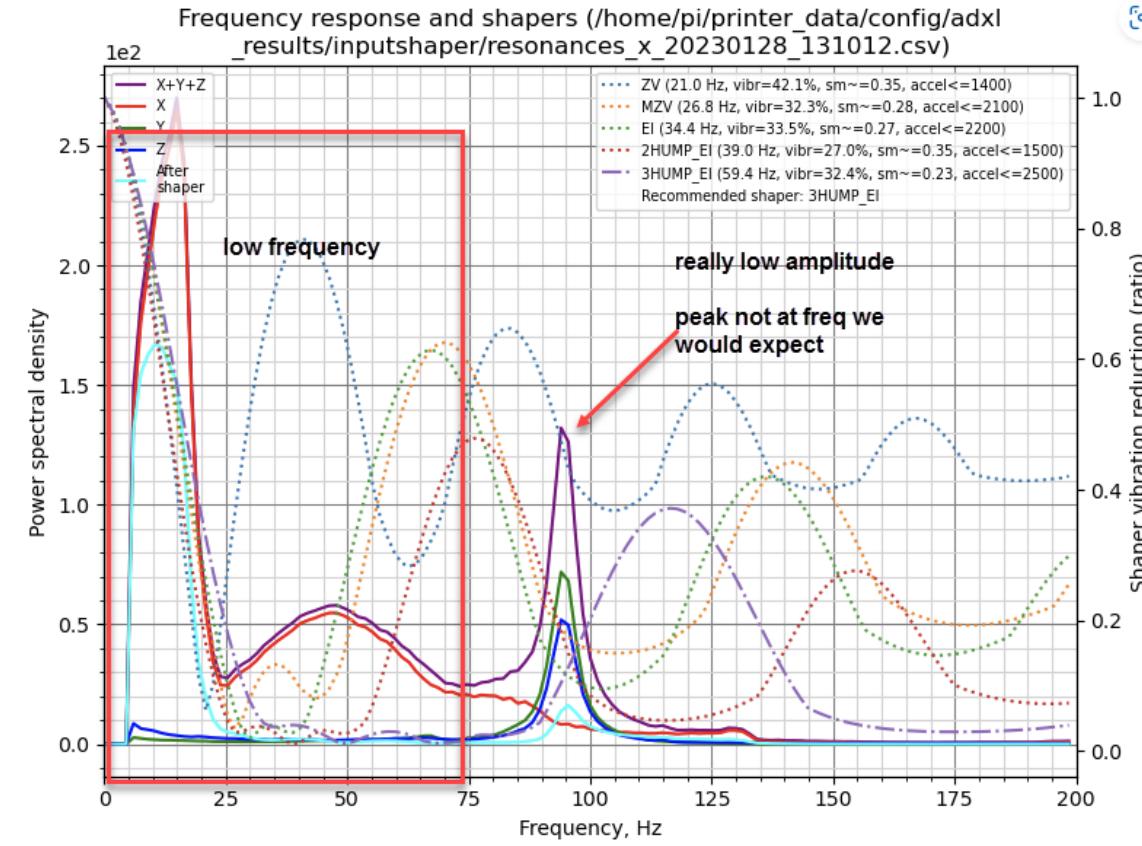
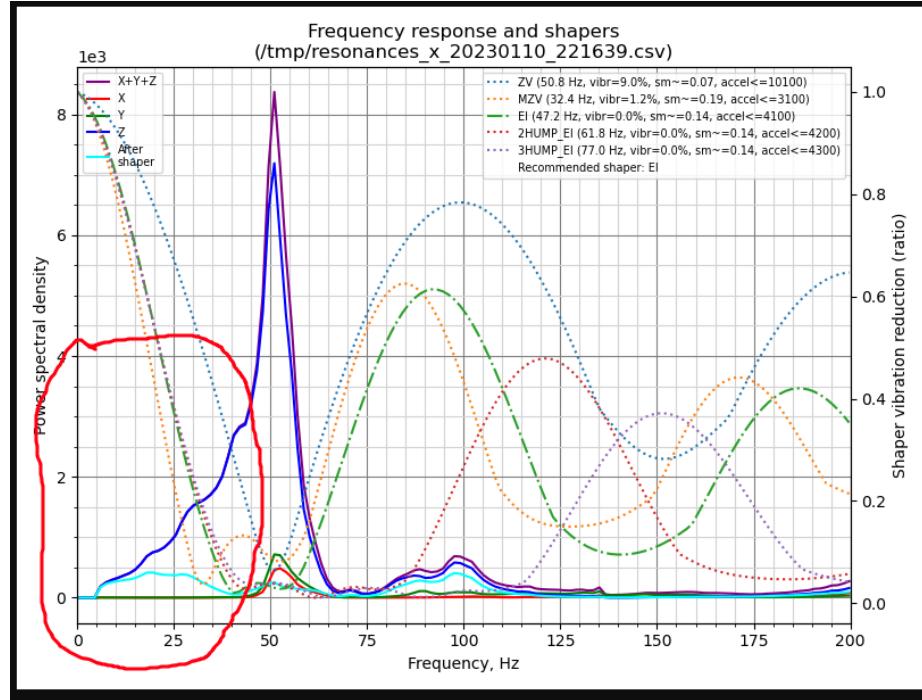
# Low frequency – binding or grinding

## something is not moving freely

check belt alignment (make sure you have the belt in the middle of the bearings, and not riding on the flange. Make sure bearings have the flange on the outside of the belt bath)  
Check linear rails, bearings, and idlers

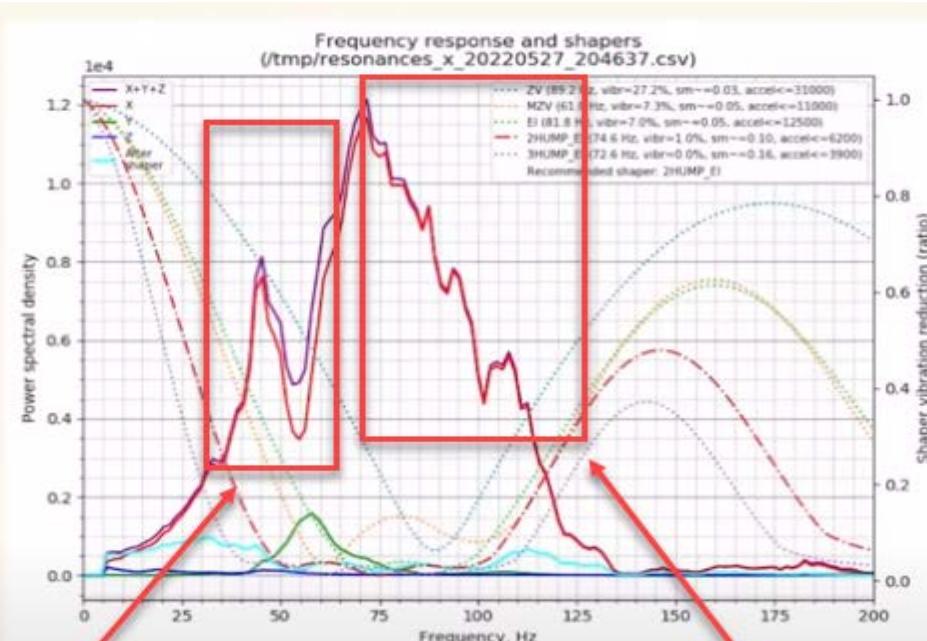
# Wireloom and loose bolt

loose bolt:  
second peak

wireloom:  
jagged peaks

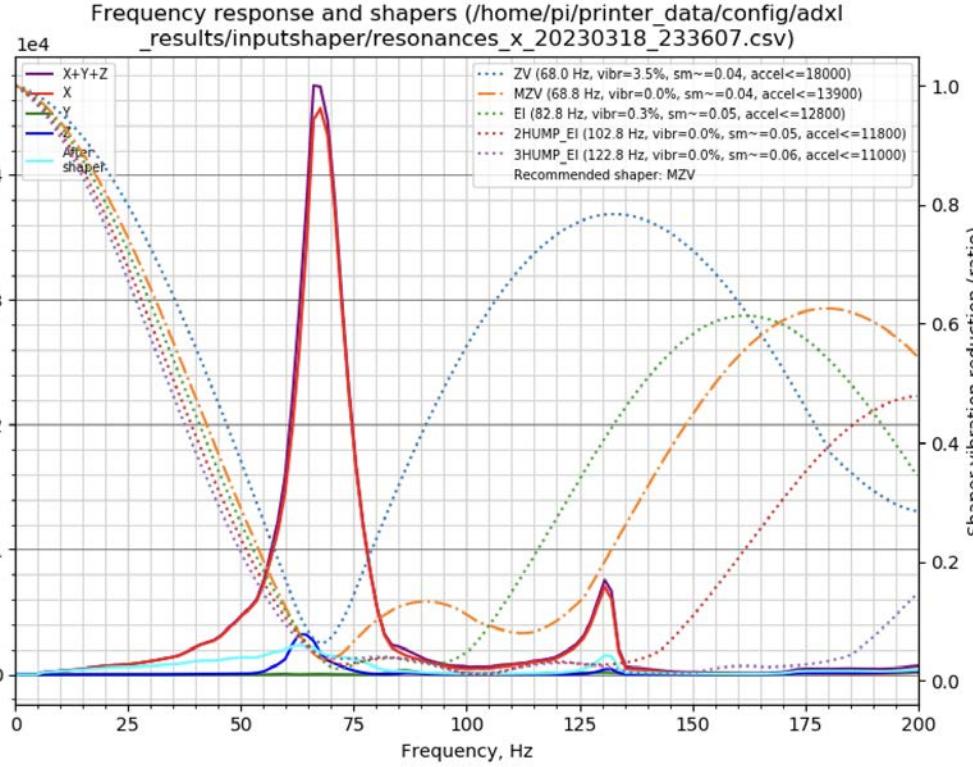
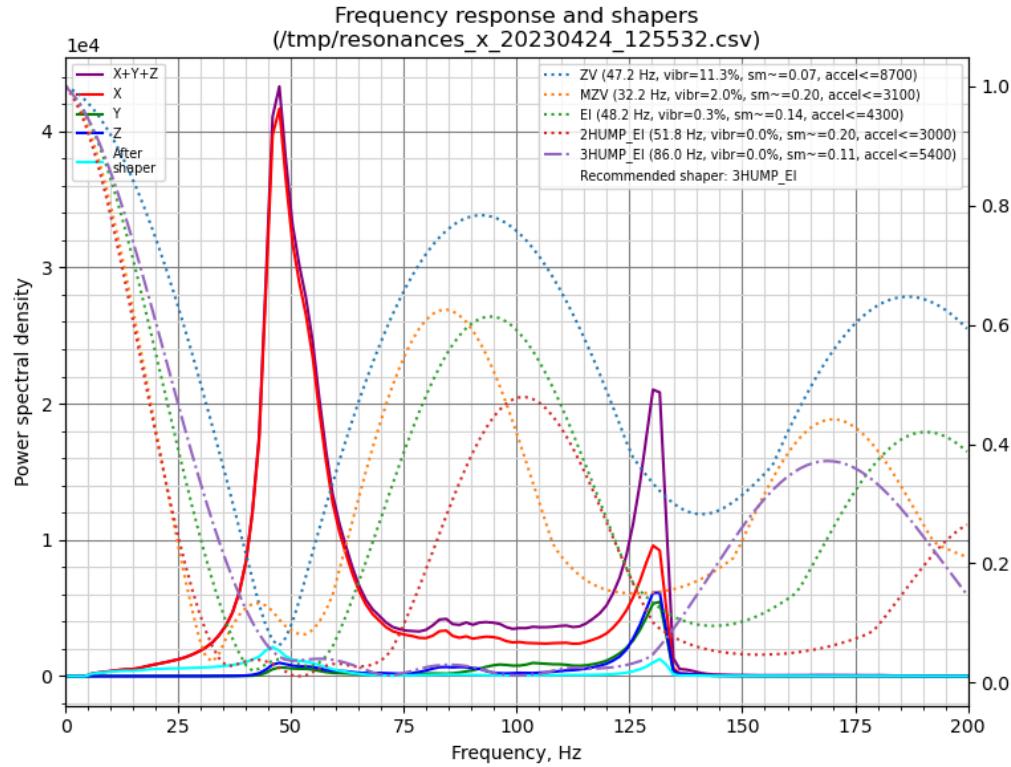
# TAP Wobble toolhead in general

TAP issues are generally around 125hz and have the general shape shown above.

Toolhead issues are also associated with, but not exclusive to, 125hz.

If you see 125hz investigate the toolhead – break it down, and make sure all screws are tight, and your tap magnets are engaged.

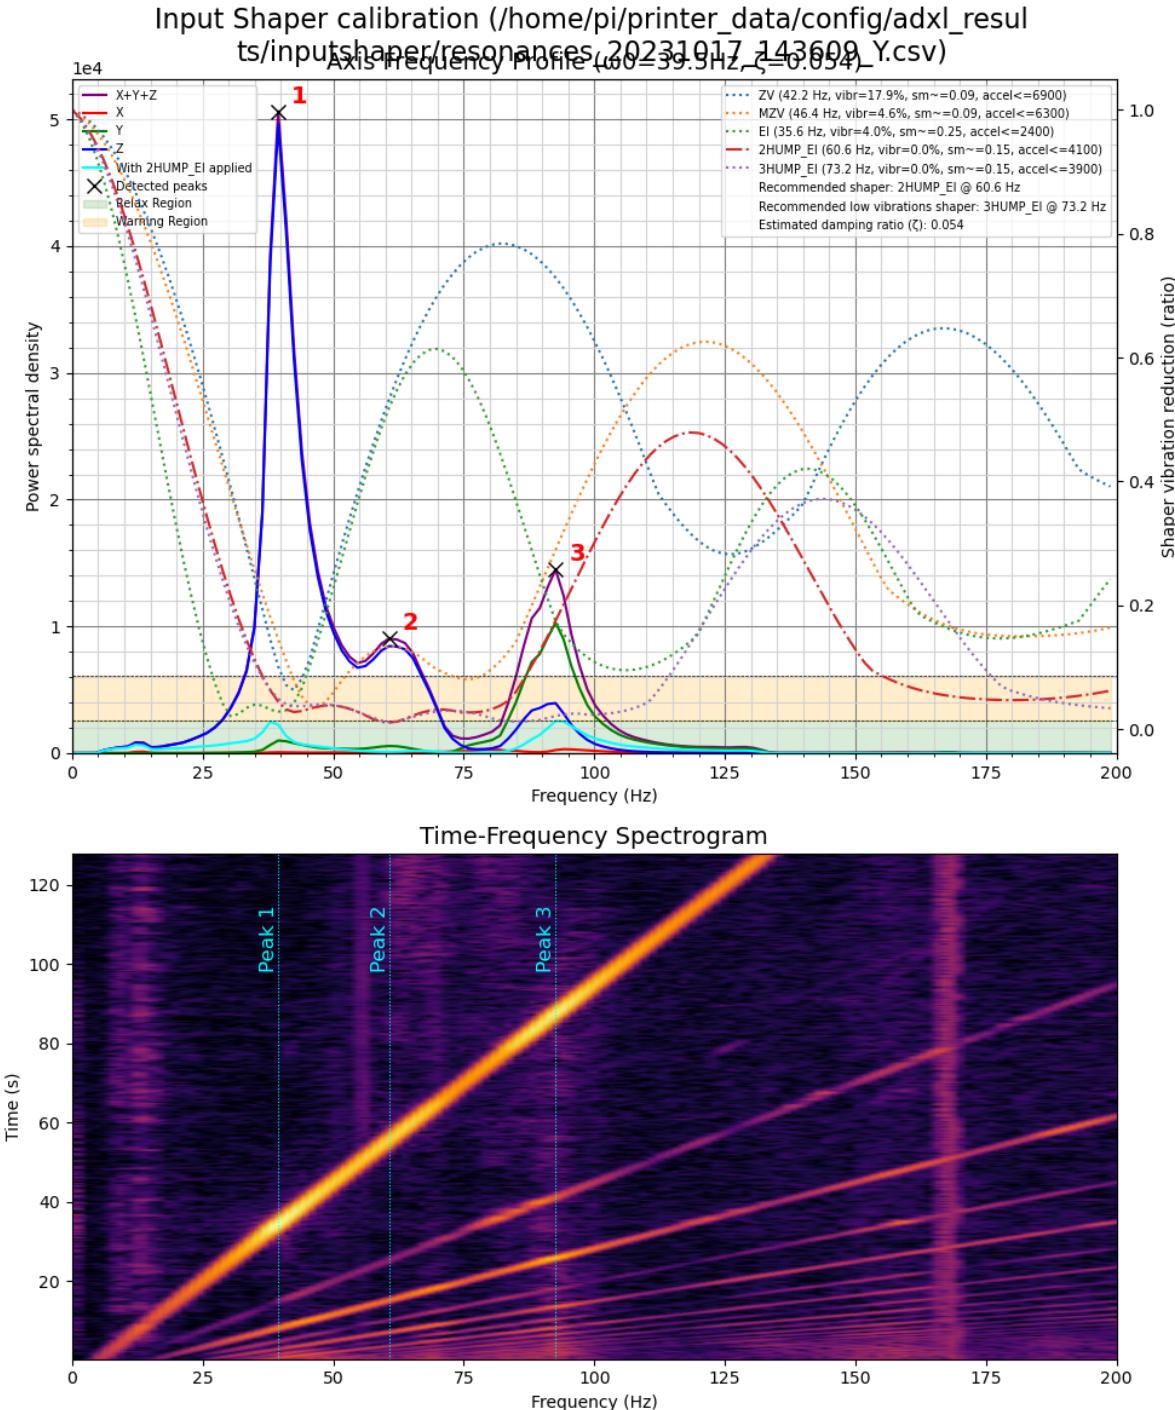
# Canbus cable, or TAP linear rail

peak 3  
this could be the canbus umbilical cable, or this could be the tap linear rail

The effect as seen is that there is a z excitation. This can be interpreted as an RX (rotation on the x axis) or as something pulling up on the tool head.

A canbus umbilical can pull on the toolhead, also the tap rail may not be good enough and allows for Rx rotation

Notice that peak 3 goes to zero on the left and right of it

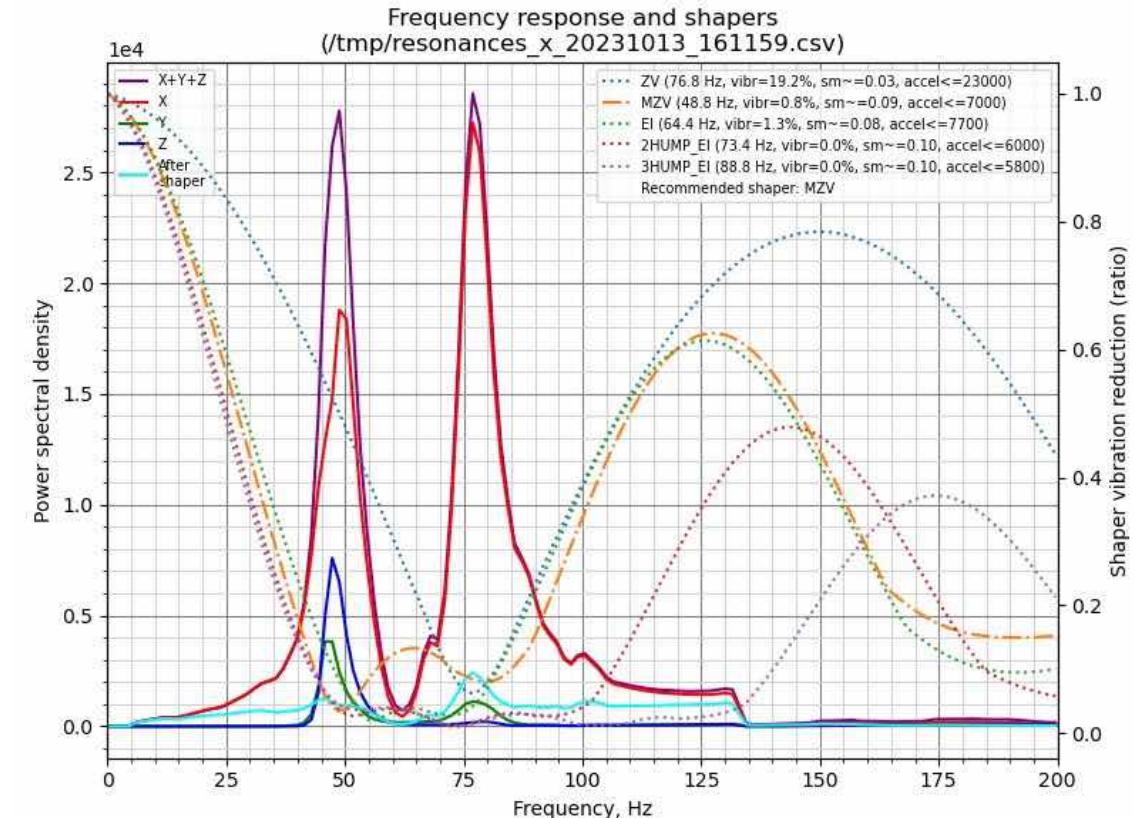
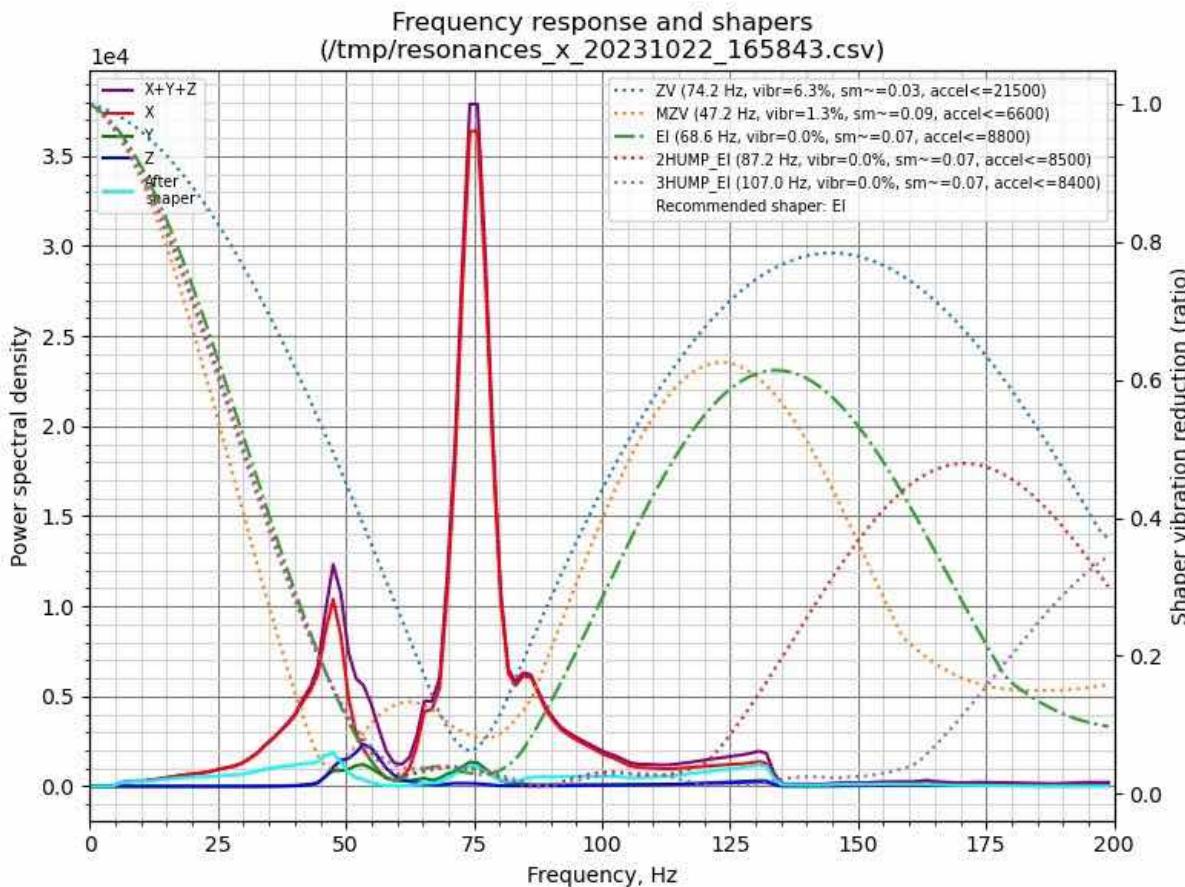
# Potential Bearing issue

What you see here is two peaks with a valley between them and the valley goes to zero. This is very similar to the canbus, tap, or linear rail.

The difference is the amplitude of the 75 hz spike is equal to or greater than the real freq of around 50hz.

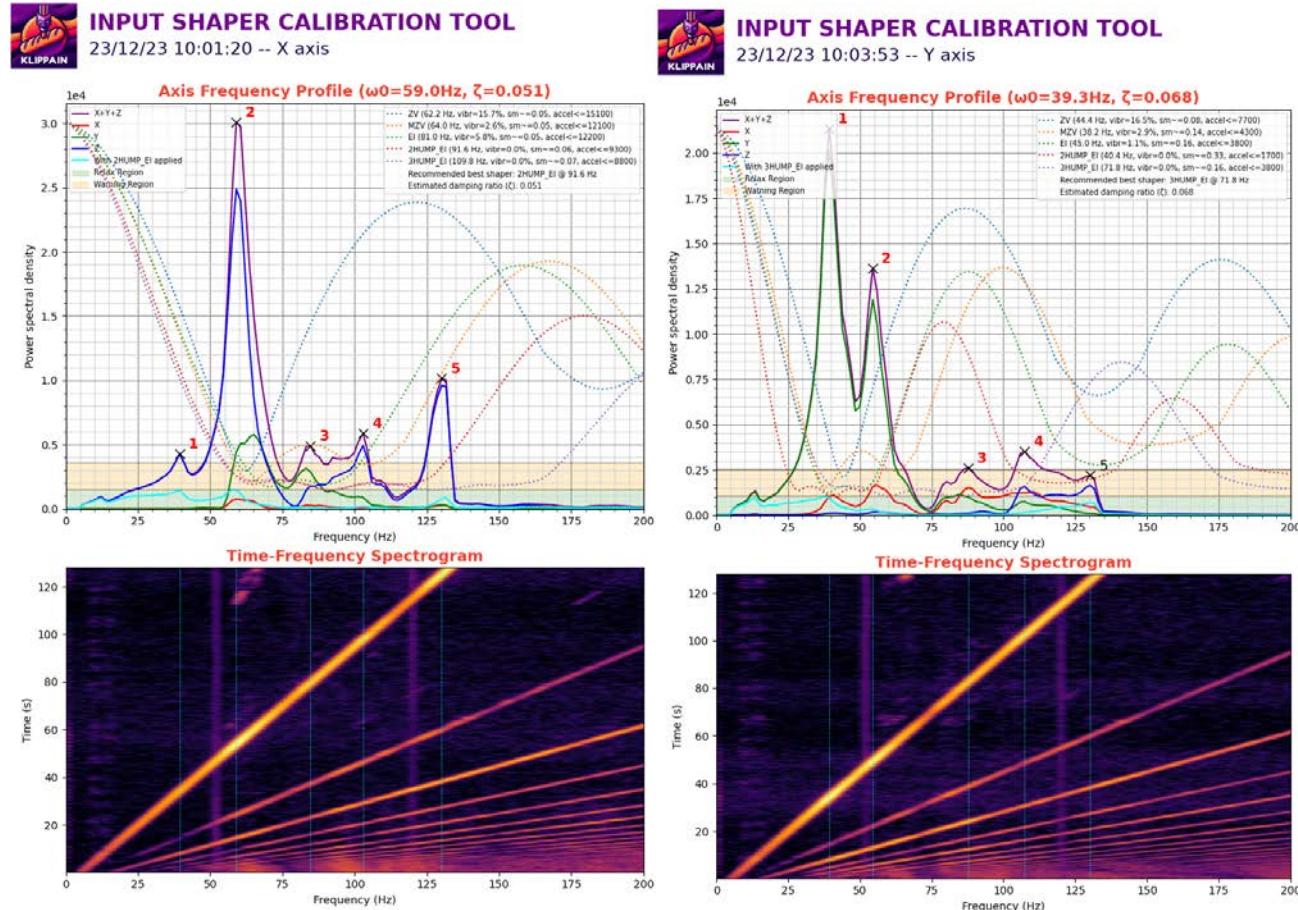
Not using all four screws to secure tap to the x-linear rail – missing two screws.  
Likely similar if screws are loose.

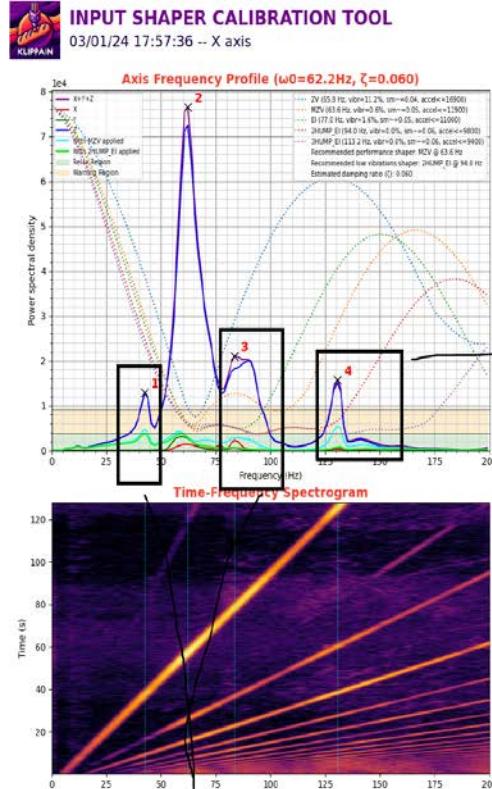
Bad linear rail - missing bearings

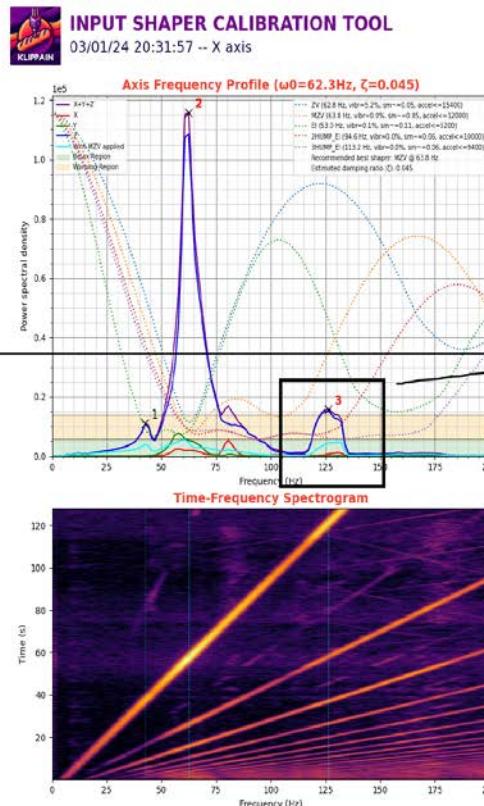
## Part 1: 125hz is not the x-linear rail

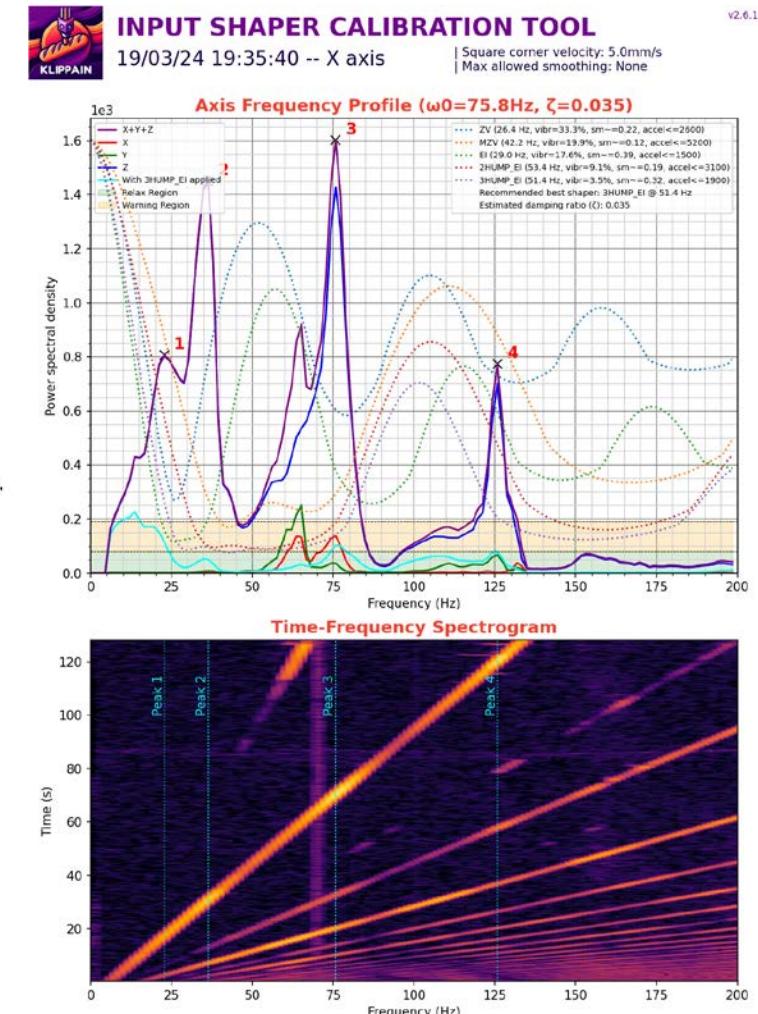
Tap:  
using mellow tap.  
likely umbilical is causing some of this.

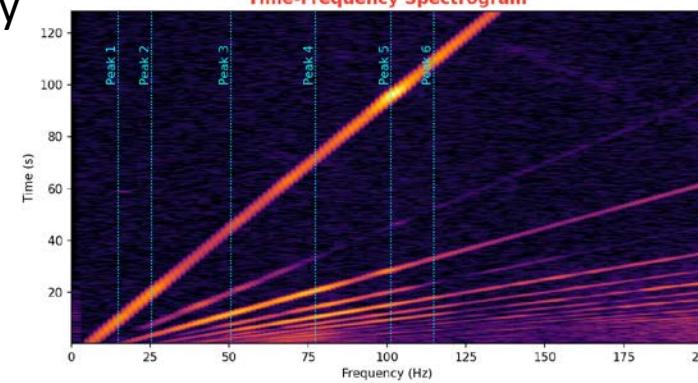
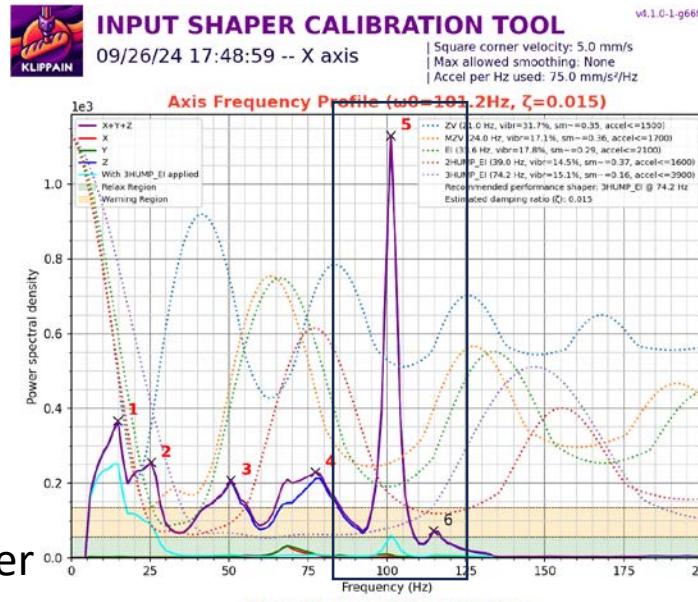
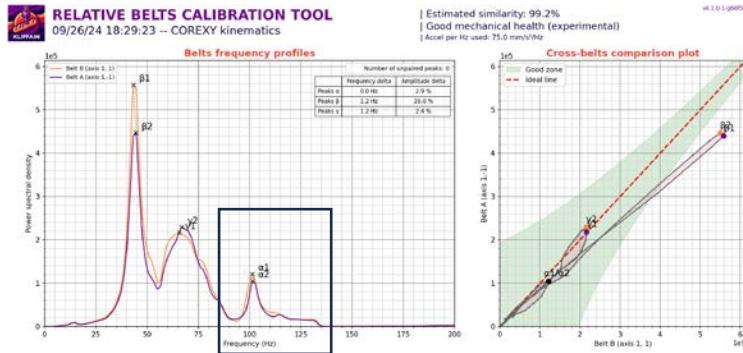
# What a bad x-linear rail looks like.

The 100hz spike in belts and x-shaper  
Is due to a rusted (pitted) potentially  
Twisted x-linear rail

This is rust/pitting of the x-linear rail

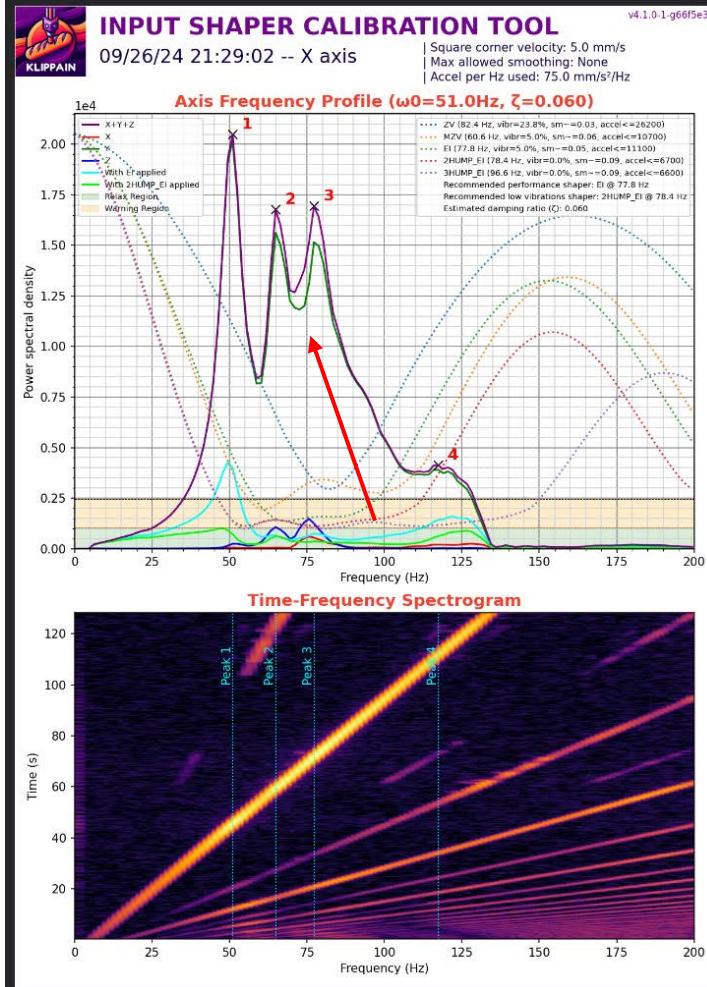
# Loose Z-mod screw (missing screw)

Before
