How to read input shaper graphs: a work in progress

Compilation by Reth (the original Reth)

Reth's Voron Trident – serial 1190

Version 4-24-2024

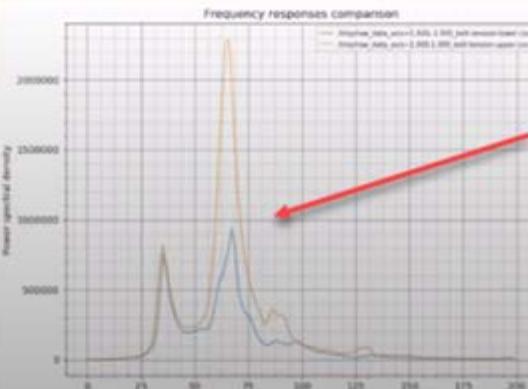
peaks not aligned
bad belt tension

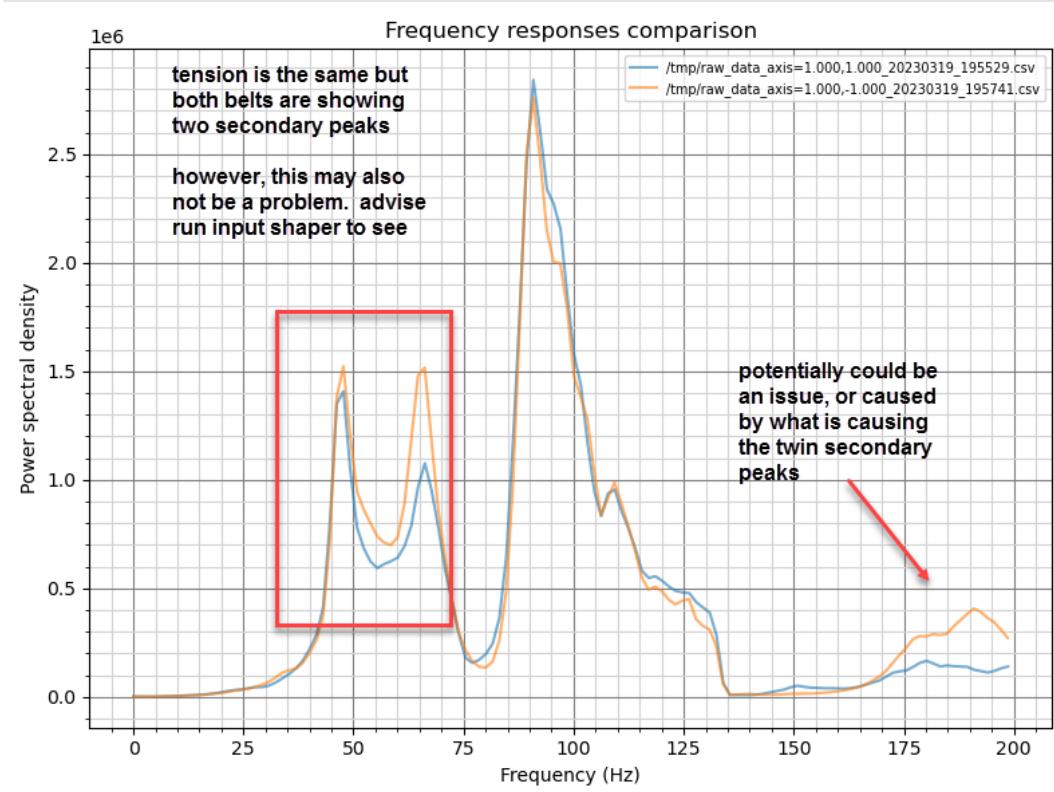
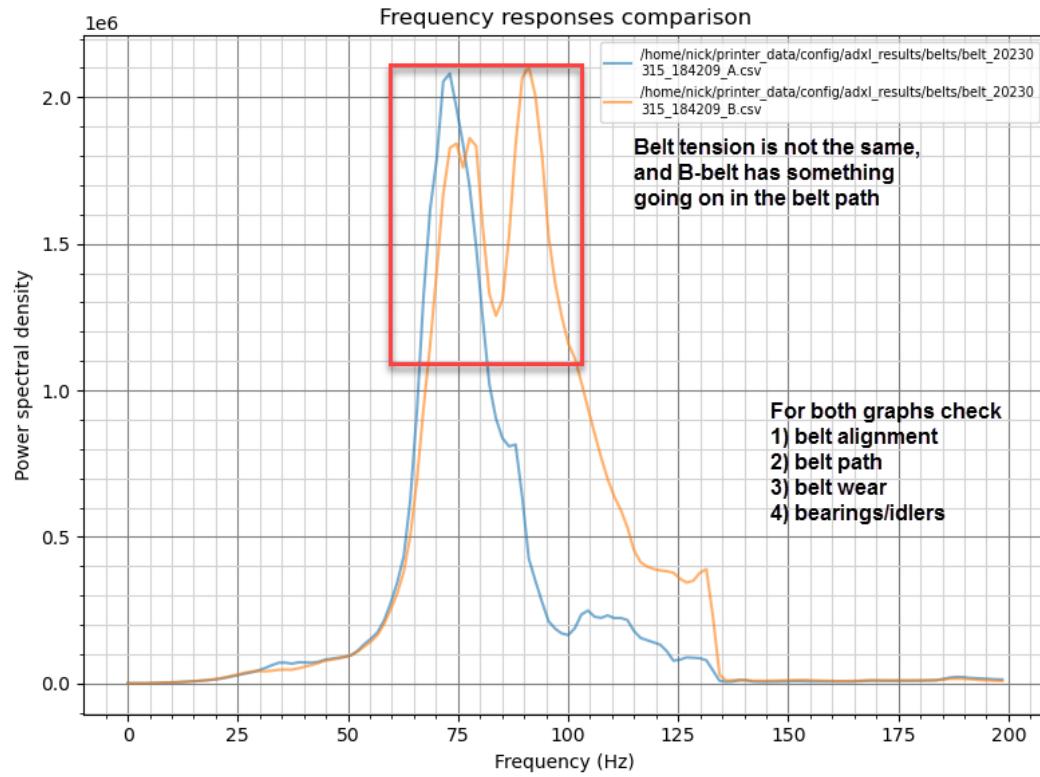
Peaks are aligned, but amplitude is to low.
generally indicates
1) belts were not cut
the same length, or
2) belts length coming
out of the x-carriage is
not the same, or
3) something else in
belt path

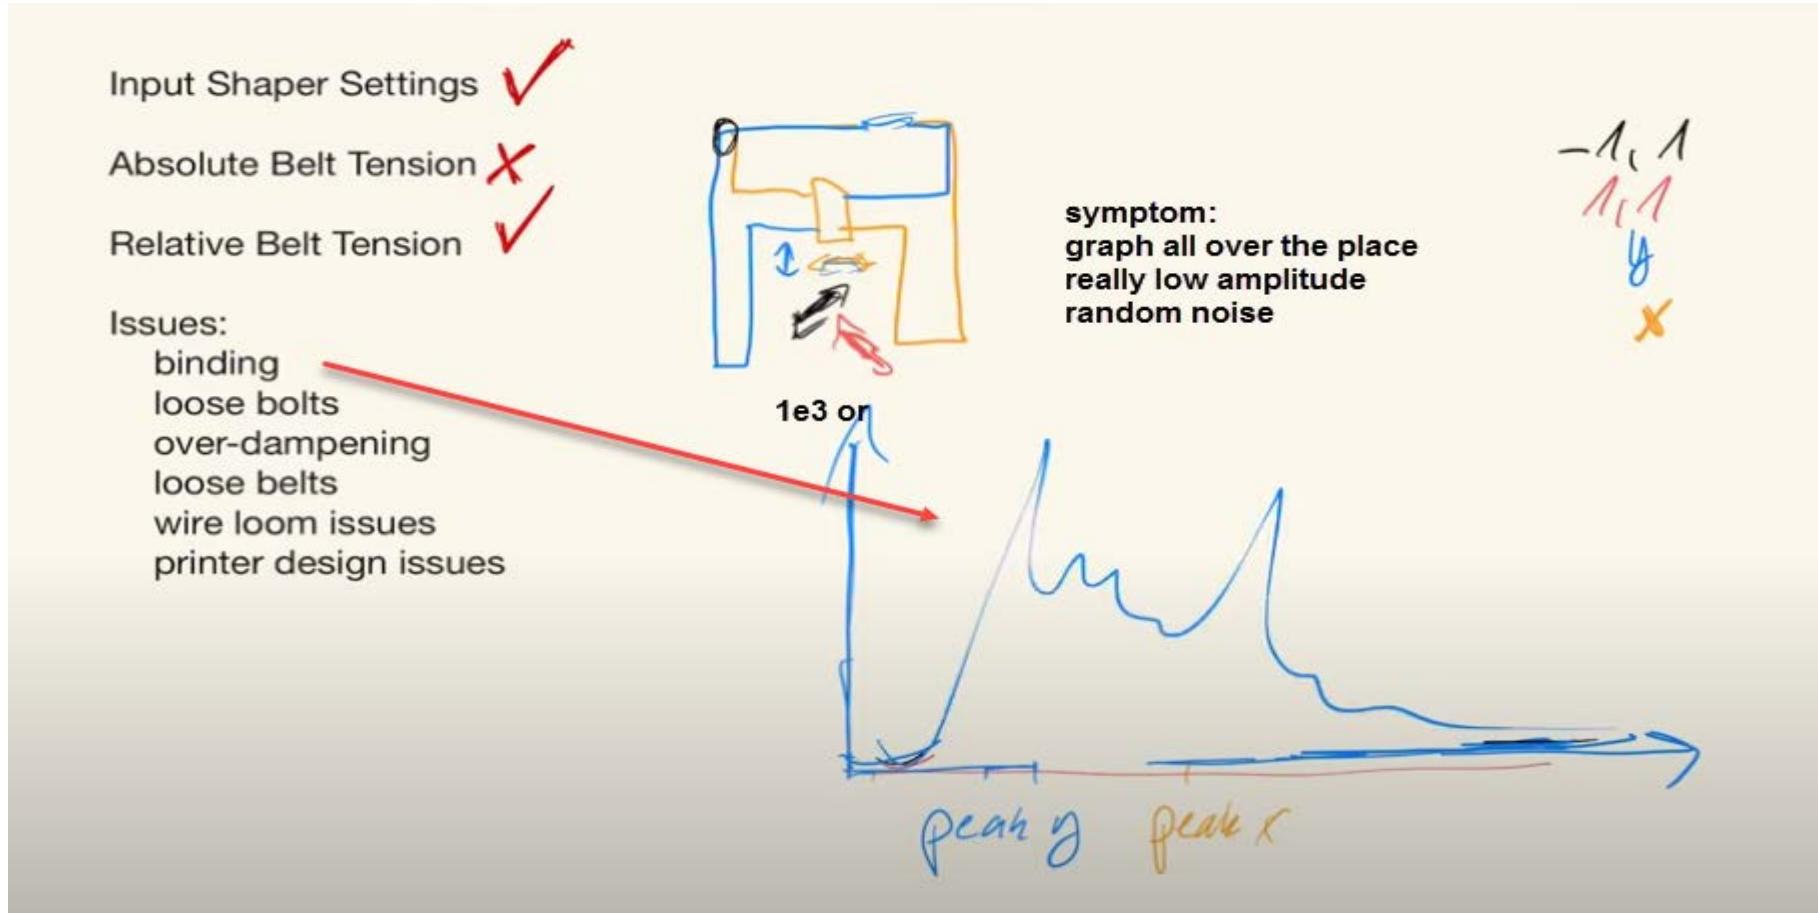
Binding

Binding, racking, wobbly table, etc.

check every moving part

start by placing printer on a stable surface (floor)

then check belt path, then derack, then belt tension.

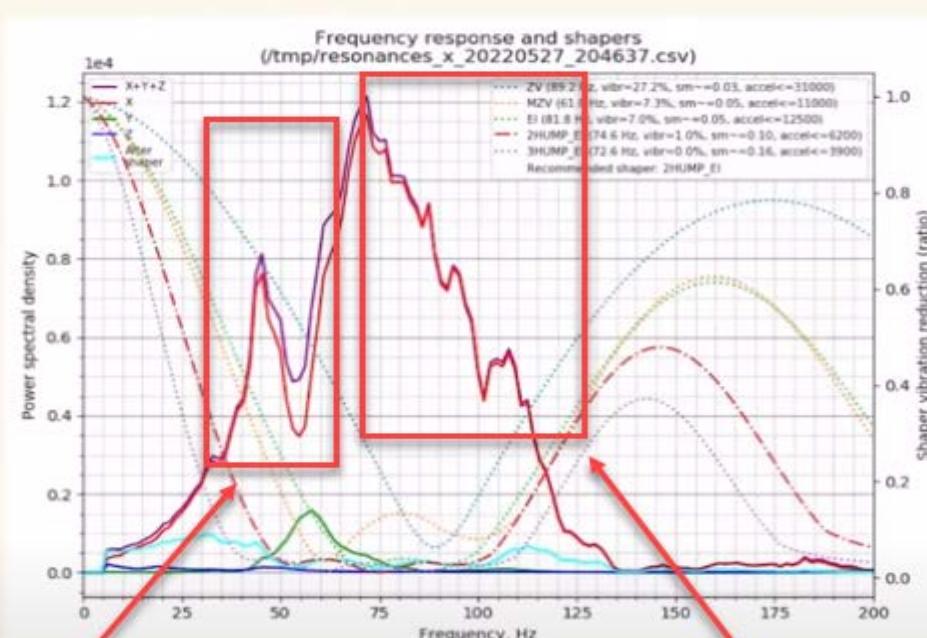
Wireloom and loose bolt

loose bolt:
second peak

wireloom:
jagged peaks

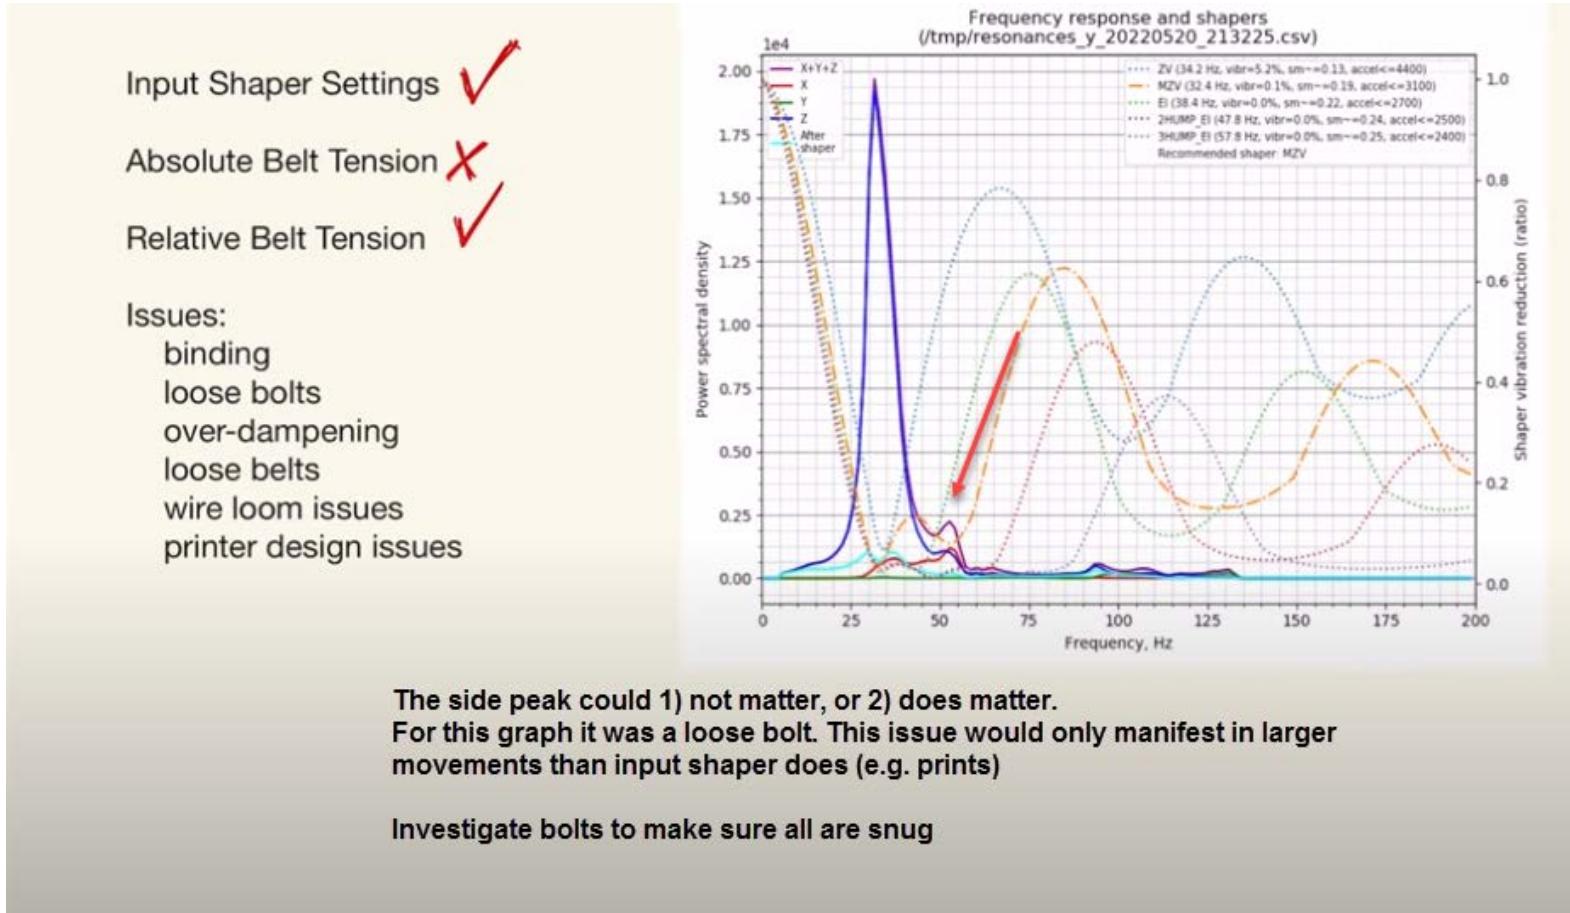
Potentially loose bolt or nothing at all

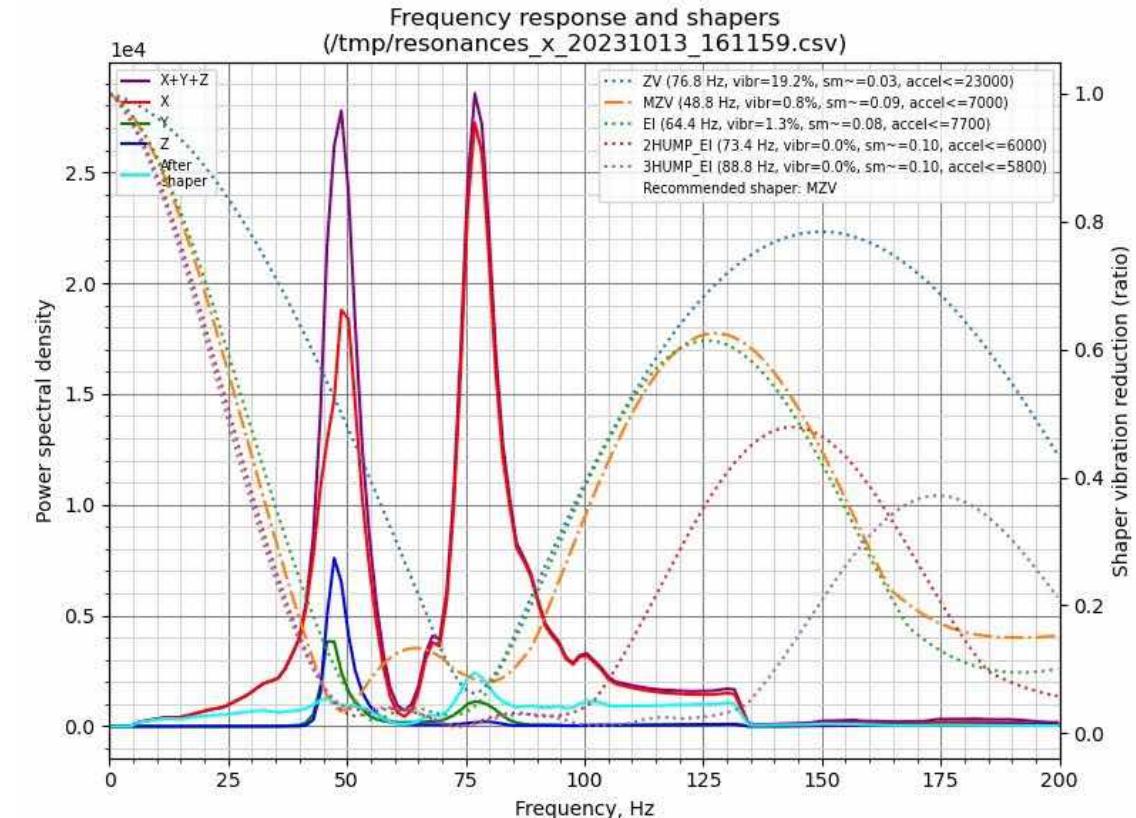
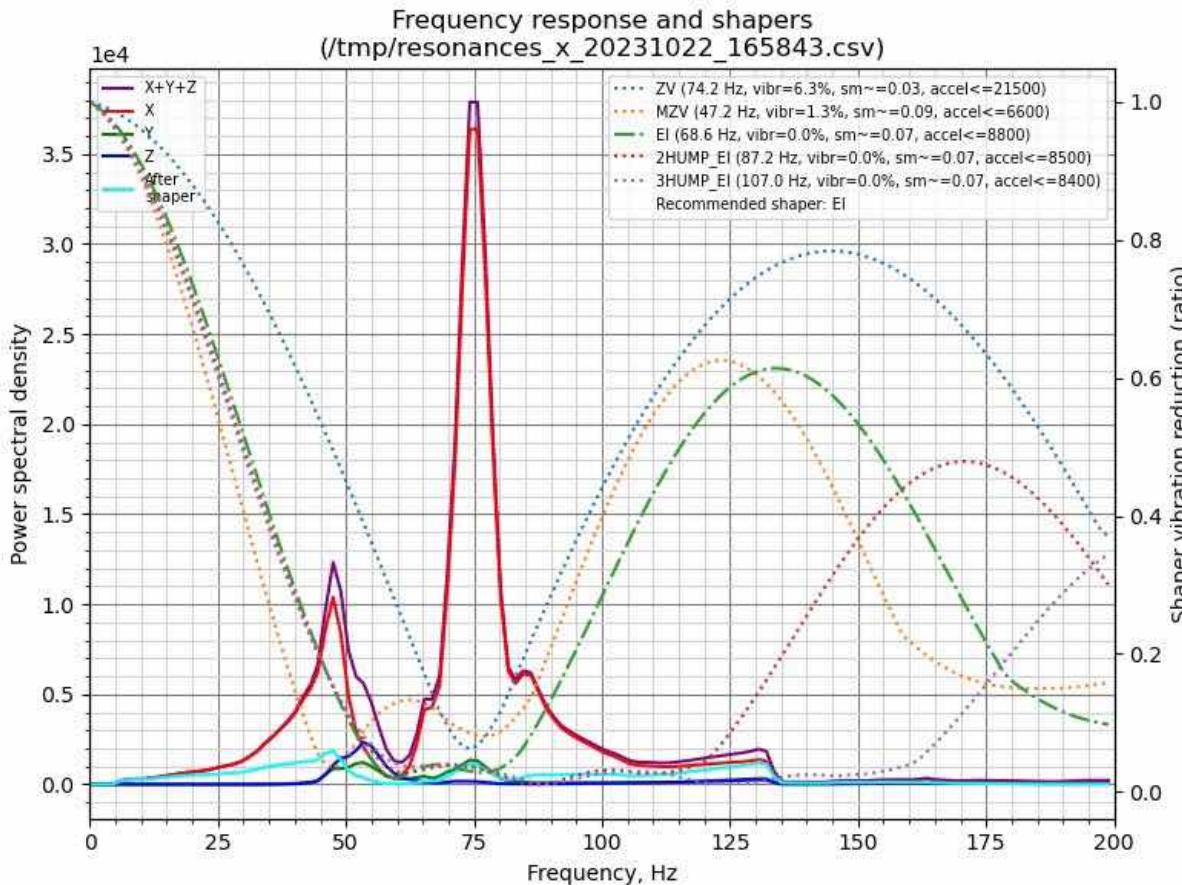
Potential Bearing issue

Notice that peak 3 goes to zero on the left and right of it

What you see here is two peaks with a valley between them and the valley goes to zero. This is very similar to the canbus, tap, or linear rail.

The difference is the amplitude of the 75 hz spike is equal to or greater than the real freq of around 50hz.

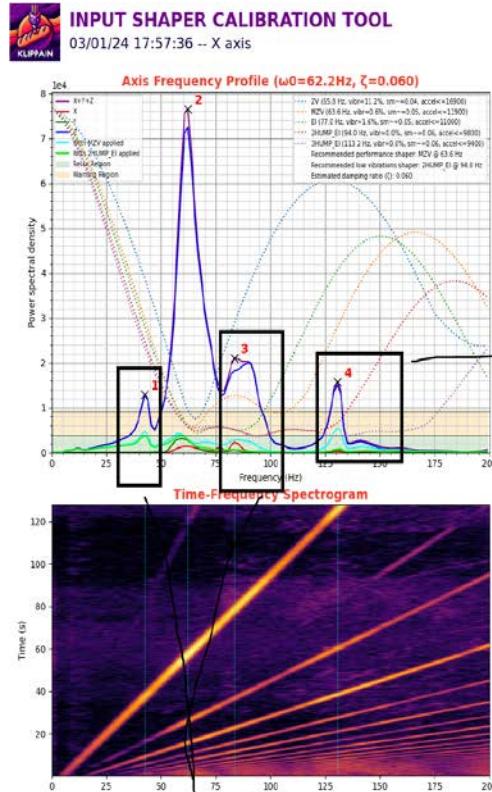
What a bad x-linear rail looks like.

Bad linear rail - missing bearings

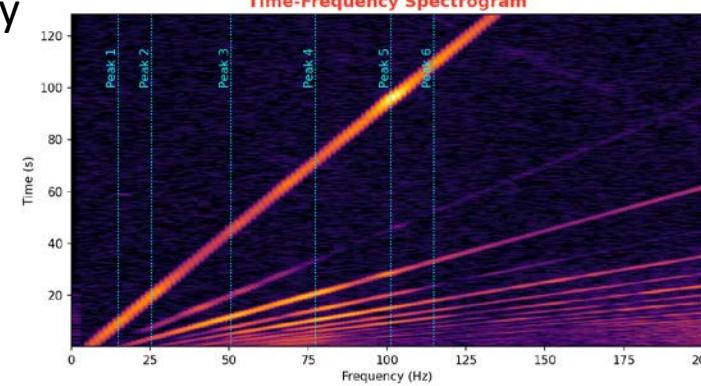
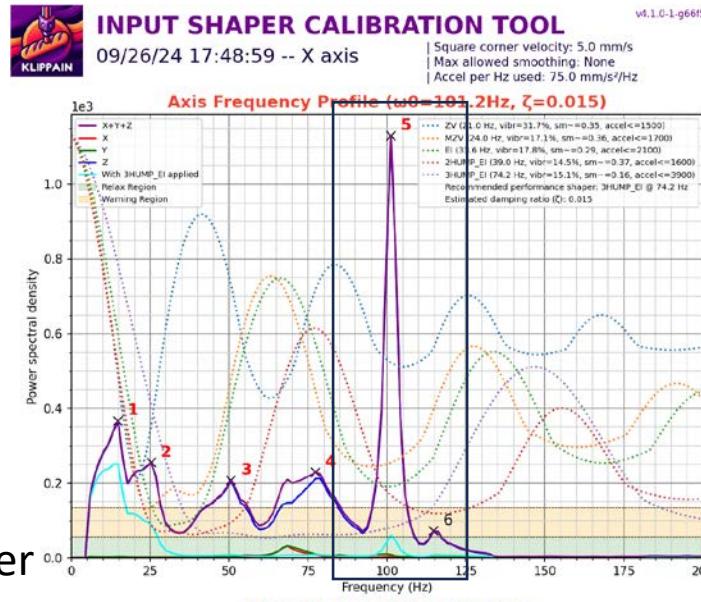
What a bad x-linear rail looks like.

The 100hz spike in belts and x-shaper
Is due to a rusted (pitted) potentially
Twisted x-linear rail

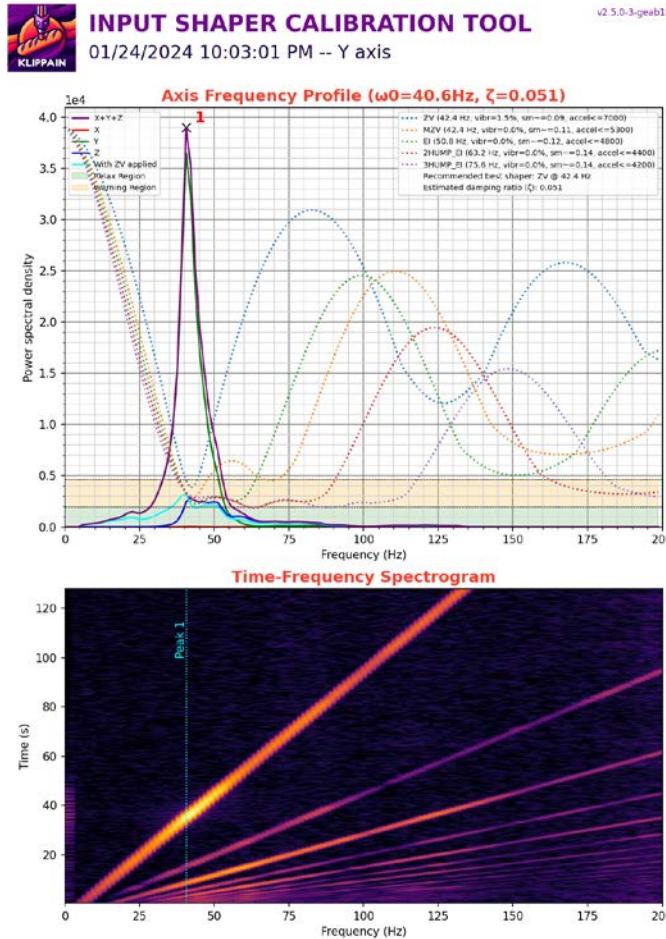
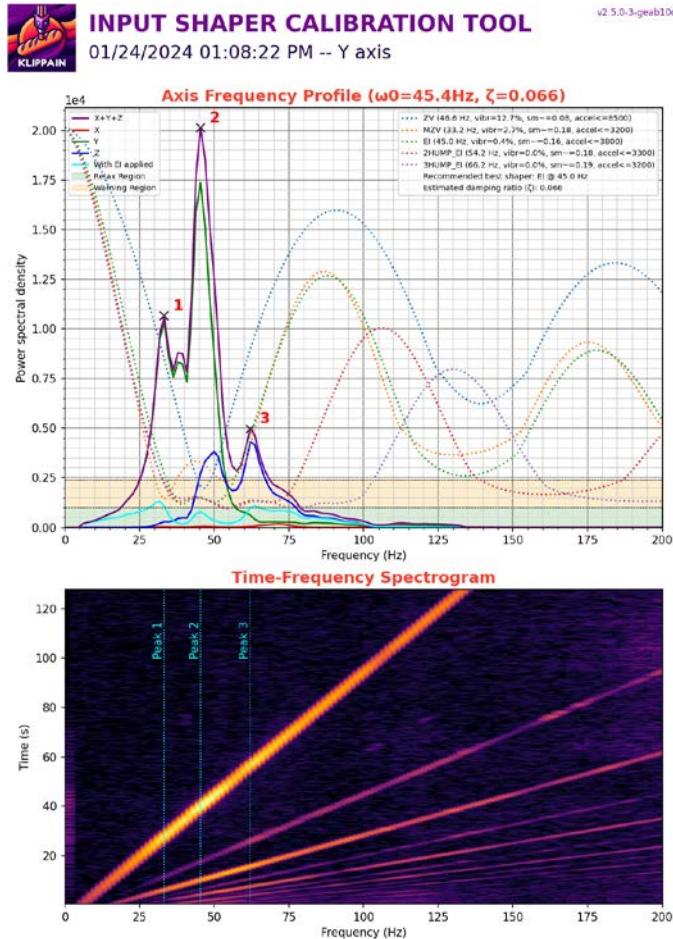
Printer wobbled on floor. Added dampers to the printer feet

Ioannis_gi V2.6589
Used: Raise It Isolation
Feet for Speaker
Vibration/Ventilation

As additional vibration
damper

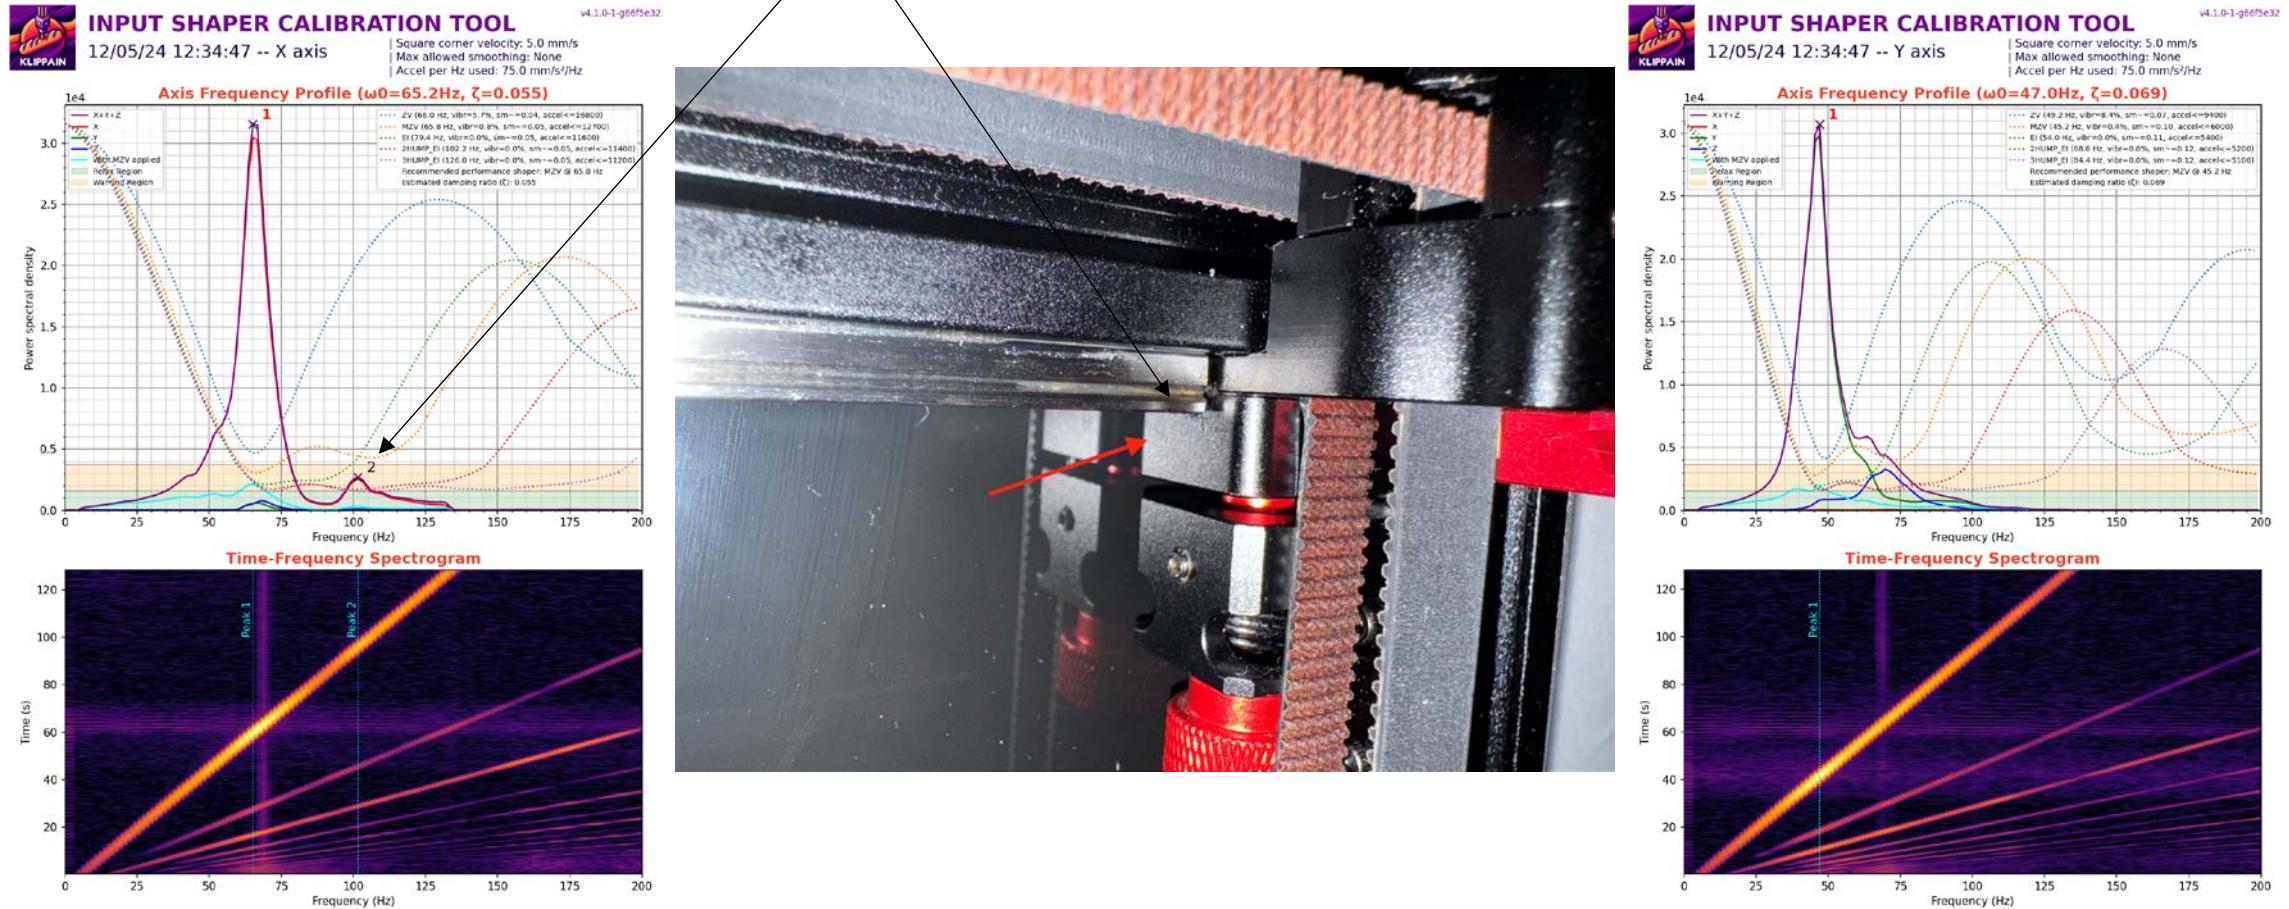
Loose Z-gantry screw (Igiannakas)

I was battling slightly off belt tension with the new belts and thought I had not cut them to exact same size. But that was not the case. I took apart the panels, re-squared the gantry and validated with my machinists square. Then when I was inspecting the Z pins for alignment I noticed that the **bottom belt clamp was not tight on any of the 4 corners.**
