# How to read input shaper graphs: a work in progress

Compilation by Reth (the original Reth)

Reth's Voron Trident – serial 1190

Version 4-24-2024

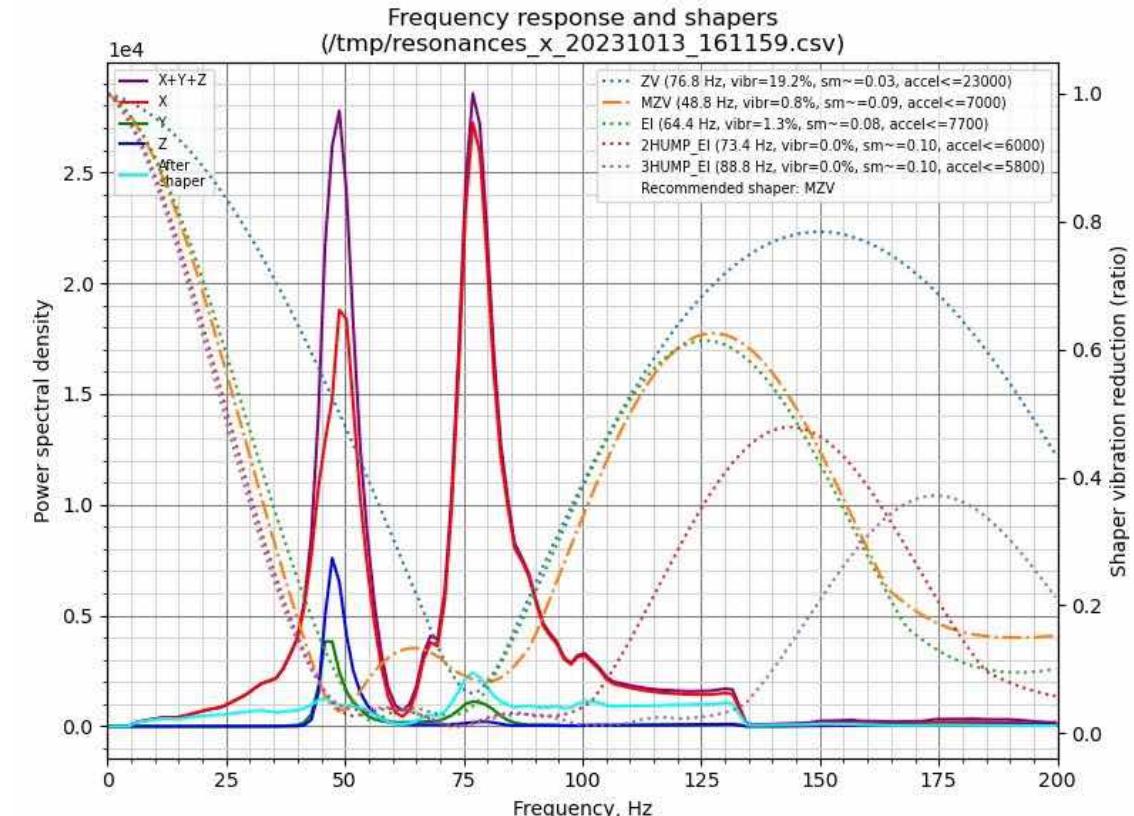
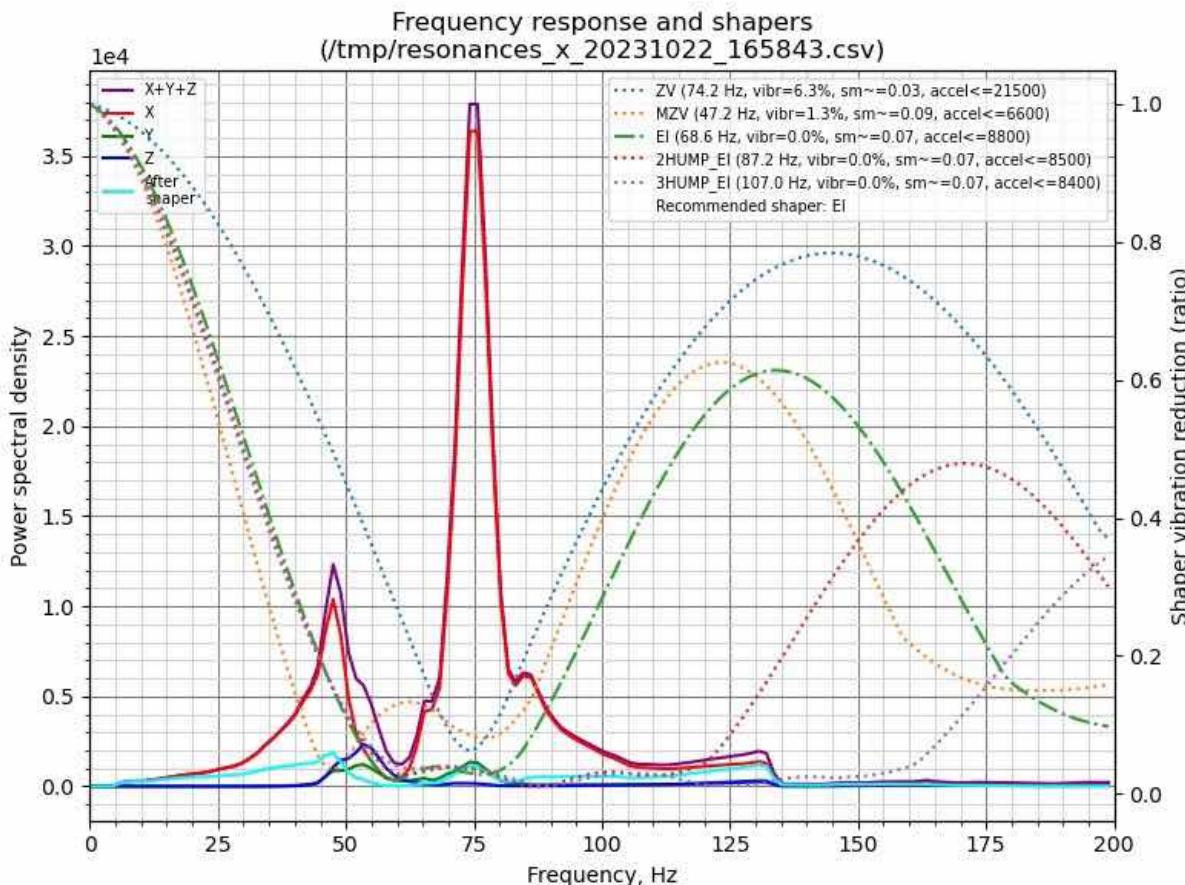
# Potential Bearing issue

What you see here is two peaks with a valley between them and the valley goes to zero. This is very similar to the canbus, tap, or linear rail.

The difference is the amplitude of the 75 hz spike is equal to or greater than the real freq of around 50hz.

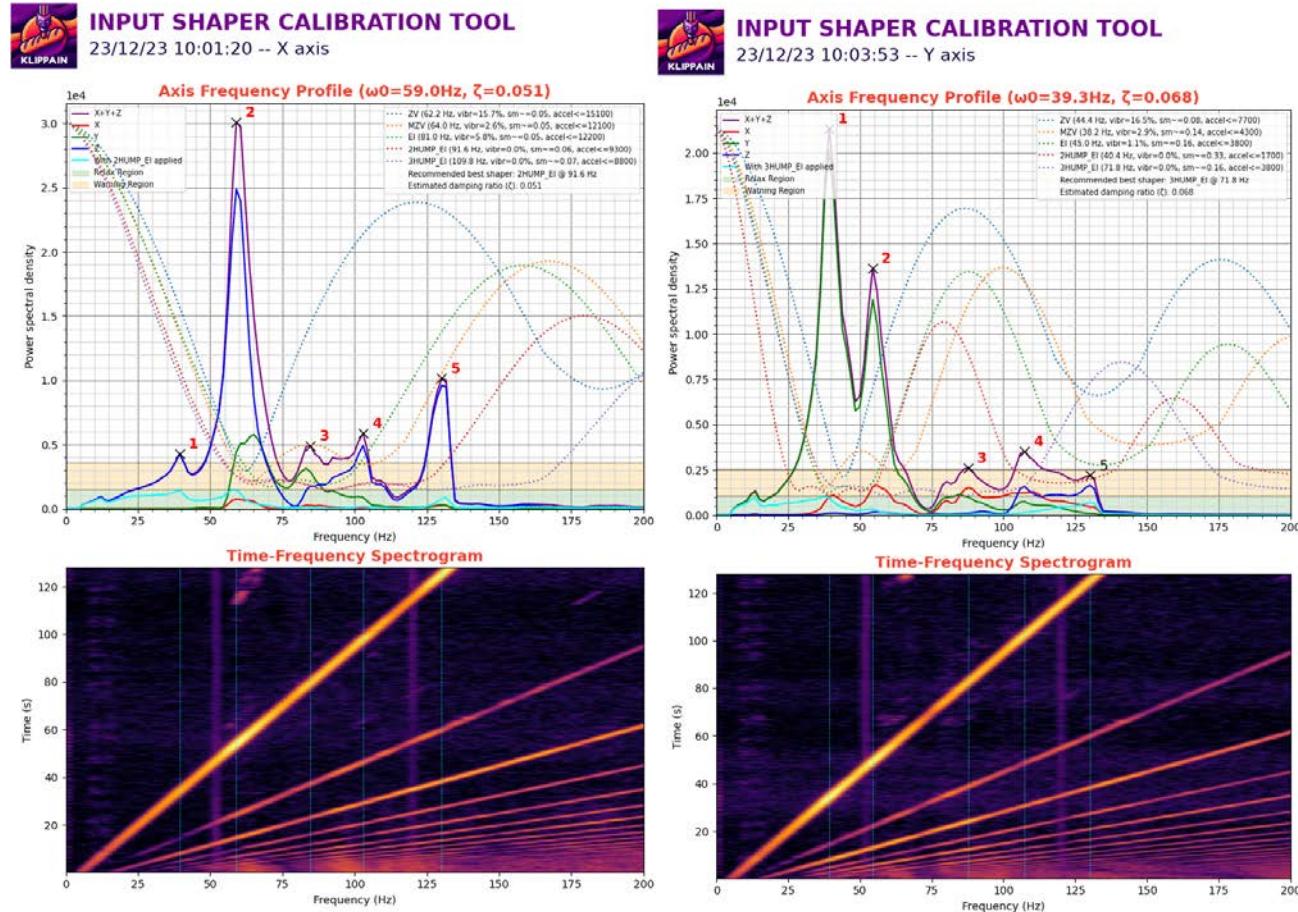
Not using all four screws to secure tap to the x-linear rail – missing two screws.  
Likely similar if screws are loose.

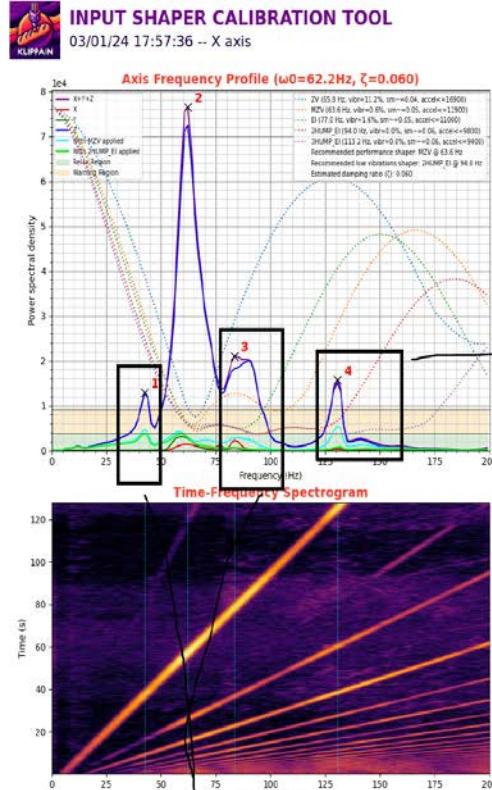
Bad linear rail - missing bearings

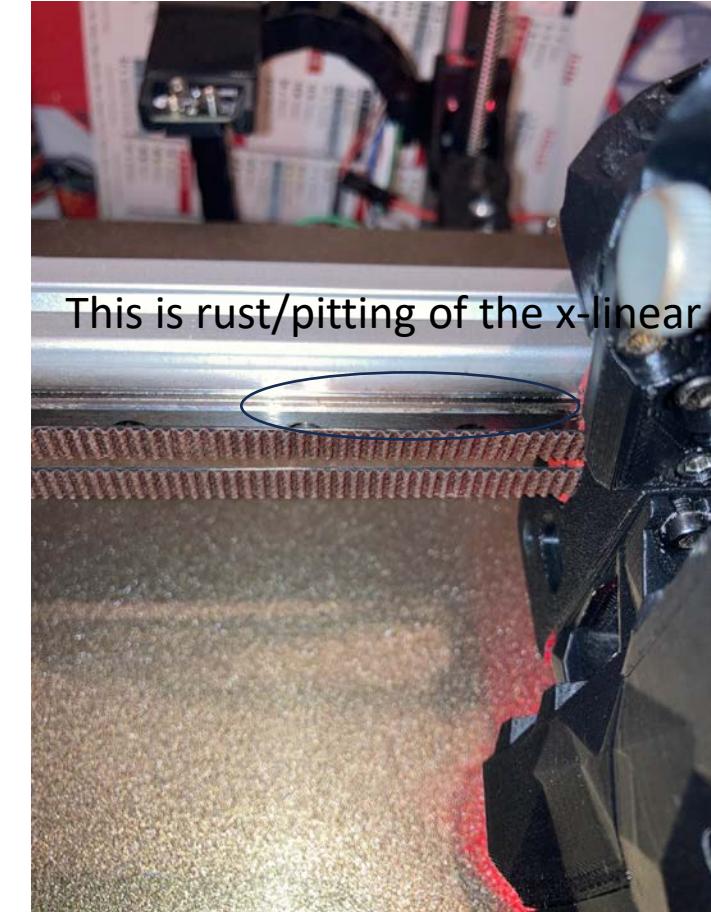
## Part 2

The 100hz spike in belts and x-shaper  
Is due to a rusted (pitted) potentially  
Twisted x-linear rail

This is rust/pitting of the x-linear rail
