Risk Mitigation of a Heritage Bridge Using Noninvasive Sensors

Keywords: heritage bridge; reinforced concrete bridge; ambient vibration test; noninvasive sensors; digital twin; incident response framework

2. Descriptions of Heritage RC Bridge in This Study

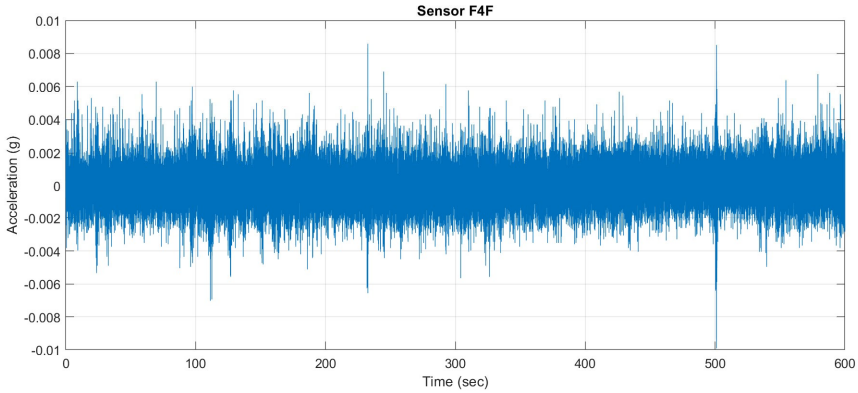
Figure 6. Typical time history of recorded vibrations.

Under ambient vibrations caused by passing traffic and environmental excitations, a typical time history of the sensor reading is shown in Figure 6. Power Spectral Densities (PSD) determined by the Welch method are shown in Figure 7. The PSD diagrams are arranged in the same order as sensor placement shown in Figure 3a for easy reference.

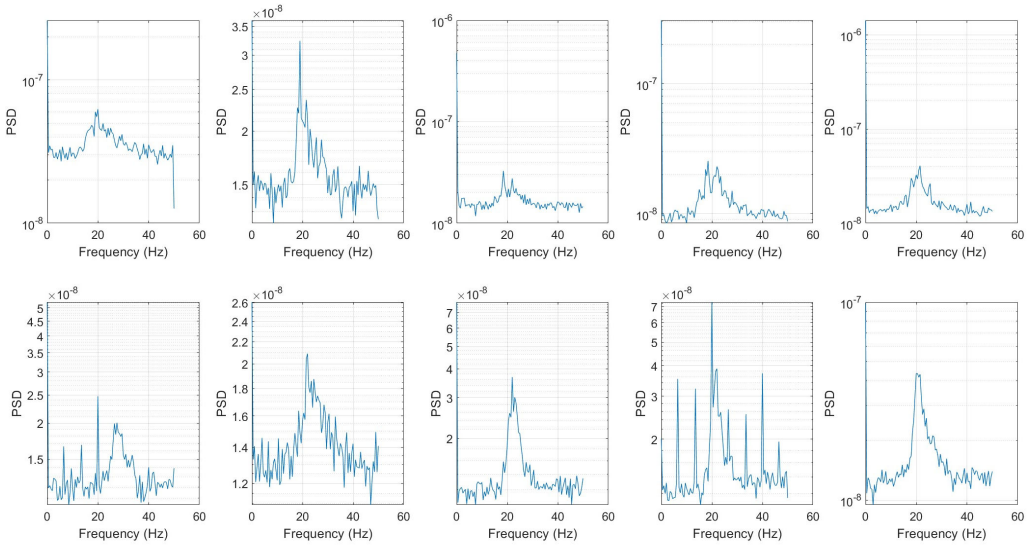
Figure 7. Power spectral density plots (figures arranged in accordance with placement in Figure 3).

The PSD results show a common sharp peak at approximately 20 Hz, indicating that it is a strong candidate for the global fundamental frequency of the bridge. Higher vibration modes are likely to be higher than 50 Hz, which is higher than the Nyquist frequency, due to the limitation of the sampling rate. Sensor F52 and CAC detected several other peaks, but they are absent from other sensors. Local excitation, such as vehicle passing near those points or local structural features, could contribute to those peaks. Additionally, calculations were done to try to determine the mode shape for each mode based on the vibration data and natural frequencies. It should be noted that a higher sampling rate could be used in future testing to capture higher dynamic modes. Mode shape computation can be done in two ways: one uses both input and output data, while the other just uses the output vibration data. The ambient vibration test limited the available approach options to solely measure output vibration data. Using input and output data, the Frequency Response Function (FRF) can be used to derive the mode shape. Although this method offers great accuracy, the system needs input data. Getting the input data for an actual bridge with traffic is really challenging. Other computation techniques, such as the Eigensystem Realization Algorithm (ERA) [29], Frequency Domain Decomposition

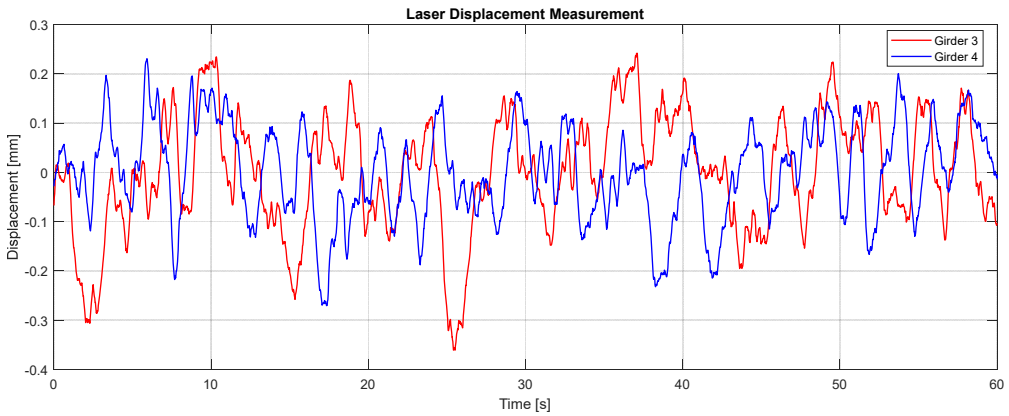
Figure 9. Typical displacement measurements.

The authors also conducted measurements to quantify girder displacements induced by traffic loading. For this purpose, non-contact laser displacement sensors were selected. Two OptoNCDTILR2250-100 sensors (resolution: 0.1 mm; range of sensors is 100 m, manufacturer: Micro-Epsilon, Melbourne, Australia) were installed at the mid-span locations of Girders 3 and 4. Data acquisition was facilitated using an 8-channel measurement amplifier (Me-Systeme GSV-8 DS, Melbourne, Australia), operating at a sampling frequency of 50 Hz. The experimental setup for displacement monitoring is depicted in Figure 8. Measurements were performed over a 20 min period during afternoon conditions with light traffic. A representative 60 s segment of recorded girder displacement is presented in Figure 9. Results indicated minor deflections, with maximum displacements remaining below 1 mm (code deflection limit is $L/600$ or 8.8 mm)

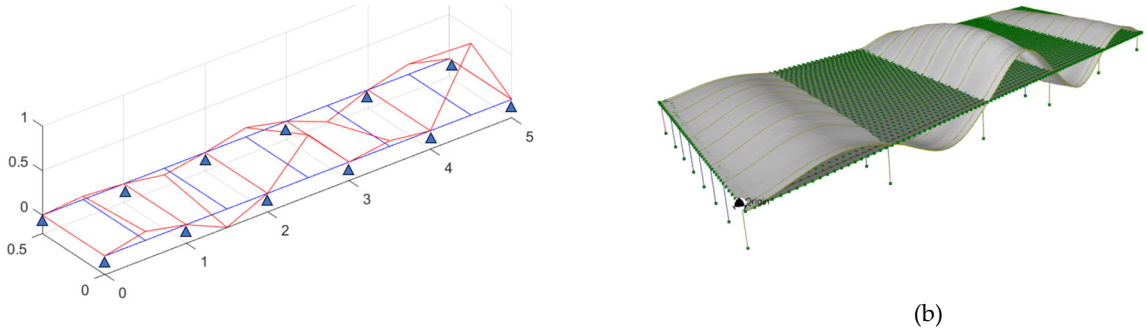
Figure 11. Fundamental mode shape of (**a**) Ambient Vibration Test and (**b**) FE model.

A dynamic frequency analysis was performed to evaluate the structural behavior of the bridge. Table 2 presents a comparison of the fundamental frequencies obtained from field measurements and the finite-element (FE) model. The corresponding mode shapes are illustrated in Figure 11. The results indicate that the FE model reliably captures the global flexural response of the structure without requiring further model calibration or updating. This agreement suggests that the assumed material properties, boundary conditions, and overall stiffness distribution in the FE model are representative of the actual bridge. However, due to limitations inherent in ambient vibration testing, higher-order vibration modes could not be clearly identified, restricting the assessment of complex dynamic characteristics. Despite this, the FE model effectively reflects the dominant structural behavior and is deemed suitable for conducting serviceability evaluations, including the parametric what-if scenario analyses presented in subsequent sections.

Field Measurement	FE Model	Difference (%)
20.15 Hz	19.51 Hz	3.2%

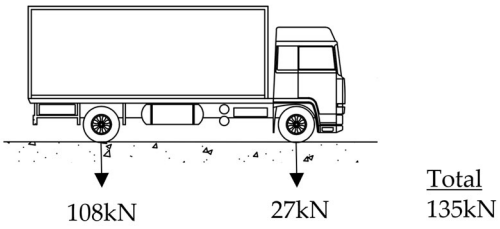
Figure 12. M13.5(H15) vehicle load to AASHTO.

The current posted load limit for the bridge, as designated by the local road authority, is 13 tonnes (127.5 kN). This value closely corresponds to the two-axle M13.5 vehicle load defined in the AASHTO Standard Specifications for Highway Bridges [32], as illustrated in Figure 12. For the purposes of this study, the M13.5 vehicle is considered representative of the allowable safe load.

The simulation results indicate that the T44 truck induces up to a 68% increase in shear force and an 81% increase in bending moment in the bridge girders when compared to the baseline M13.5 vehicle. The M1600 vehicle imposes an even more severe demand, generating shear forces and bending moments exceeding three times those of the allowable load case. On the other hand, deflection estimation using clear span L=5255 mm and serviceability vehicle loads indicated that deflections caused by these design vehicles were all well under the code limit of $L/600$. This was primarily due to the very short span of this heritage bridge. As such, the main consideration is that the significant increases in internal

forces due to shear and moment caused by overweight vehicles are likely to cause cracking or, in extreme cases, structural failure of the bridge girders. These findings underscore the critical importance of strict enforcement of the posted weight limit to preserve the structural integrity of this heritage bridge.

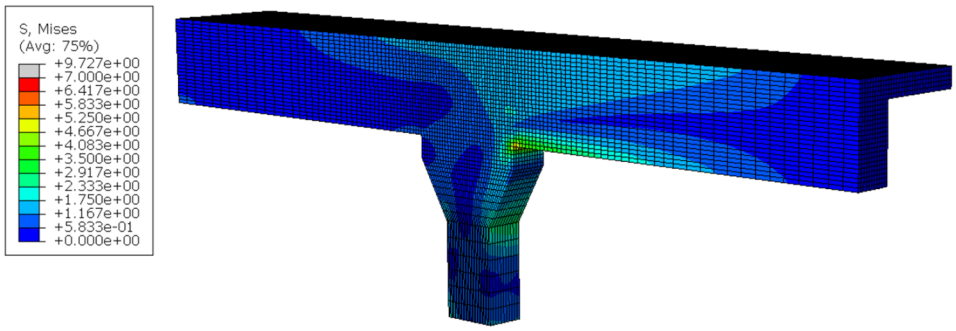
Figure 13. Stress contour of detailed FE modeling.

A supplementary investigation into the effects of overloading was conducted using a nonlinear finite-element model developed in Abaqus, employing the Concrete Smeared Cracking material model. The analytical model comprised a representative girder–pier subframe, in which the base and one girder end were fixed, while a prescribed displacement, equivalent to the mid-span displacement due to an M1600 vehicle, was applied to the opposite end of the girder. The resulting stress distribution is illustrated in Figures 13 and 14. Notably, stress concentrations were observed at the girder–pier interface and at the transition region where the pier cross-section widens. These localized stress zones align well with the locations of visible cracking identified during the field inspection (refer to Figure 4), thereby validating the model's predictive capability.

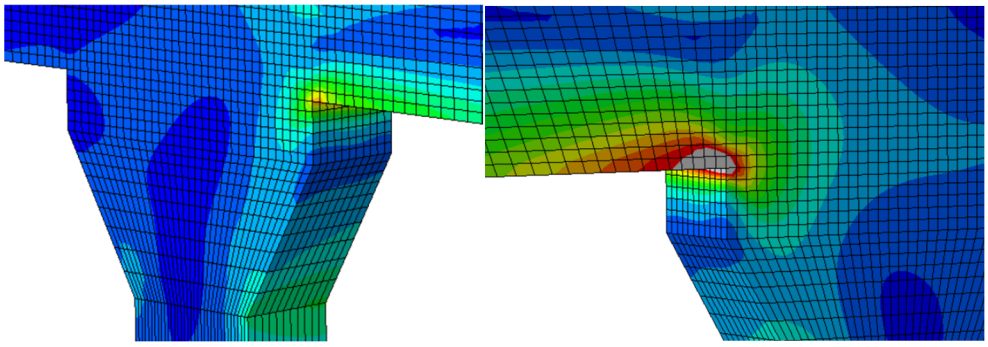
Figure 14. Stress concentrations at girder–pier junction.

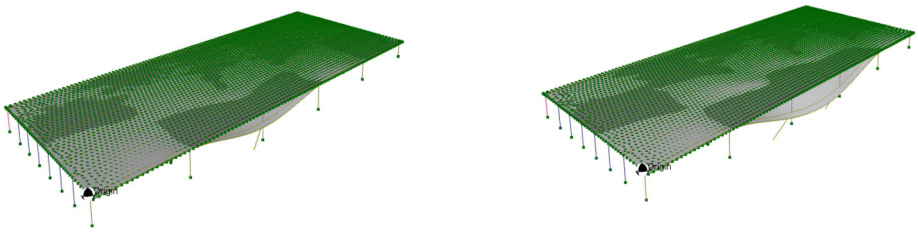
This section investigates the potential influence of scour damage at one or more bridge piers on the dynamic characteristics of the structure. Specifically, it aims to examine whether such damage would manifest as measurable changes in the identified mode shapes and corresponding natural frequencies obtained through ambient vibration testing. To simulate the effects of scour, structural damage was introduced in the finite-element model by removing translational restraints at piers C1 and D1, thereby representing a loss of lateral and vertical support due to foundation instability. Piers C1 and D1 were selected for this simulation based on their direct exposure to the predominant river flow, which increases their vulnerability to scour. Scour damage is particularly challenging to detect through routine bridge inspections, as it typically occurs below the waterline and remains hidden from visual assessment [35,36]. If scour-induced degradation leads to detectable shifts in modal frequencies or alterations in mode shapes, ambient vibration-based modal analysis may offer a practical and non-invasive means for early detection and monitoring of scour-related damage in bridge foundations. Figure 15 shows the fundamental mode shapes of the two scour scenarios and Table 4 illustrated the change in fundamental frequencies.

No Damage	Scour C1	Scour C1 & D1
19.51 Hz	10.54 Hz	7.91Hz

The simulation results suggest that foundation instability due to scour can lead to significant shifts in the natural frequencies and notable alterations in the mode shapes of the bridge. These findings highlight the potential utility of routine ambient vibration testing as a non-invasive tool for monitoring changes in the bridge's dynamic response, thereby enabling early detection of scour-related damage.
