Hindawi
Advances in Civil Engineering
Volume 2022, Article ID 9568967, 13 pages
https://doi.org/10.1155/2022/9568967

Research Article

Digital Twin-Based Investigation of a Building Collapse Accident

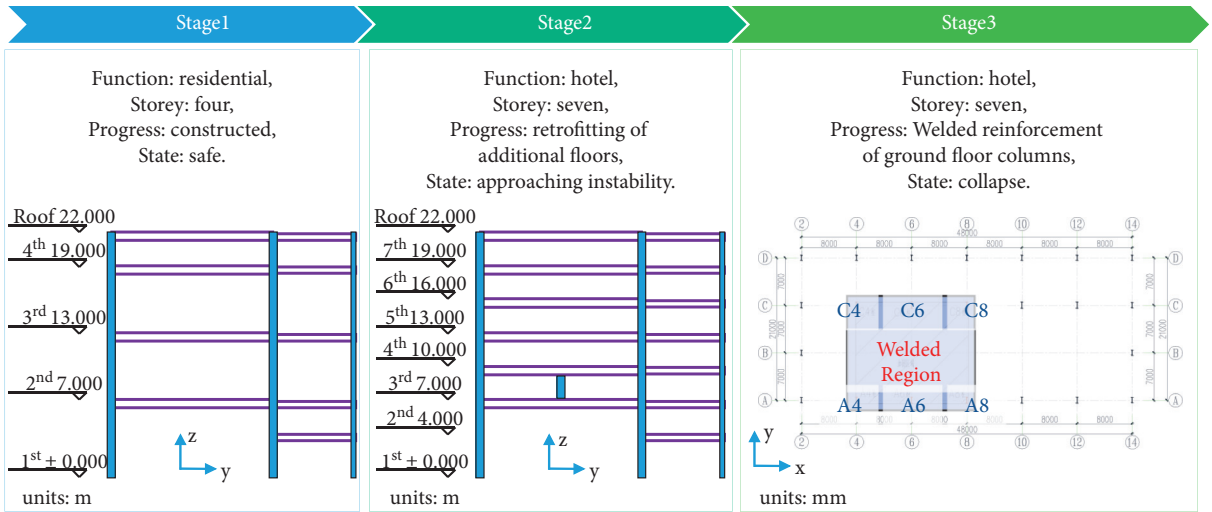
3.2. Building Information and Data Acquirement. The building was retrofitted many times, and the major retrofitting processes are briefly presented in Figure 3. In the first stage, the building was a four-story commercial building, and the building was safe. In the second stage, the building underwent major retrofitting. Subsequently, the building was remodeled into a seven-story hotel. In the third stage, welding strengthening was applied to the base columns of the building. Subsequently, the building collapsed.

Figure 3: Conversion of the building.

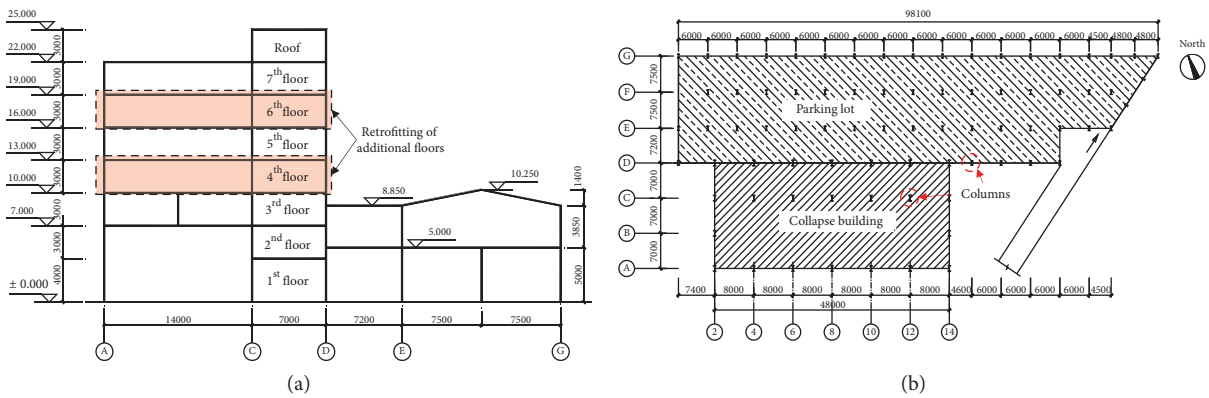
The plane view and elevation view of the building in Stage 2 are shown in Figure 4. The height of the collapsed building is 22 m. The length of the building in the east–west direction is 48 m, with 8 m × 6 spans, and the length of the building in the north–south direction is 21 m, with 7 m × 3 spans.

Figure 4: Basic views of the building. (a) Elevation view (the elevation units: m; other units: mm). (b) Plane view (units: mm).

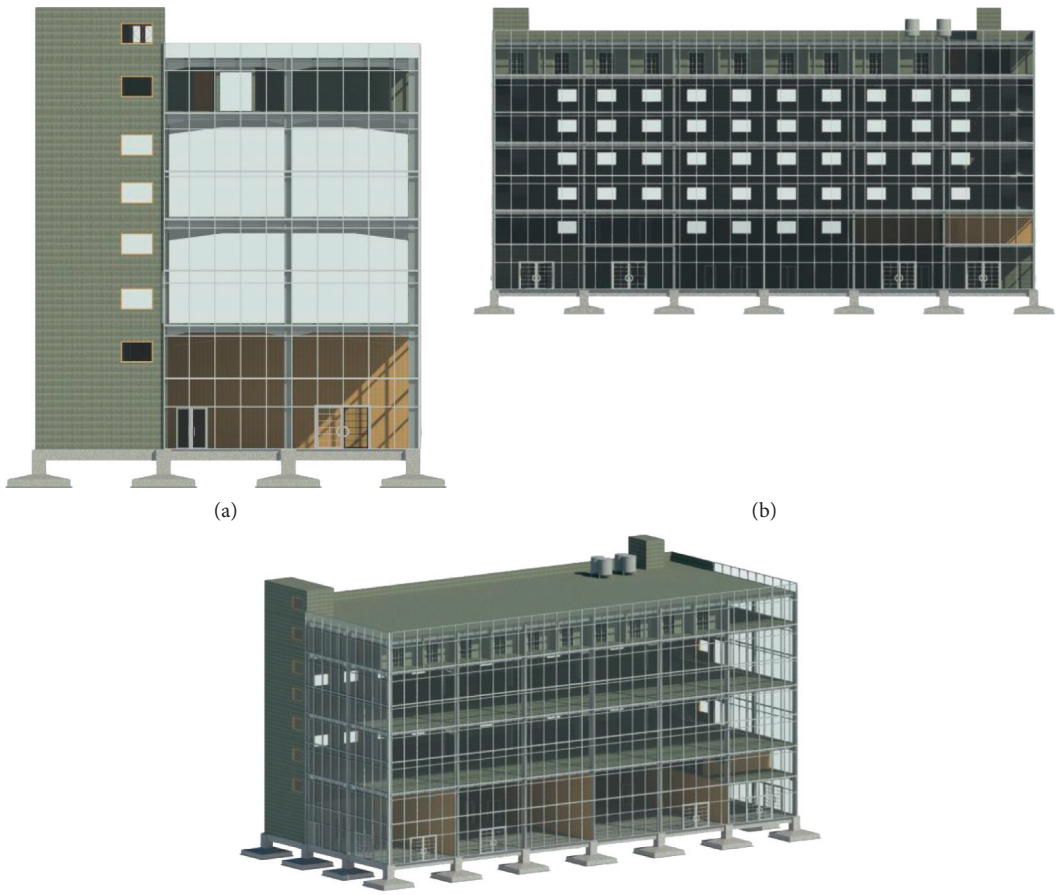
(1) *Stage 1*. The initial structure before retrofitting is four stories. The analysis results show that the total gravity load of the model before retrofitting was 3114 tons. The vertical ultimate bearing capacity of the structure calculated by finite element analysis was 5208 tons. Therefore, the total weight accounts for approximately 60% of the vertical ultimate bearing capacity. The maximum axial force of the first-story column was approximately 232 tons (C4), which was 63% of its stable ultimate bearing capacity. Therefore, the structure was in an elastic state (Figure 9(a)).

(2) *Stage 2*. The structure after the major retrofit had seven stories. The analysis results showed that the total gravity load of the modified model was 5214 tons, and the vertical load increased by 67%. The analysis results showed that the vertical ultimate bearing capacity of the structure was 5312 tons. Therefore, the total weight accounts for approximately 98% of the vertical ultimate bearing capacity and exceeds the vertical ultimate bearing capacity of the original four-story structure of 5208 tons. The maximum axial force of the first-story column is approximately 389 tons (C8), which is 105% of the theoretical ultimate load-carrying capacity of the column on the C-axis. The maximum compressive stresses in the web plates of steel columns C6, C8, and C10 in the structure exceeded their buckling stress. The structure was in a critical state (Figure 9(b)).

(3) *Stage 3*. After the welding strengthening in Stage 3, the building collapsed. According to the analysis results of the FEM of Stage 2, the total structural gravity load of the retrofitted 7-story steel structure under the actual use load is 5214 tons, which is very close to the vertical ultimate bearing capacity (Figure 9(c)). Although the bottom columns were in a critical state and plastic deformation occurred, the structure did not collapse. This suggests that the immediate cause of building collapse requires further investigation.

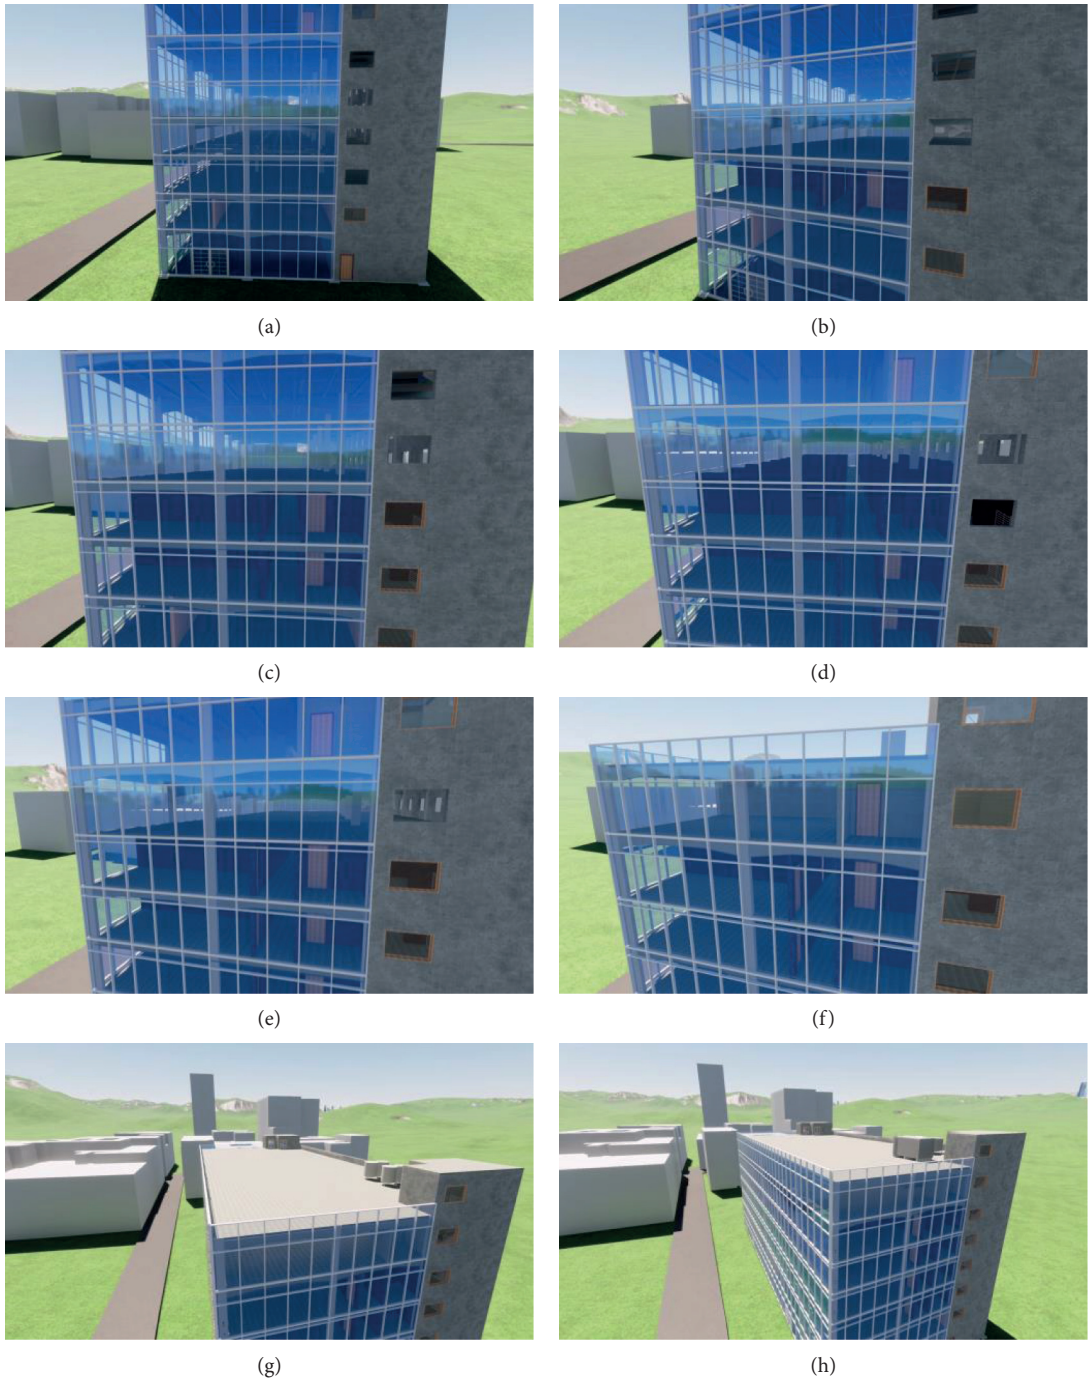
Figure 8: Updating the BIM animation. (a–h) Steps 1–8.

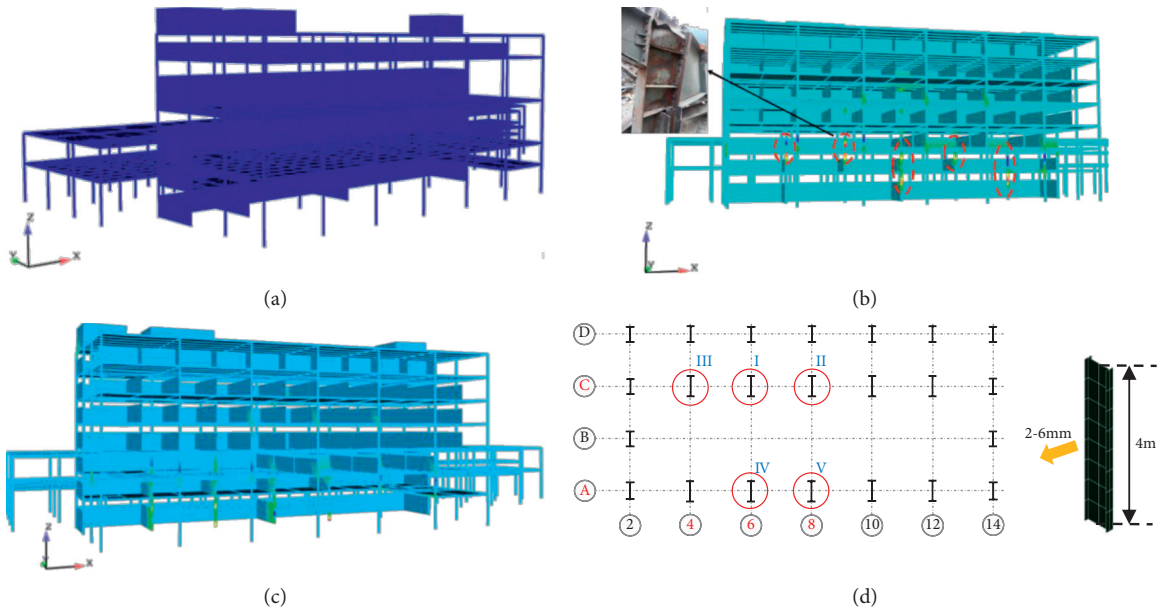
section of the steel columns (e.g., C4, C6, and C8) at the bottom introduced a horizontal deformation with an amplitude of 2–6 mm (Figure 9(d)). Thus, according to the on-site investigation results, the corresponding horizontal deformation was added to the FEM based on the analysis of Stage 2. Subsequently, the structure underwent initial collapse.

FIGURE 9: Axial forces of the beams and columns of the building. (a) Stage 1. (b) Stage 2. (c) Stage 3. (d) Critical elements. (a) Stage 1: no damage. (b) Stage 2: plastic hinge at top of first story center column. (c) Stage 3: initial collapse. (d) Key columns causing structural collapse.

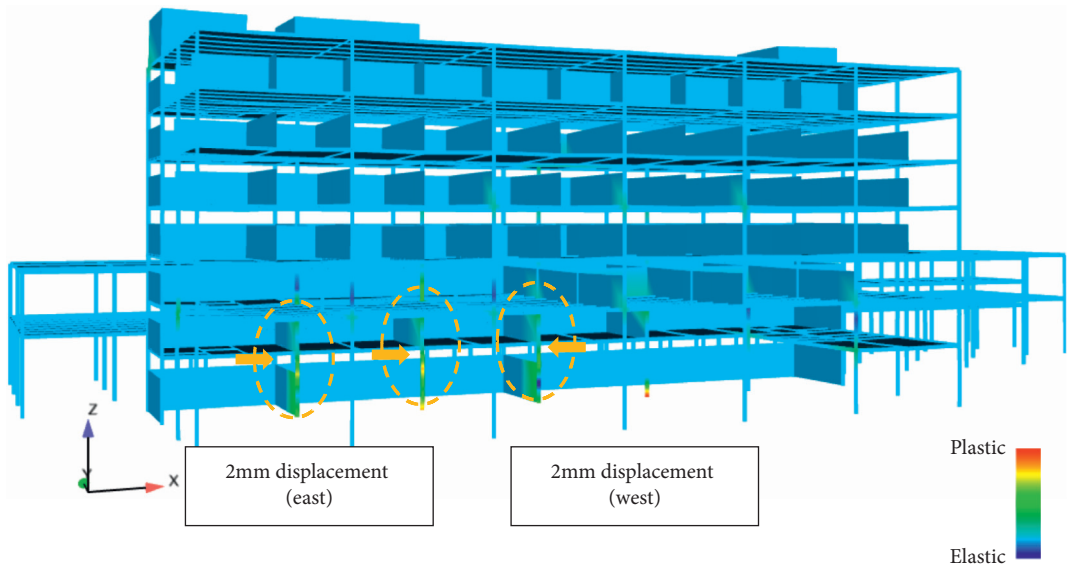
disproportionately propagated, and the structure entered the collapsed state, as shown in Figure 10.

Therefore, according to the finite element analysis results, the local buckling, plastic deformation, and flexural deformation of the bottom columns are increased by the welding construction. Taking the bottom C4 steel column as an example, the horizontal deformation in the middle increases by 2–4 mm. As a result, severe disturbances were generated owing to the high load, inducing damage to the bottom steel columns and the overall collapse of the structure. Thus, the mechanism and critical causes of the structural collapse accident were determined.

FIGURE 10: Collapse initial state of the building.

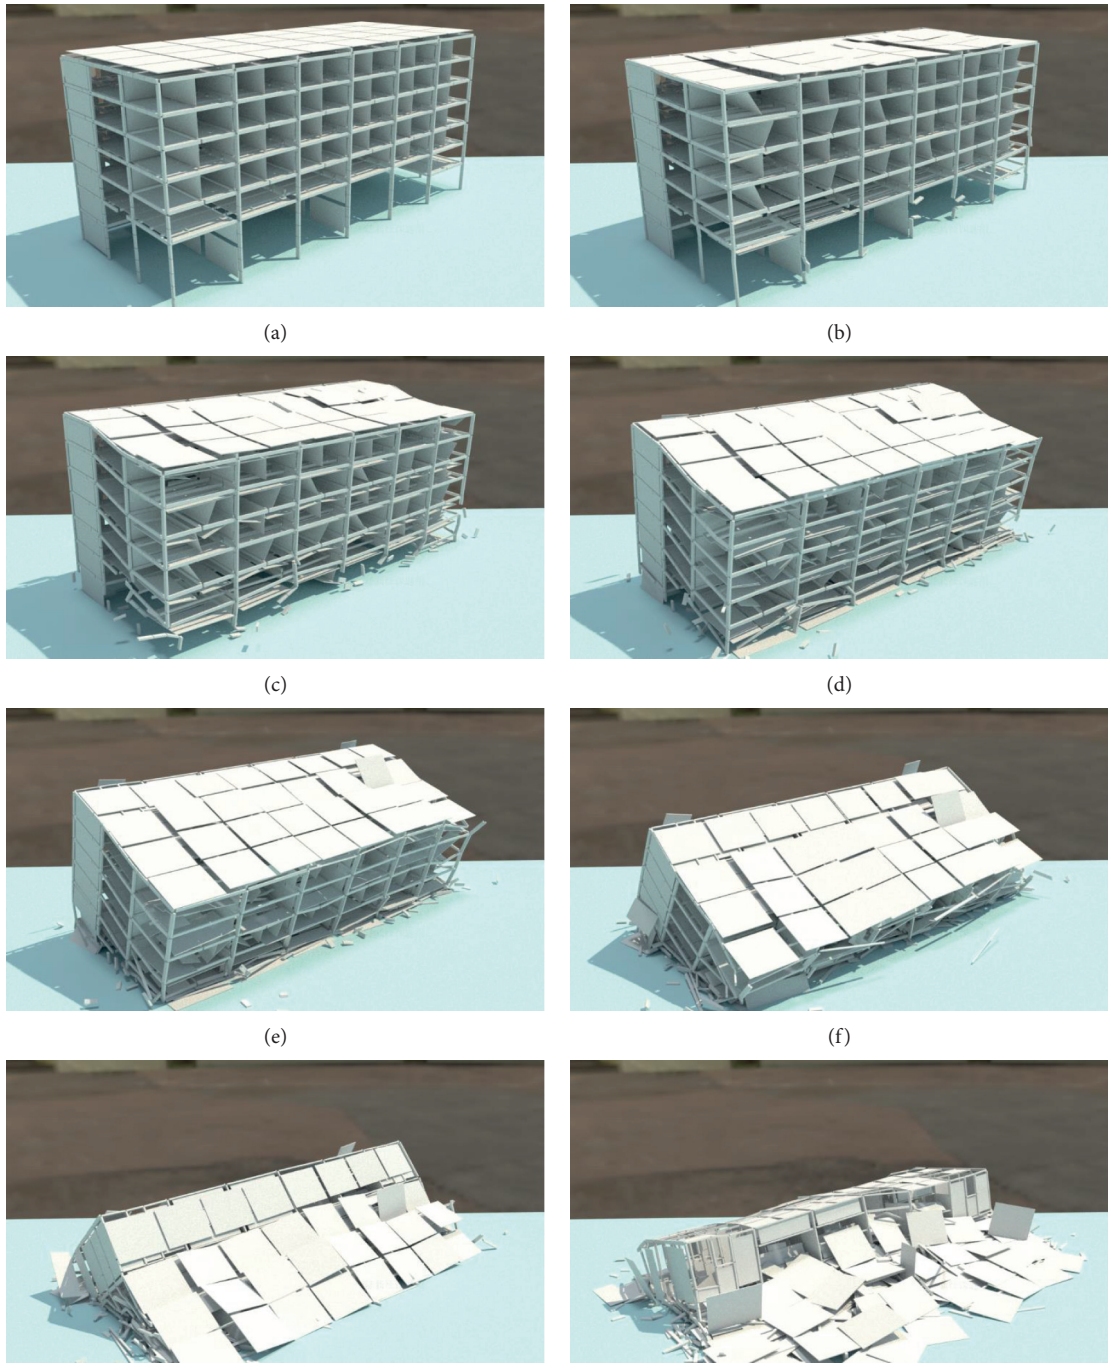
Initially, the middle steel column of the first floor on the A-axis bends in the east–west direction (Figure 11(b)). The vertical compressive bearing capacity of the steel column decreased rapidly, resulting in the steel column being unable to support the gravity weight of the upper structure. Subsequently, the upper structures, especially the parts of the three stories above the range from axis A to axis C, start to collapse. Meanwhile, the buildings started to tilt in the southern direction (Figure 11(c)). The span of the building along the C-axis to D-axis direction is 7 m, which is shorter

Figure 11: Collapse progress of the building. (a) Collapse begins; (b) column at A-axis starts buckling; (c) the columns on the first floor at the A-axis lose their vertical bearing capacity; (d) the third-floor slab at A-axis first touches the ground, and the upper structure tilts to the south; (e) the fourth-floor slab first touches the ground, and the upper structure severely tilts; (f) column at D-axis pulls off, and several floors at A-axis touch the ground; (g) the building tilts to the south and several upper floors touch the ground; (h) collapse process is complete.

than the span along the A-axis to the C-axis direction of 14 m. Moreover, there are more infill walls in the north–south direction along the C-axis to the D-axis than along the A-axis to the C-axis. The column at the A-axis gradually loses its load-carrying capacity, and the load from the upper structure is then transferred to the columns at the C-axis and D-axis. This resulted in severe buckling of the column at the C-axis and accelerated the overall collapse of the upper structure. Subsequently, the third-floor slab near the A-axis first touched the ground (Figure 11(d)). Gradually, as the overall southward tilt deformation increased, the upper floors successively came to the ground. The column at the D-axis was

subjected to increasing tension, and the bottom of the column was pulled off (Figure 11(f)). After that, the whole building fell toward the south, and the floor slab broke apart. Finally, the collapse process was completed, and only debris was left.
