Transmitter

Sheet: /
File: car_mp3.kicad_sch

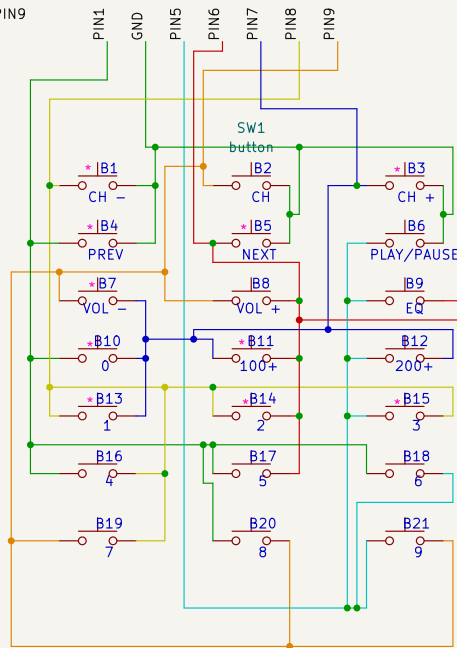
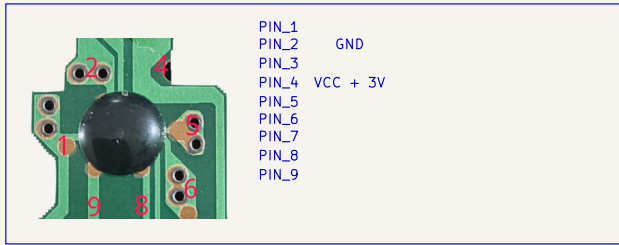
WORKING_BUTTONS TOT=10

1, 5, 3
4, 7, 10, 11, 13, 14, 15

NON-WORKING_BUTTONS TOT=11

2, 6, 8, 9, 12, 16, 17, 18, 19, 20, 21

PIN 5 ?? OR PIN 8 9 ??

MCU PIN 1 ---- buttons 4, 10, 16, 17, 18, 20
MCU PIN 2 ---- buttons 1, 2, 3, 4, 5, 6
MCU PIN 5 ---- buttons 6, 9, 12, 15, 18, 21
MCU PIN 6 ---- buttons 5, 8, 9, 11, 14, 17
MCU PIN 7 ---- buttons 3, 7, 10, 11, 12, 13
MCU PIN 8 ---- buttons 1, 13, 14, 15, 16, 19
MCU PIN 9 ---- buttons 2, 7, 8, 19, 20, 21

@ Good x Not	GND	PIN 1	PIN 5	PIN 6	PIN 7	PIN 8	PIN 9
GND	NIL	*	*	*	*	*	*
PIN 1	@/B4	NIL	*	*	*	*	*
PIN 5	*	*	NIL	*	*	*	*
PIN 6	@/B5	*	*	NIL	*	*	*
PIN 7	@/B3	@/B10	*	@/B11	NIL	*	*
PIN 8	@/B1	*	@/B15	@/B14	@/B13	NIL	*
PIN 9	*	*	*	*	@/B7	*	NIL

I'm not sure why it is not working. The MCU pins are not accessible because they are covered with epoxy. I will investigate it further later.
