IMS BEARING PREDICTIVE MAINTENANCE TECHNICAL REPORT

Report Date: 2026-10-09 11:04:14 Asset: Rexnord ZA-2115 Bearing #1

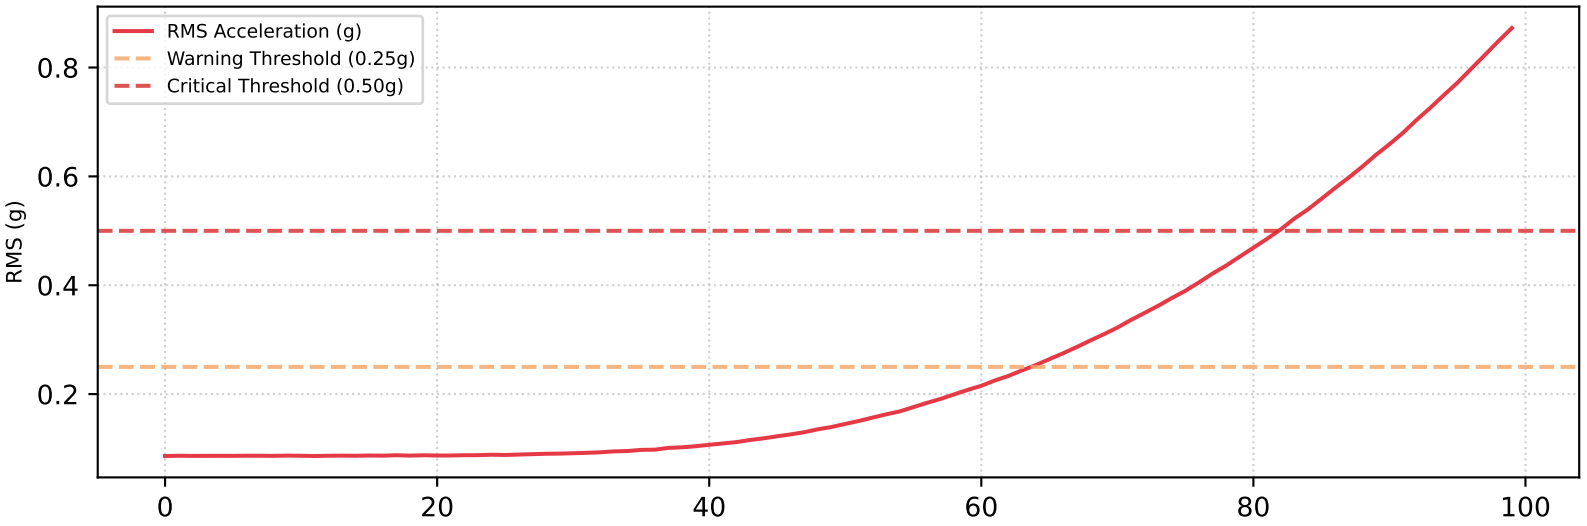
Vibration RMS Degradation Curve over Time

Parameter	Engineered Value	Operational Status
Initial Vibration RMS	0.0863 g	Normal (Baseline)
Final Vibration RMS	0.8725 g	Severe Degradation
Peak Kurtosis	0.21	Spike Damage
BPFO Fault Energy	837210.03117	Outer Race Fault
Estimated RUL	0.0 Hours	Replace Immediately
