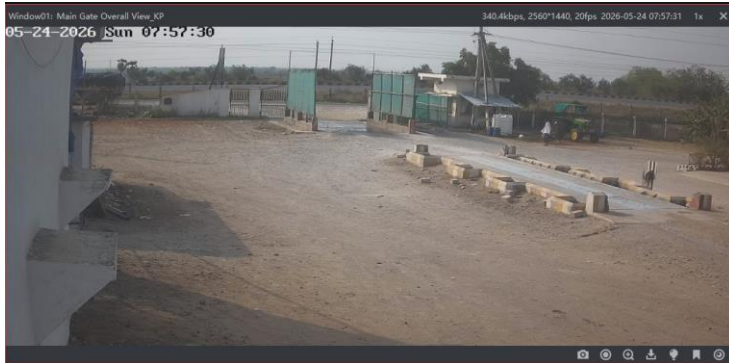
1.1 - Main Gate Camera

Weighment

Comment - Gate include weighment also , camera is far away from main gate ,
- Number of vehicle is running on the highway , large vehicle bounding bbox can collide with entry line , may be create false positive case with this angle.

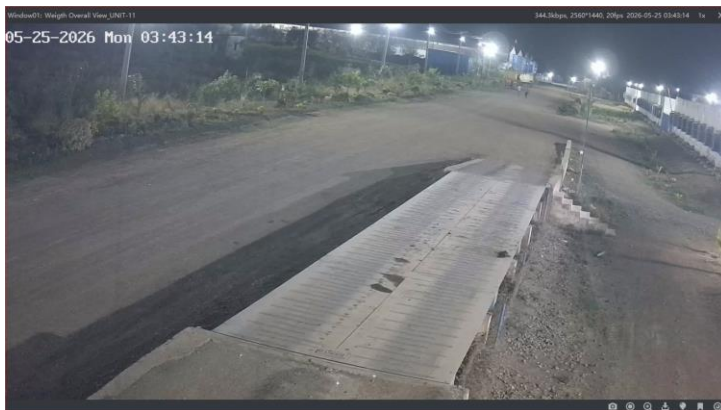
Unit 11: Weight overall view unit-11

Comment – Weightment View is Good and ok , but main gate entrance need to check

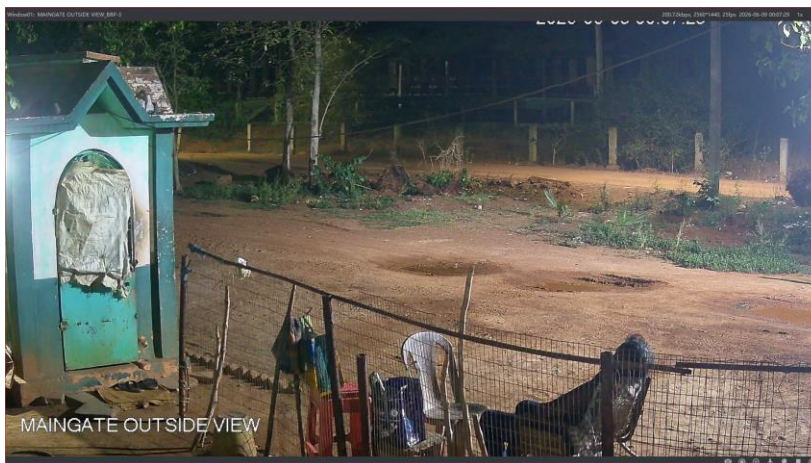
BBP-3: Main Gate Outside view

- No weighments

Camera is too far away

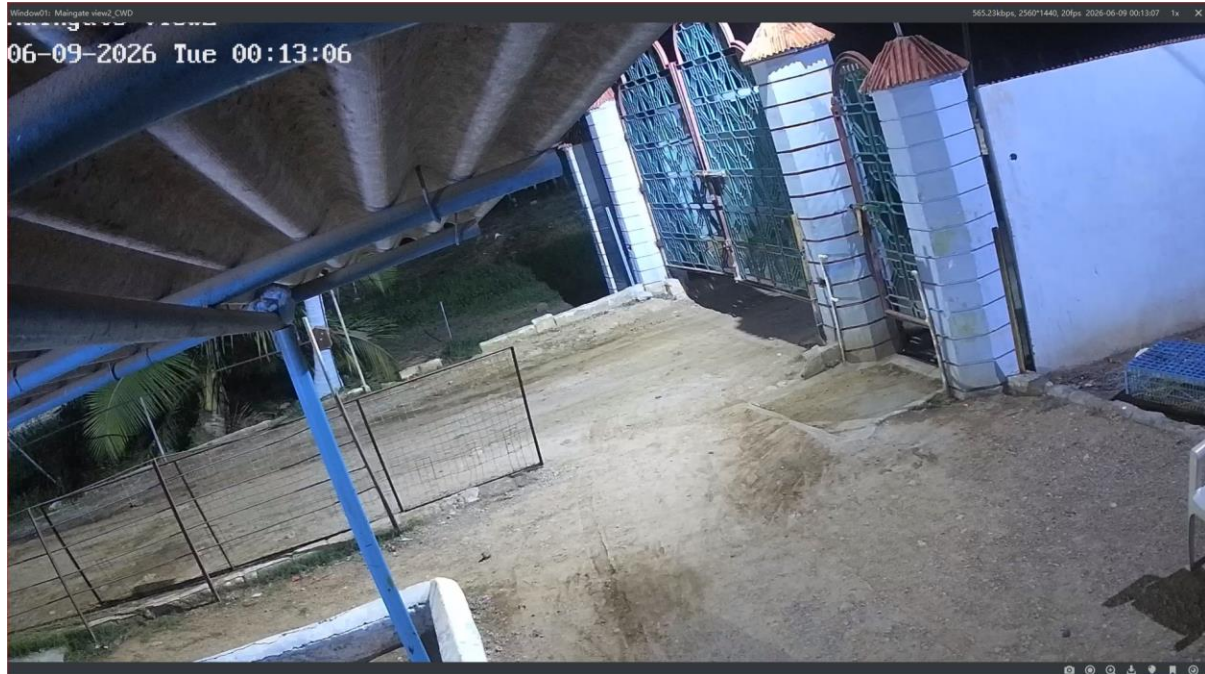
12) UNIT-3: Main Gate not working

- Main gate overall outside and main gate outside cameras are not working
- Main gate and weighments area camera is not working
- Weighments front view and weighments back view camera is not working
