PEST CONTROL SERVICE REPORT

German Roach Cleanout Service

Initial Treatment & Inspection Report

1145 Lucaya Circle, Orlando, FL 32824
Service Date: April 8, 2026 · Account #1052

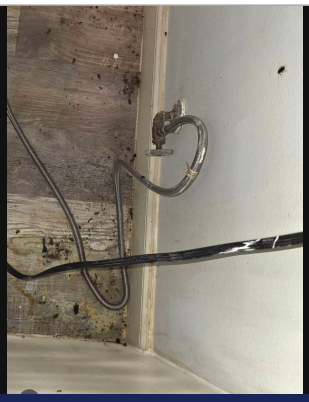
Location	Observations	Activity Level
Kitchen — Appliances	Primary source of infestation. Heavy nesting identified within the motors and rear panels of appliances. Dense frass accumulation, live roaches of all stages observed on walls, floor, and appliance surfaces.	**SEVERE — Primary Nest**
Kitchen — Cabinets & Drawers	Live roaches found on cabinet door panels and drawer fronts directly adjacent to the refrigerator. Multiple nymphs and adults observed. Heavy frass spotting along upper cabinet edges.	**HIGH**
Kitchen — Floor	Multiple live roaches confirmed across kitchen floor surface, including adults and nymphs. Evidence of heavy foot traffic from infestation.	**HIGH**
Pantry Door Tracks	Active nesting colony located within door track channels. Live roaches visible inside tracks. Heavy frass, debris, and surface staining. Consistent with long-term harboring.	**HIGH**

Behind Refrigerator — Primary Nesting Zone
Heavy frass covering floor and rear panel. Live roach visible on wall. Water/utility lines contaminated. Long-established harborage site.

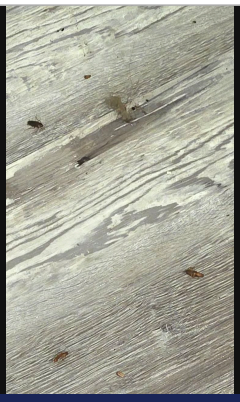
Kitchen Floor — Live Roach Activity
Multiple live German Roaches of mixed life stages confirmed scattered across kitchen floor during inspection.

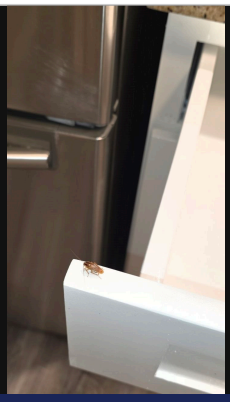
Kitchen Cabinet Drawer — Live Adult Roach
Adult German Roach perched on cabinet drawer edge directly adjacent to refrigerator — primary nesting zone. Clear specimen documentation.

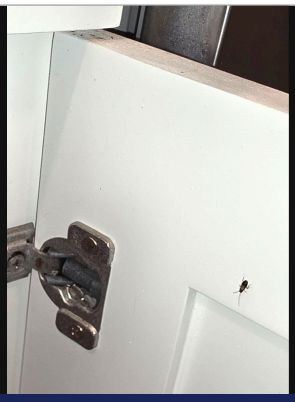
Kitchen Cabinet — Late-Stage Nymph
Late-instar nymph on cabinet door panel near hinge. Frass spotting visible on door surface. Confirms all developmental stages present in kitchen area.

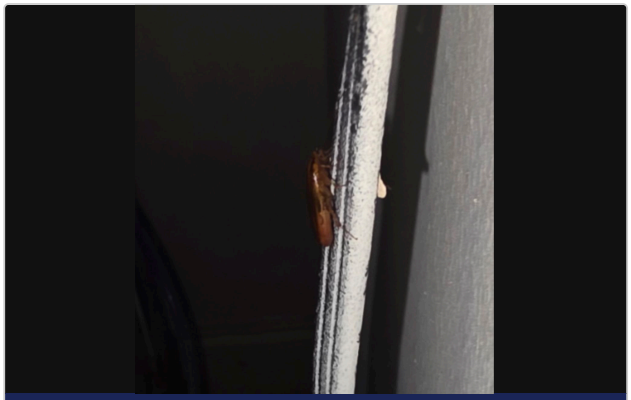
Gravid Female — Active Ootheca (Egg Case)
Pregnant female German Roach with ootheca visibly protruding from abdomen. Confirms active on-site reproduction. One ootheca = 30–40 eggs.

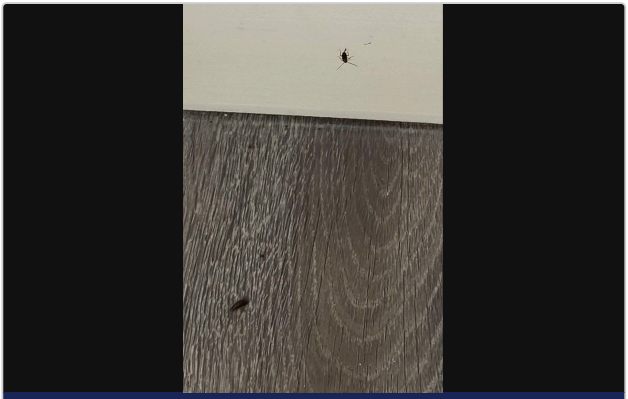
Living Room — Baseboard Activity
Live nymph on wall above baseboard. Confirms spread well into the primary common living area.

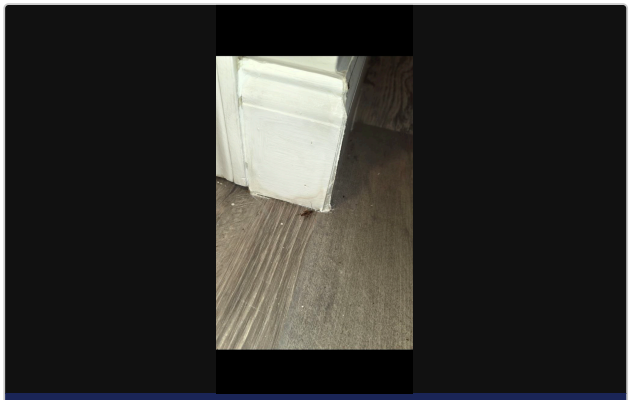
Hallway	Live adult German roach at base of door frame. Frass debris on floor nearby. Confirms full-unit spread via primary corridors.	**MODERATE**
Secondary / Guest Bathroom	Live adult German roach confirmed on floor at baseboard junction. Activity present in both bathrooms.	**MODERATE**
Cracks & Crevices / Wall Voids / Door Frames	Multiple nests flushed from cracks and crevices, wall voids, and door frames throughout the unit during treatment. Nesting evidence consistent with a long-established infestation.	**HIGH — Widespread**

Hallway — Live Roach at Door Frame Base
Adult German Roach at base of door frame with frass debris on floor. Confirms spread through main corridor of the unit.

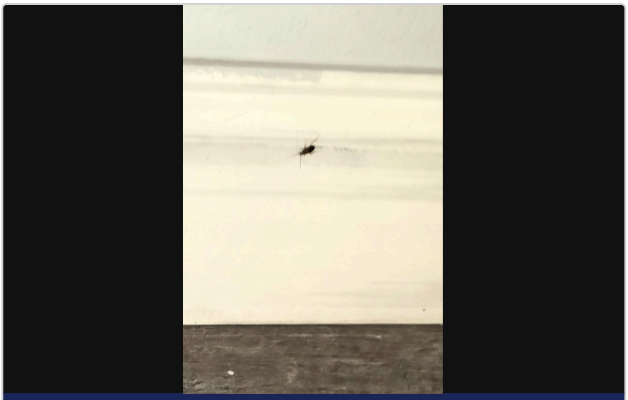
Secondary Bedroom — Live Roach on Baseboard
Live adult German Roach on wall above baseboard. Confirms activity in all sleeping areas.

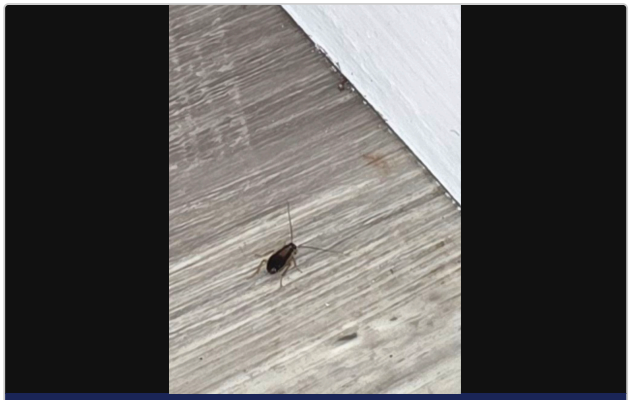
Secondary / Guest Bathroom — Live Adult Roach
Large live adult German Roach on floor at baseboard junction. Clear, well-documented specimen. Activity confirmed in both bathrooms.

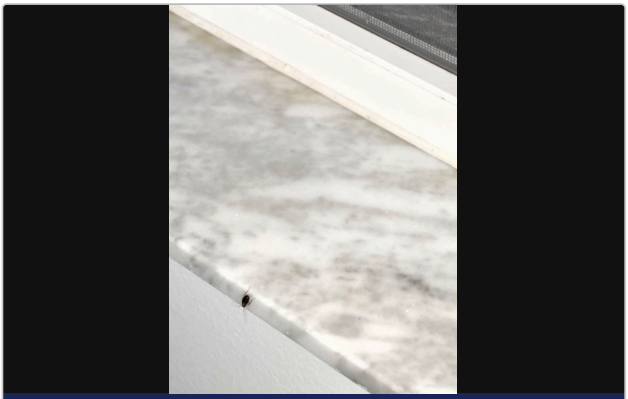
Master Bedroom — Window Sill Activity
Live nymph at front edge of window sill. Confirms spread into master bedroom and window frame areas.
